## RED LBP PRE-PURCHASE REPORT

# PRE-PURCHASE BUILDING REPORT

<b>Property Address</b>	36 Burn Street, Levin 5510
<b>Client</b>	Iraia Peni
<b>Date of Inspection</b>	12th December 2025
<b>Time</b>	1:00 pm
<b>Inspector</b>	Tom Kimberley National Certificate in Carpentry, Licensed Building Practitioner.
<b>LBP Number</b>	131336
<b>People Present</b>	Inspector
<b>House Occupied</b>	No

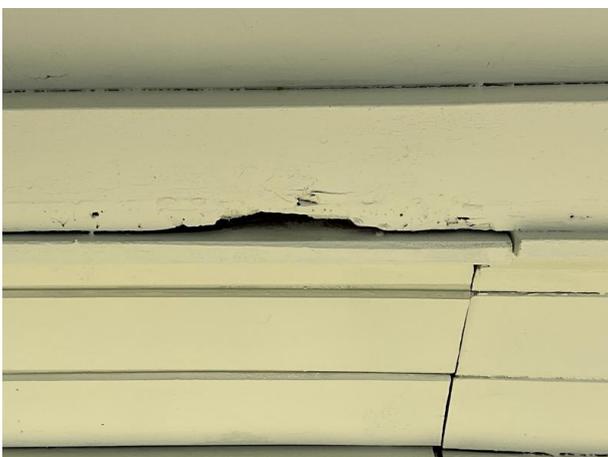
**Photo 9**  
Area of visible timber decay at surface to the support beam on the western side.

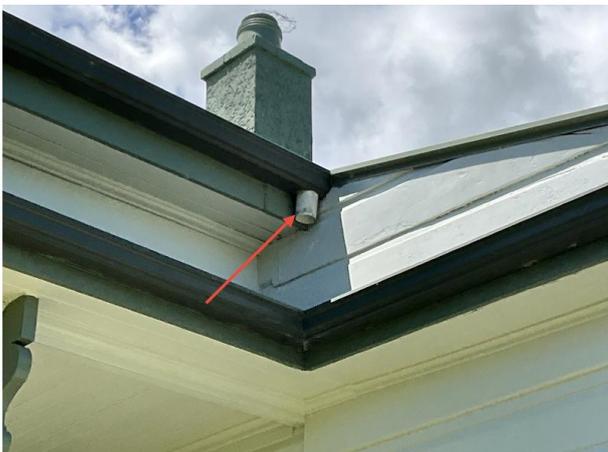
**Photo 10**  
There is no downpipe attached to the dropper on the southwestern corner.

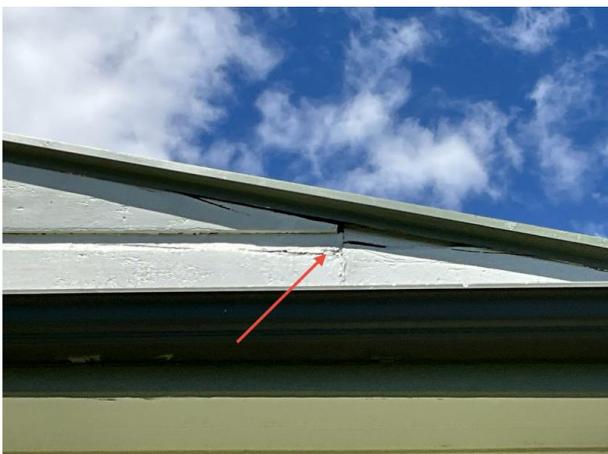
**Photo 14**  
Deterioration to the weatherboard cladding located on the southwestern corner.

It is recommended to inspect the exterior cladding and repair or replace any sections that are rotten or damaged. Deteriorated cladding can compromise the building's weathertightness, leading to moisture ingress, structural weakening, and potential mold growth. Ensuring that all damaged cladding is properly replaced or repaired will help maintain the integrity and durability of the building while preventing further deterioration.

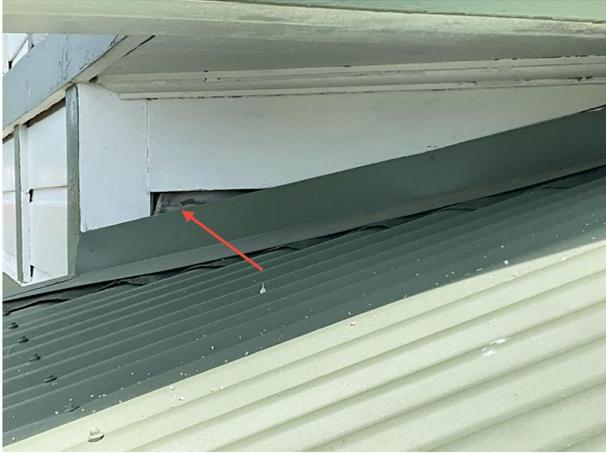
**Photo 15**

Area of missing cladding located on the northern side.

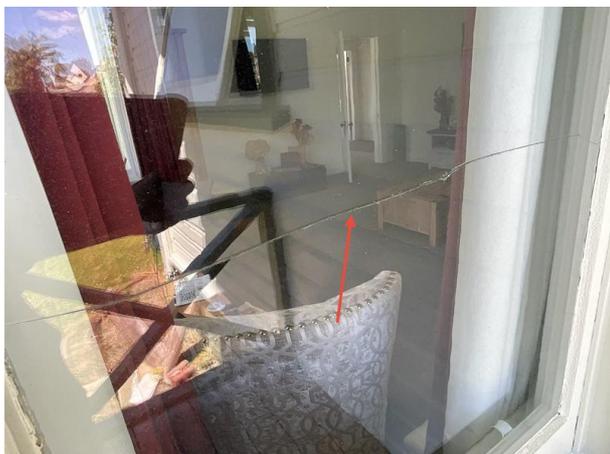
**Photo 19**  
Cracking to the glass of the bay window  
on the southwestern corner.

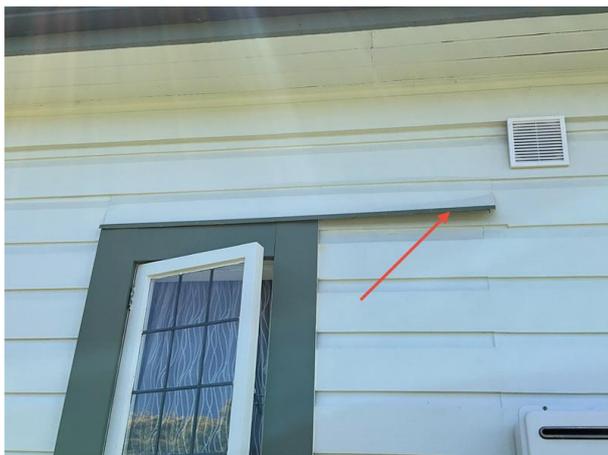
**Photo 20**  
The window head flashing on the southern side of the house is loose

Head flashings are absent to sections of the exterior joinery, increasing the risk of moisture ingress at the junction between the joinery and cladding. It is recommended that suitable head flashings be installed by a suitably qualified contractor or Licensed Building Practitioner (LBP) to direct water away from the joinery and improve the weathertightness of the exterior envelope.

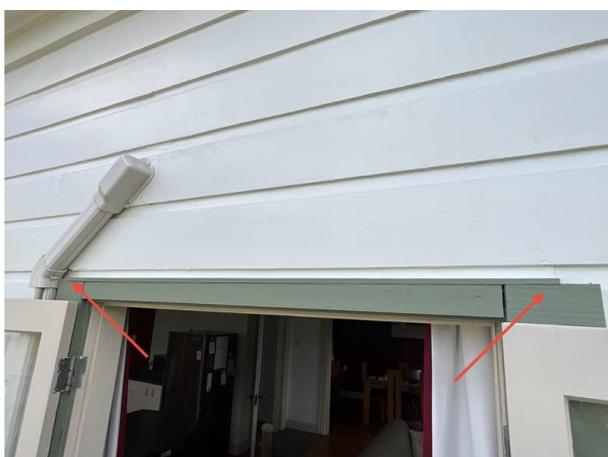
**Photo 21**  
Head flashing located above the timber window joinery on the eastern side of the house above the deck does not extend the full length of the timber joinery.

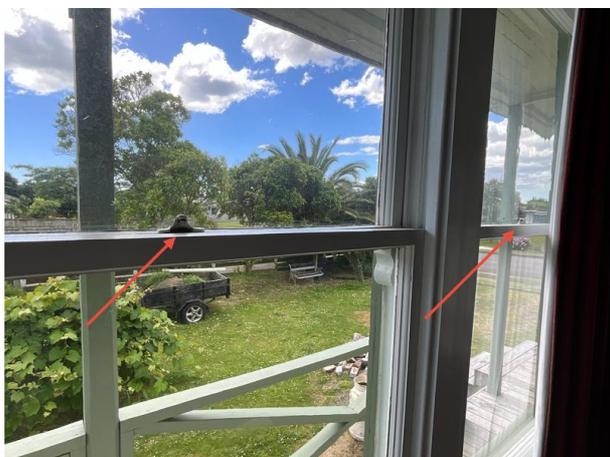
**Photo 24**  
Non-functional window hardware located in the living room.

Some repairs required to the opening sashes of the windows in order to restore functionality and to reduce draughts.

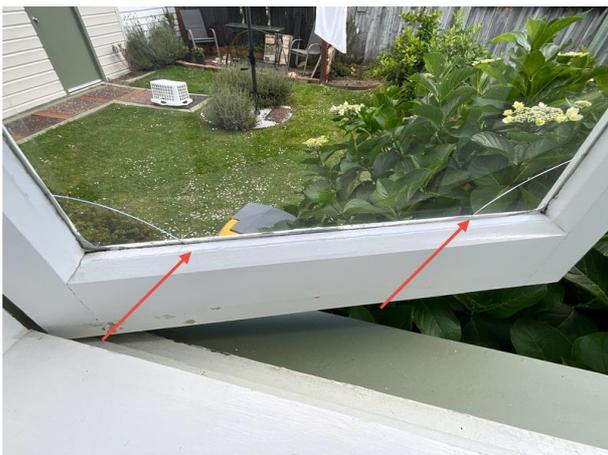
**Photo 26**  
Cracking to the glass in the western window of bedroom 3.

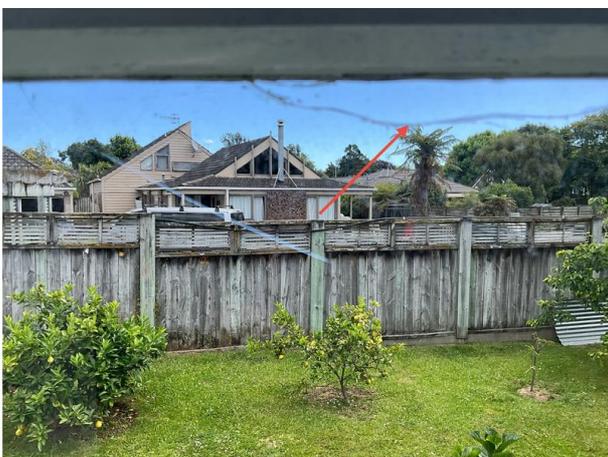
**Photo 27**  
Cracking to the glass in the western window of bedroom 3.

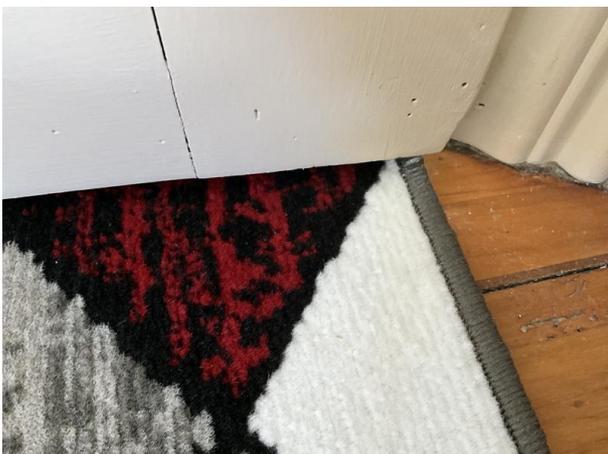
**Photo 28**  
The lounge exterior door is binding on the bottom edge.

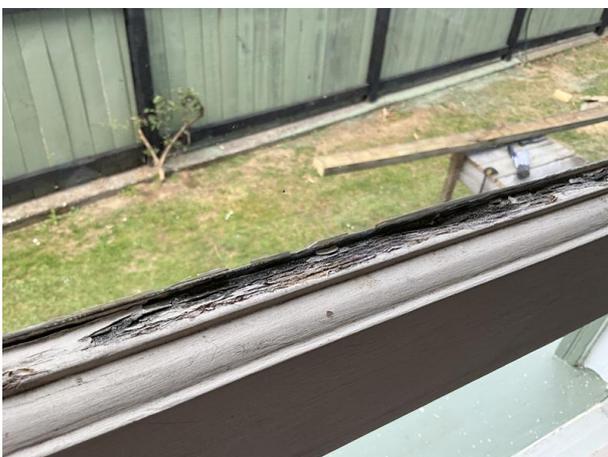
**Photo 30**  
Moisture damage to the painted surface of the lounge window sashes.

Painting should be maintained in accordance with normal exterior maintenance schedules.

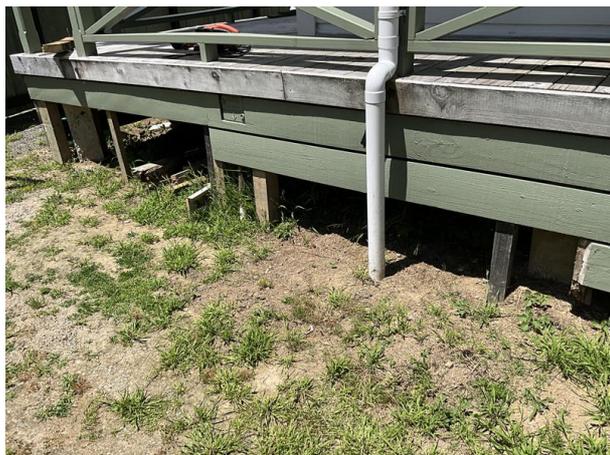
**Photo 31**  
Missing foundation baseboards located on the western and southern sides of the house.

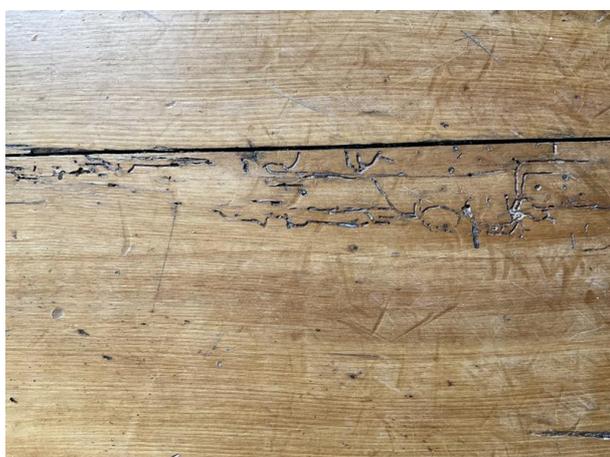
Borer-damaged flooring timbers were evident, as expected and consistent with buildings of this age. No urgent maintenance is required.

**Photo 32**  
Visible borer damage to the lounge floor.

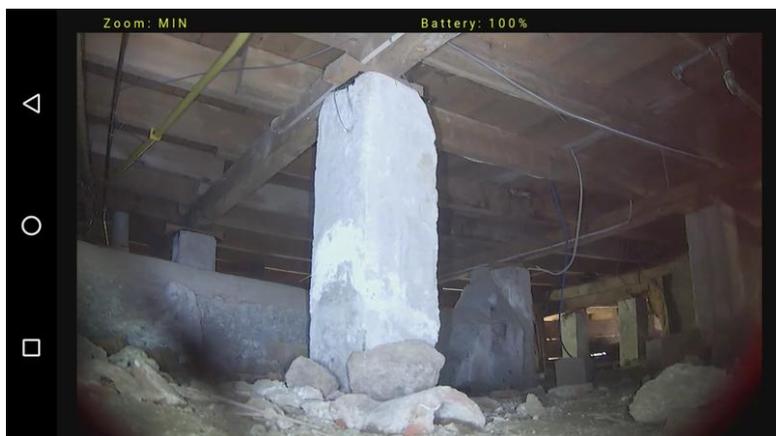
**Photo 33**  
Pre-cast concrete piles. No underfloor insulation. Ariel wiring and yellow gas pipe.

It is recommended to install code-compliant subfloor insulation.

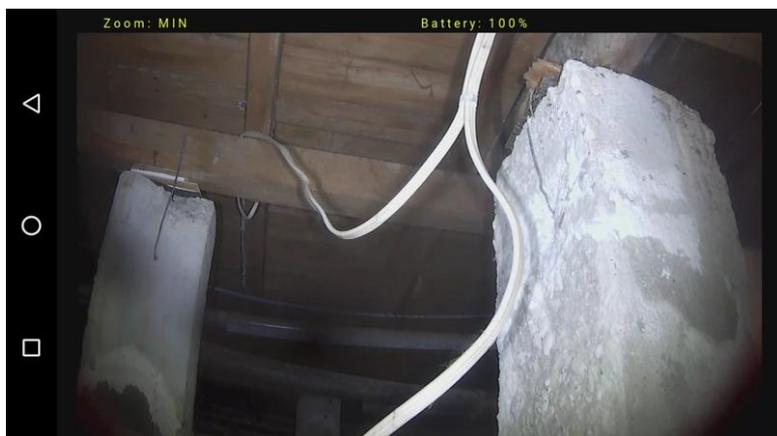
**Photo 36**  
Unsupported TPS wiring.

It is recommended to support any loose wiring.

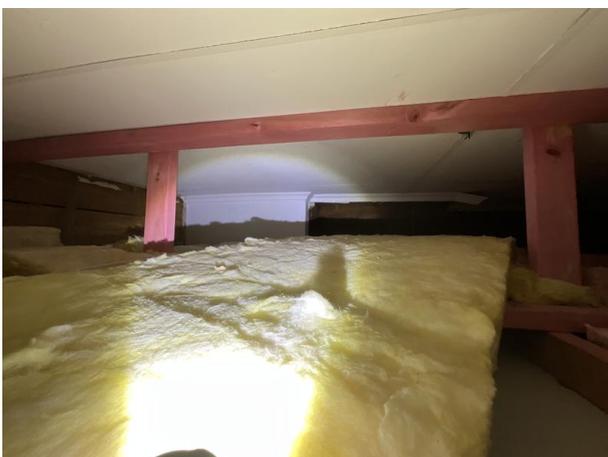
**Photo 38**  
Area of insulation requiring tidying above the bedroom 2 roof space.

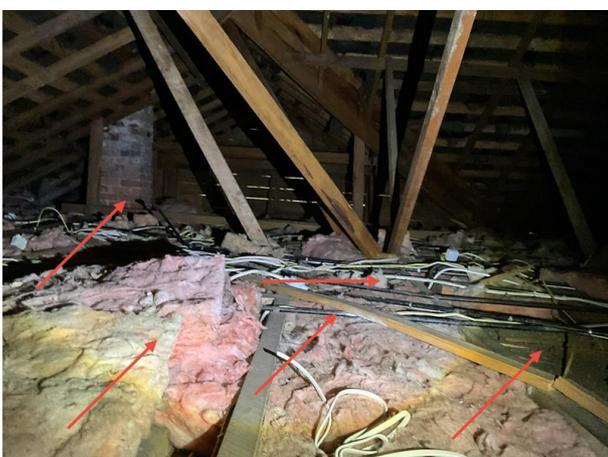
**Photo 41**  
Disrupted glass wool insulation, modern TPS and steel conduit wiring, chimney penetration. Missing area of insulation.

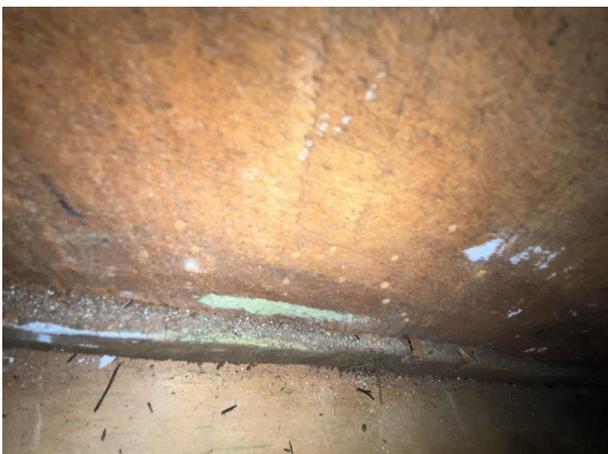
**Photo 45**  
Borer damage located around the main  
man hole in the kitchen.

Borer-infested timber can be treated, but if timbers are severely weakened you should strengthen the timber or ultimately the timber may need to be replaced.

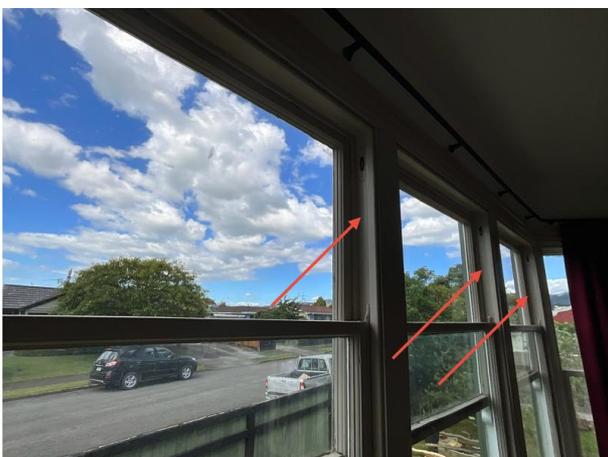
**Photo 63**  
The lounge windows are missing their counterweight ropes.

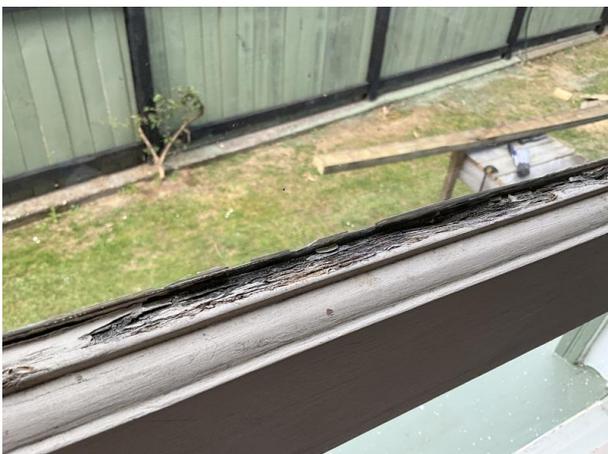
**Photo 64**  
Moisture damage to the painted timber window reveals of the lounge window.

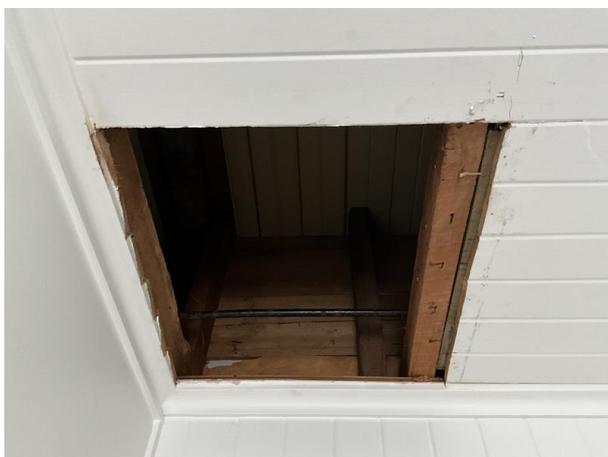
**Photo 70**  
Area of ceiling in the bathroom has been cut away.

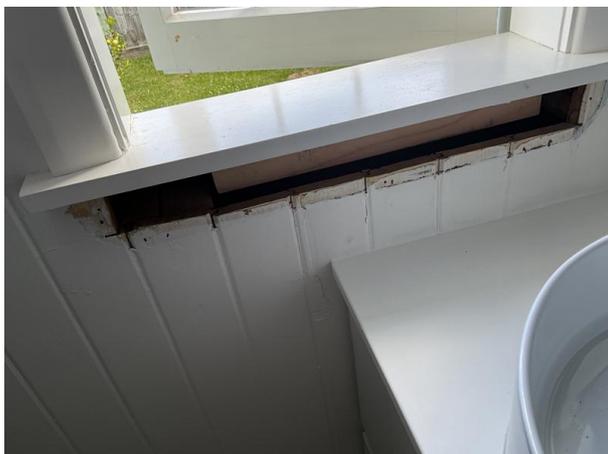
**Photo 71**  
Missing area of wall lining below the bathroom window.

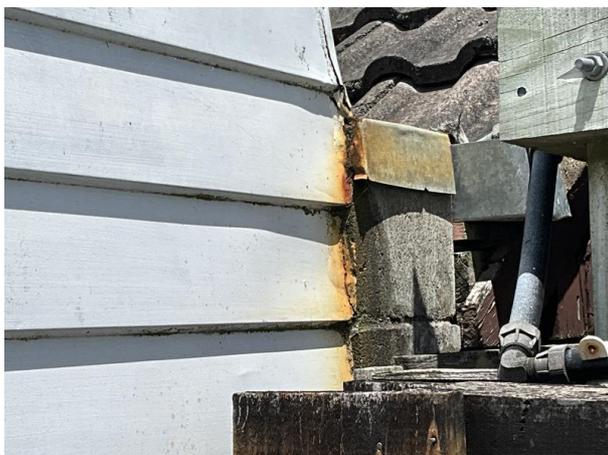
**Photo 73**

Area of corrosion to the metal cladding on the southwestern side of the garage.

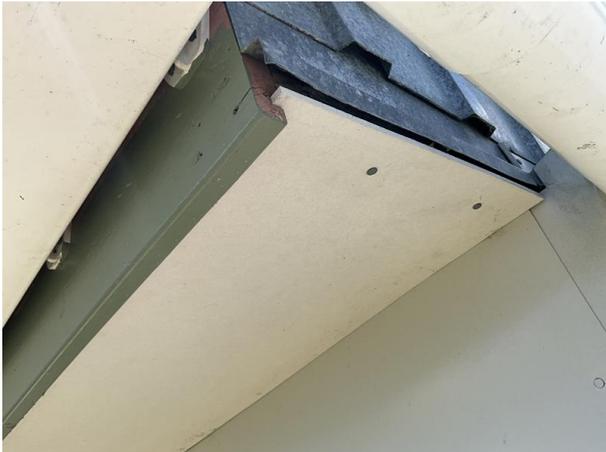
**Photo 74**  
There is no decoration to the fibre cement soffits of the garage.

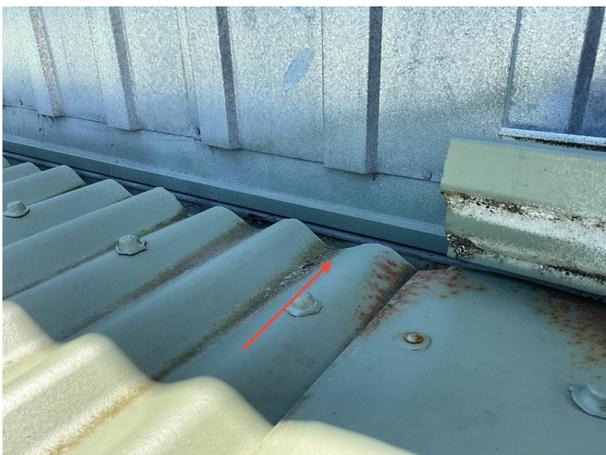
**Photo 77**  
Corrosion to the profiled metal sheeting of the linen tube behind the garage.

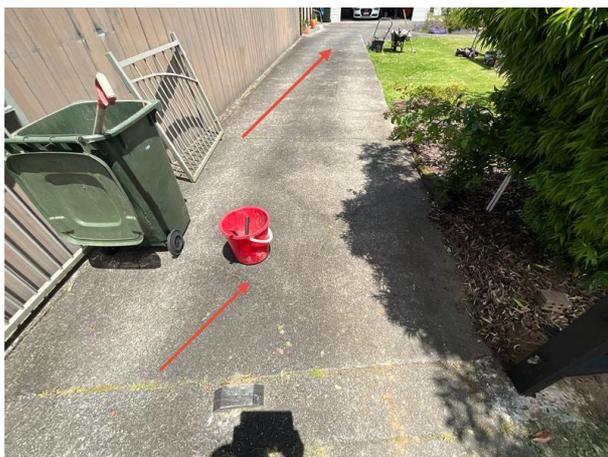
**Photo 79**  
Concrete driveway located on the eastern side of the house. Areas of visible cracking.

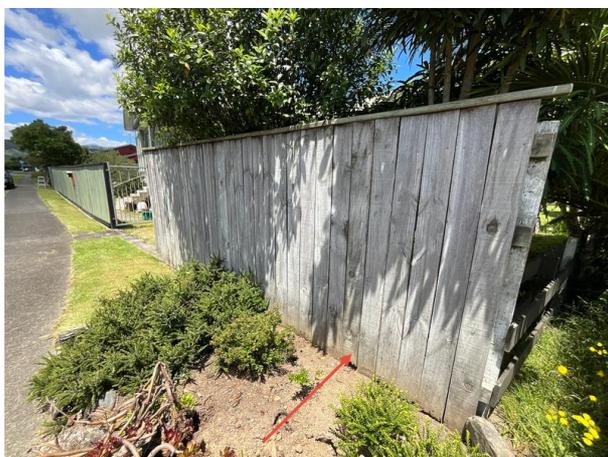
**Photo 80**

Northern Boundry fence. Painted and unpainted timber palings with timber rails and posts. The unpainted area of fencing is in a direct contact with the ground.

Ensure regular upkeep and maintenance by keeping vegetation and soil away from exterior timbers. These timbers are treated for external exposure but are not designed for prolonged contact with vegetation or soil, which can trap moisture and accelerate rot. Periodically inspect the area and clear any overgrowth or soil buildup.

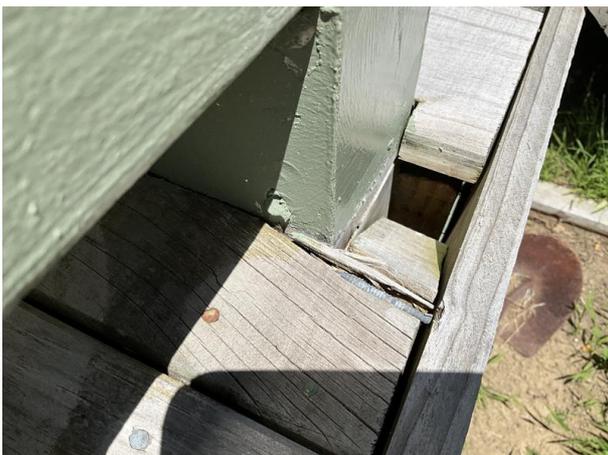
**Photo 89**  
Area of damaged decking on the western side.

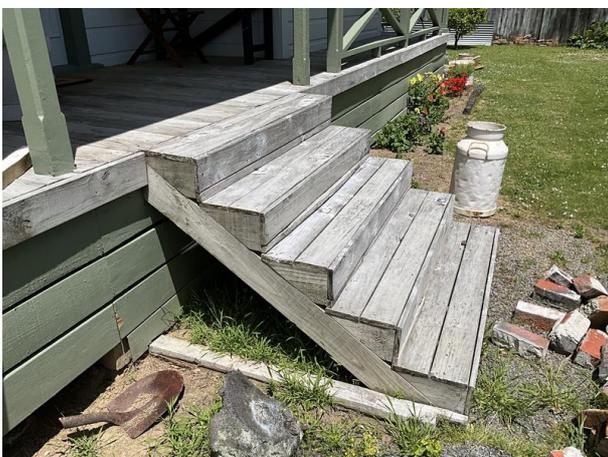
**Photo 90**  
Western deck steps. No handrail has been installed.

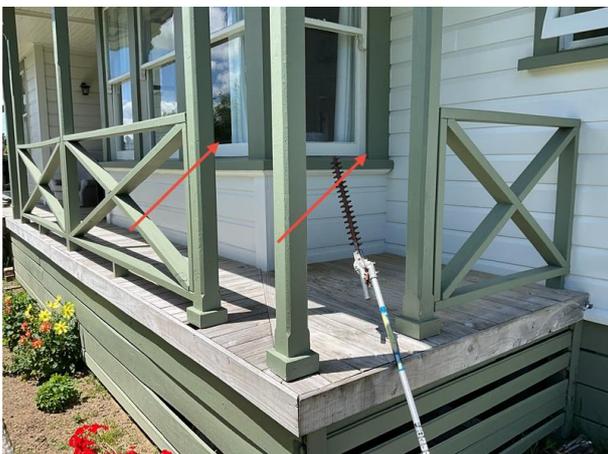
**Photo 94**  
Area of missing balustrade to the deck on the western side of the house.

It is recommended that the missing areas of balustrade are reinstated.
