HUTT HOUSE INSPECTIONS LTD

PROPERTY REPORT

**4 Thackeray Street
Trentham**

**CERTIFICATE OF INSPECTION IN ACCORDANCE
WITH NZS 4306:2005**

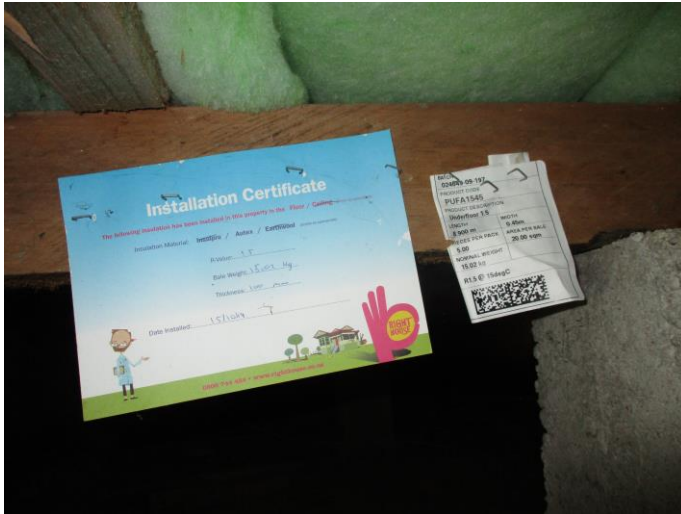
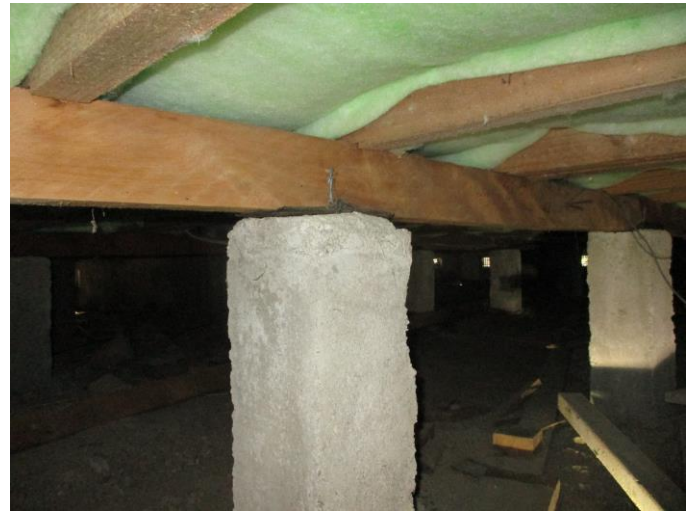
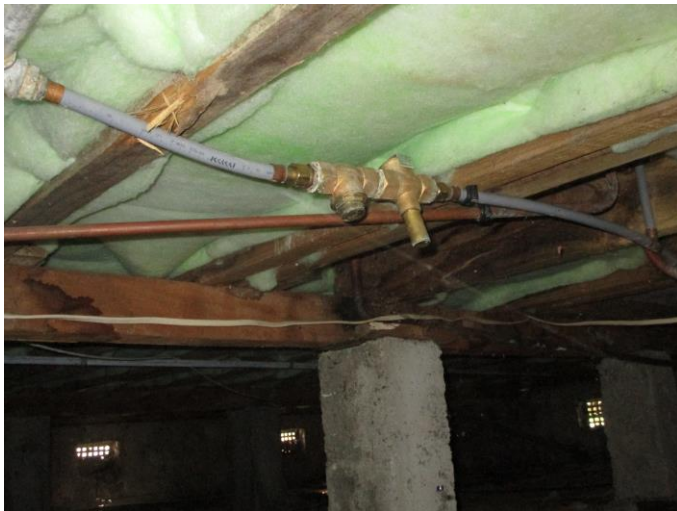
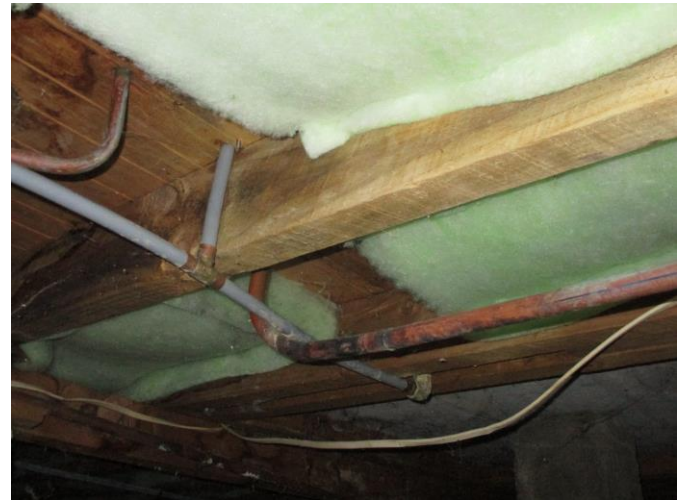
SUBFLOOR		
FEATURES INSPECTED	YES	COMMENTS
Location of access point	✓	Through foundation wall
Accessibility	✓	Good
Foundation type	✓	Traditional
Foundation walls	✓	Concrete
Ground condition	✓	Dry
Ventilation adequacy	✓	Good
Pile type	✓	Concrete
Pile to bearer connections	✓	Wired
Bearers and floor joists	✓	Timber
Floor type	✓	Timber floorboards
Insulation	✓	R1.5 Autex installed
Plumbing	✓	Copper and buteline
Electrical	✓	TPS wiring
Insect and pest infestation	✓	Nothing noted

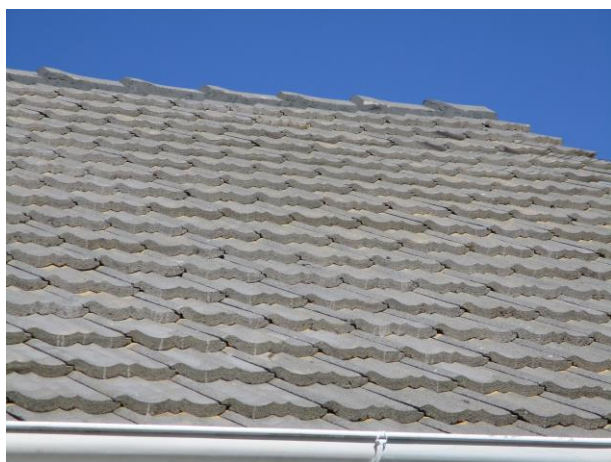
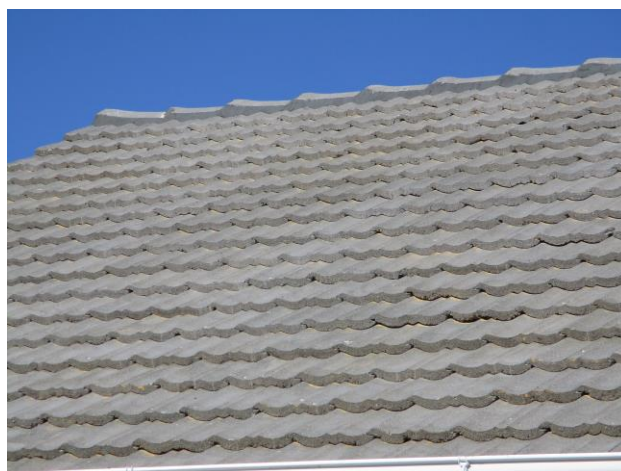
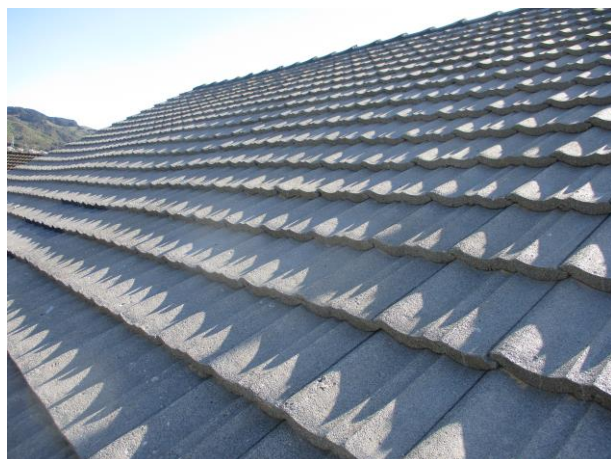
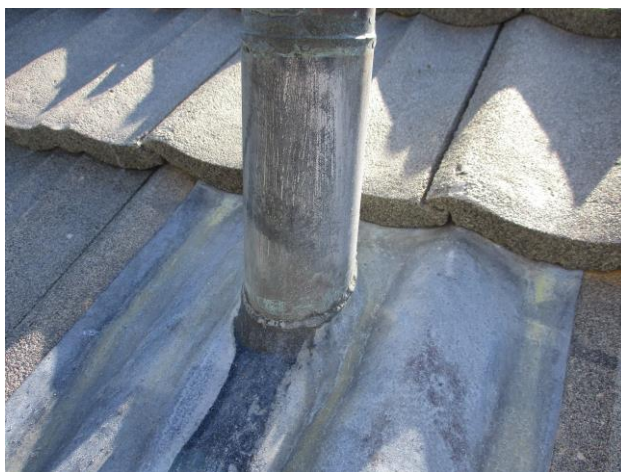
ROOF		
FEATURES INSPECTED	YES	COMMENTS
Roof material	✓	Concrete tiles
Roof condition	✓	Well maintained
Spouting	✓	Copper
Downpipes	✓	Copper
Eaves	✓	Yes
Fascia & Bargeboards	✓	Painted timber
Soffits	✓	Fibrolite

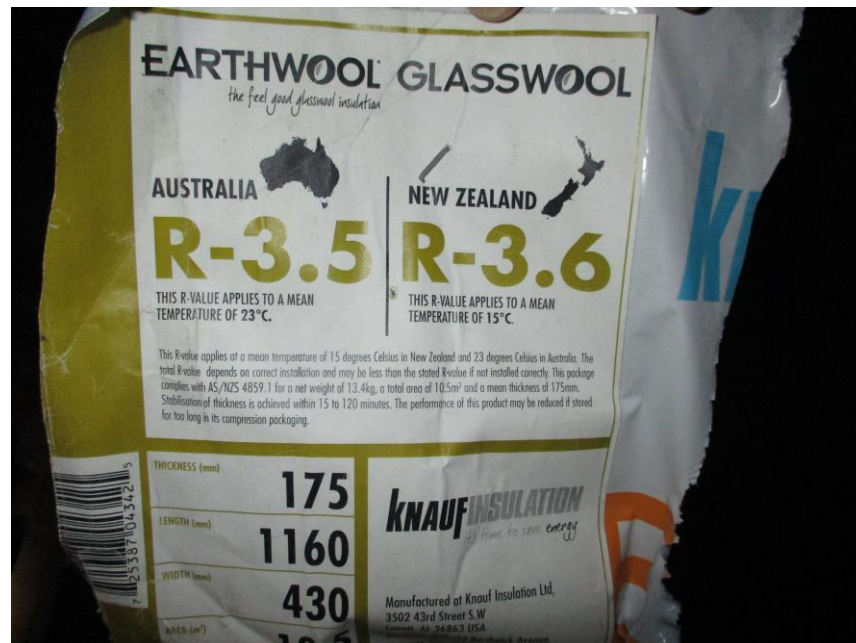
FEATURES INSPECTED	YES	COMMENTS
Accessibility	✓	Hatch in laundry
Insulation	✓	R3.6 pink batts laid over existing insulation
Roofing underlay & support	✓	Tile battens
Roof frame construction	✓	Pitched rafters
Ceiling construction	✓	Ceiling joists
Insect and pest infestation	✓	Nothing sighted
Electrical	✓	TPS wiring
Tile fixings	✓	Tiles wired to battens

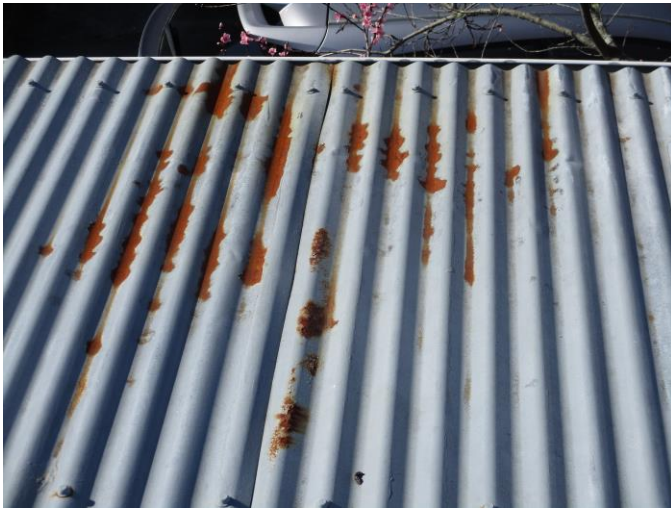
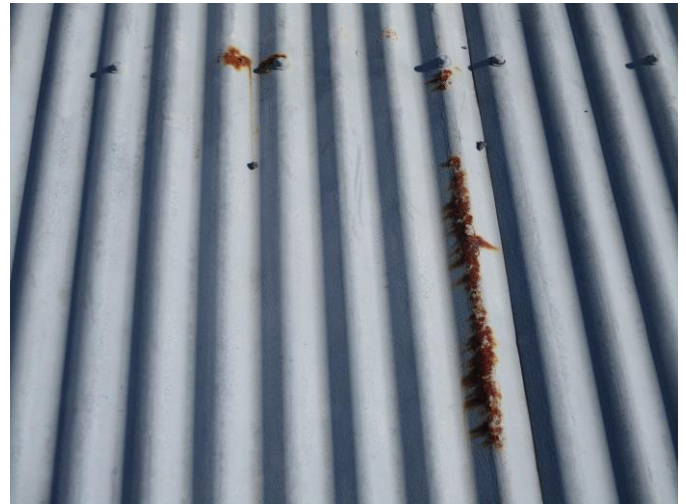
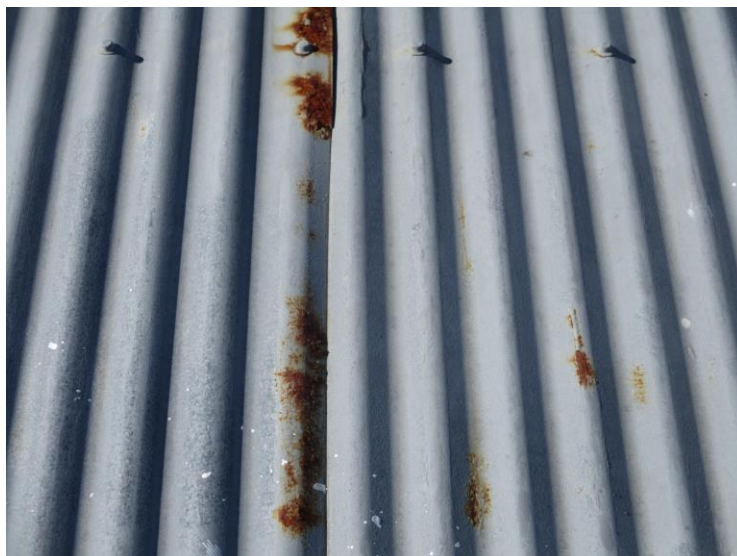
There is surface rust visible on the carport roof and this will need treating and the roof should be painted.

CARPORT		
FEATURES INSPECTED	YES	COMMENTS
Location and type	✓	Single attached carport
Exterior claddings	✓	Timber vertical board
Roofs	✓	Corrugated iron
Roof construction	✓	Timber rafters
Wall construction	✓	Timber framed boundary wall lined with either fibrolite or hardiflex sheets
Floor type	✓	Concrete

Some of the sheets may require replacing.
