# Independent Builders Report

Total Home Inspection Services Porirua City Ltd

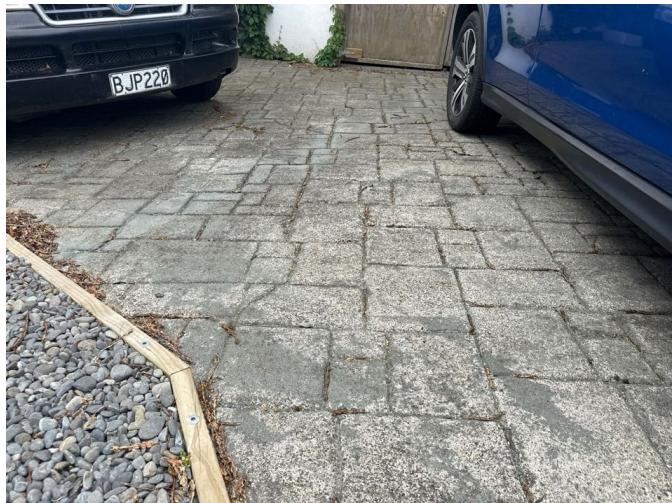
The driveway slopes towards the garage. Common and minor shrinkage cracking to the driveway noted.

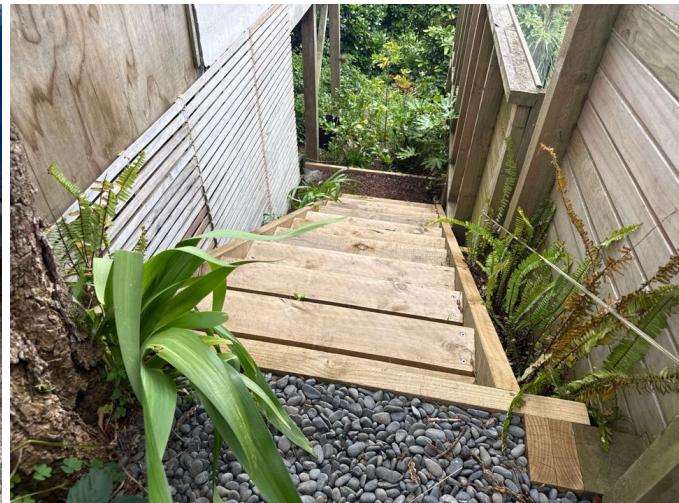
The timber stairs down the south side of the garage are solid and secure

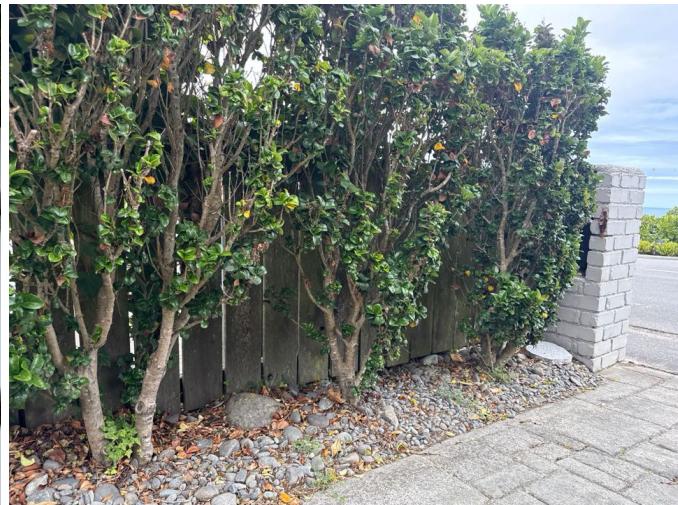
T.H.I.S is unable to comment on the condition of fencing or retaining that are concealed by vegetation.

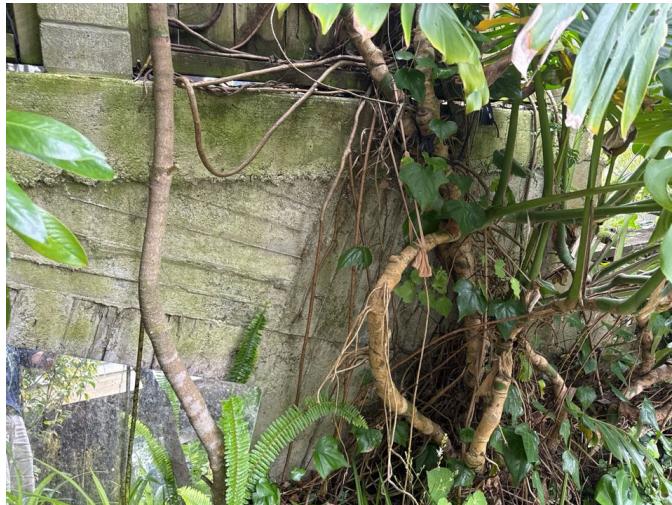
The concrete retaining wall on the north side was showing no evidence of damage

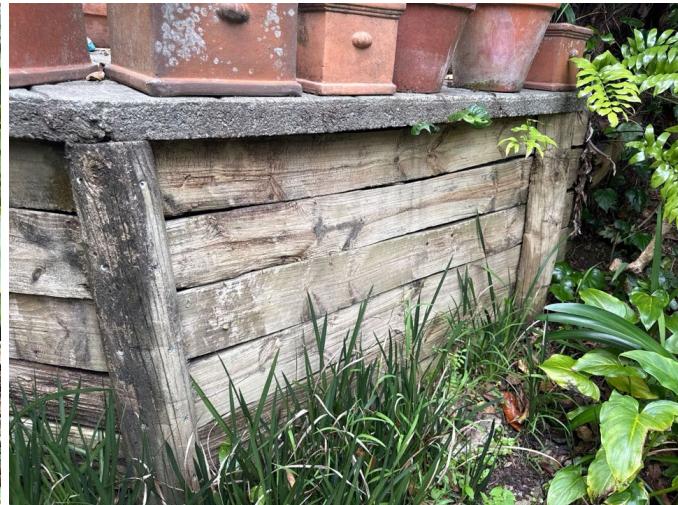
Age related wear to the timber retaining walls which will need to be monitored. These are still effective.

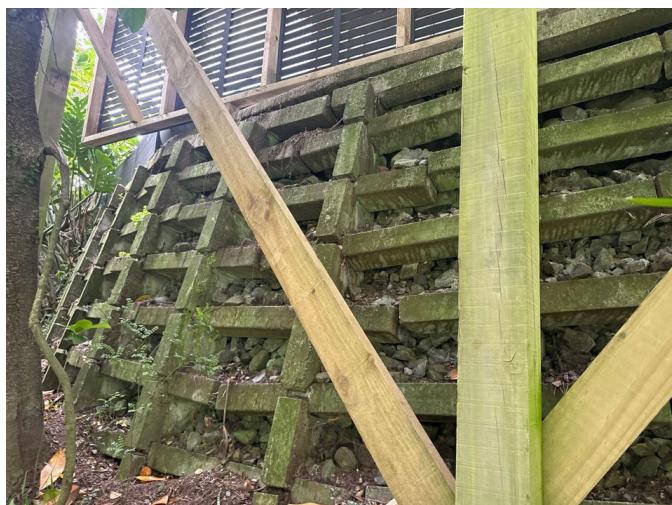
The concrete crib retaining wall is solid and secure

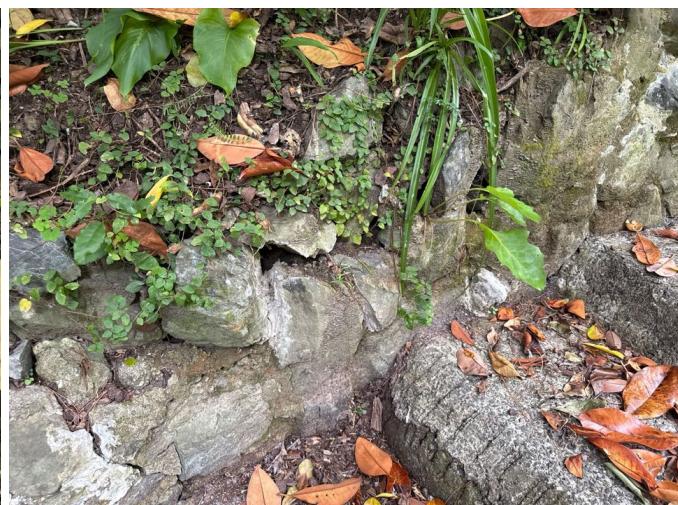
Deterioration to the original stone retaining wall on the steep east side. Retaining improvements are required where deterioration is present.

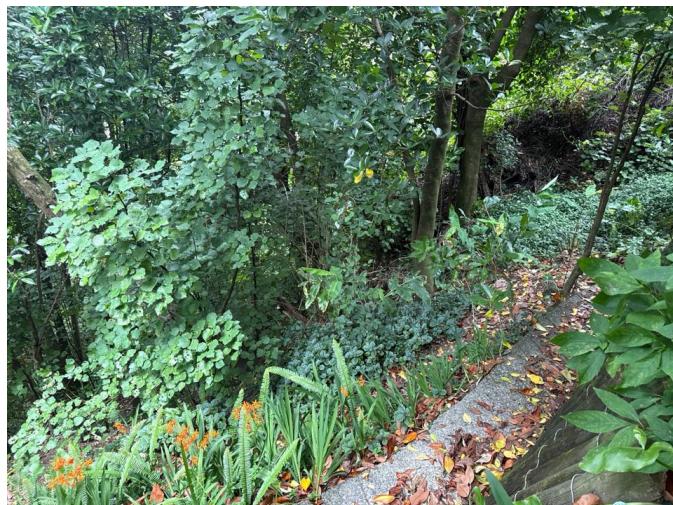
Steep bush clad section to the east side noted.  
There was no evidence of significant erosion sighted  
on the day of the inspection.

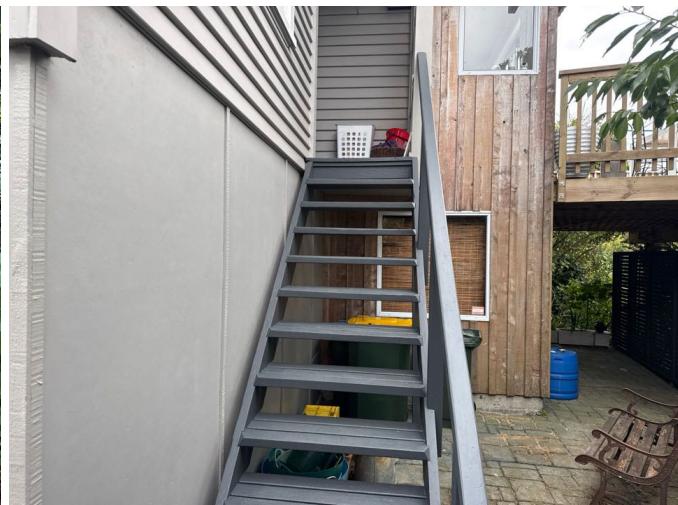
The timber stairs and handrail are solid and secure

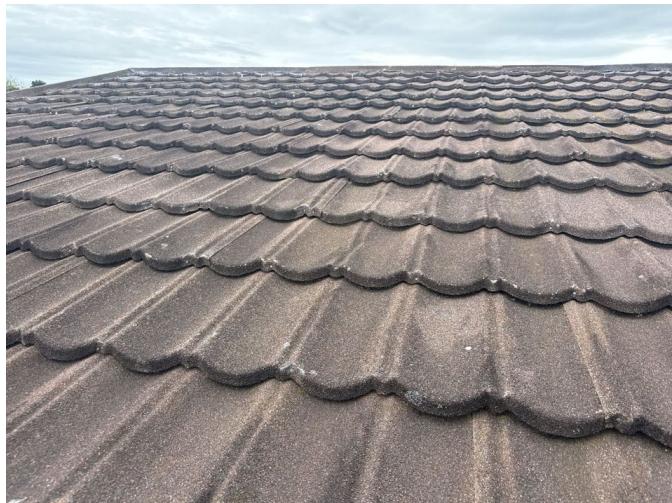
Some Decramastic tiles from the early 80's and previous decades can potentially contain Asbestos fibres in the glues used to adhere the stone chips. There are no risks associated with pressed metal roof tiles containing Asbestos if they remain in good condition and left undisturbed. This type doesn't appear to have mastic or bitumen binding the chip coat however testing would be required to fully determine this.

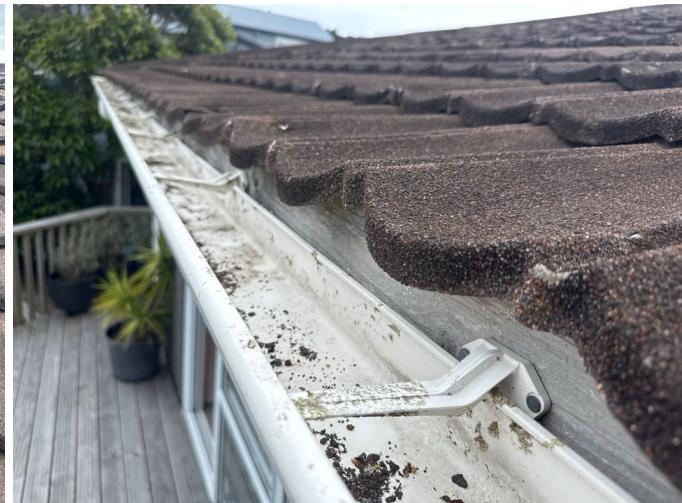
The spouting is in an average condition and is clear. The effectiveness of the spouting will need to be checked during rainy periods. Due to the dry conditions that were evident on the day of our inspection we cannot comment on any leaks that maybe evident to the spouting or down pipes.

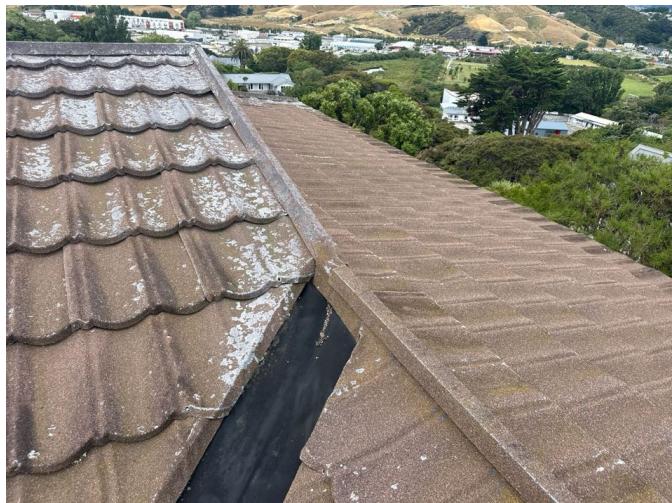
The roof flashings appear to be secure, intact and are effective. No sign of failure could be found beneath where accessible to view.

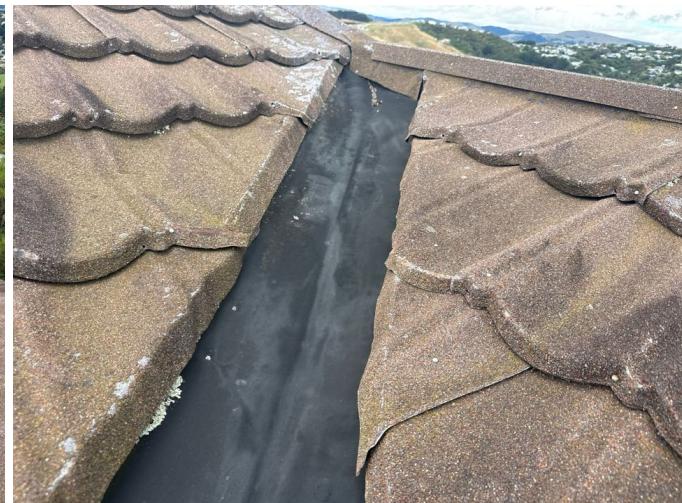
The Butynol waterproof membrane to the valleys is intact

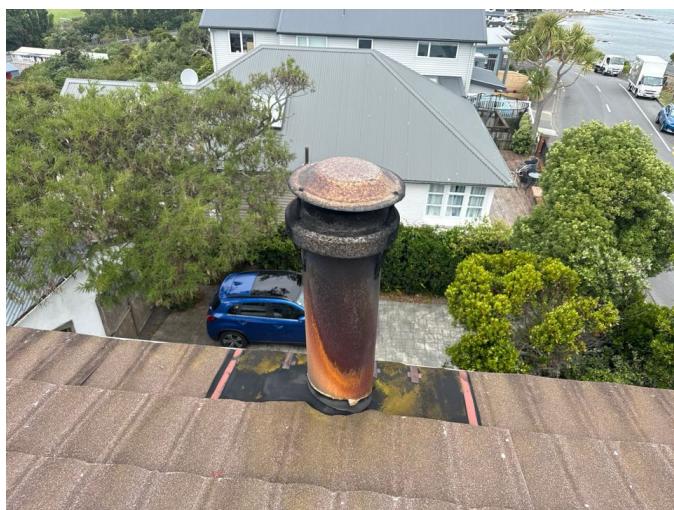
Age related wear to the steel flue. The waterproof membrane flashing appears to be secure, intact and effective.

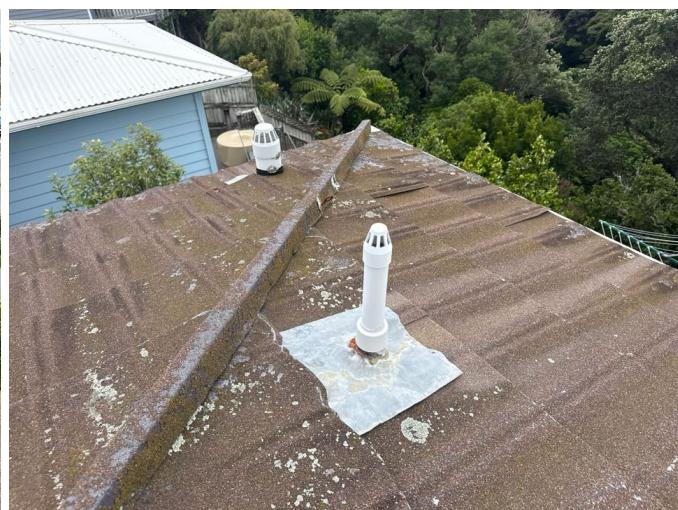
The roof penetrations are effectively sealed

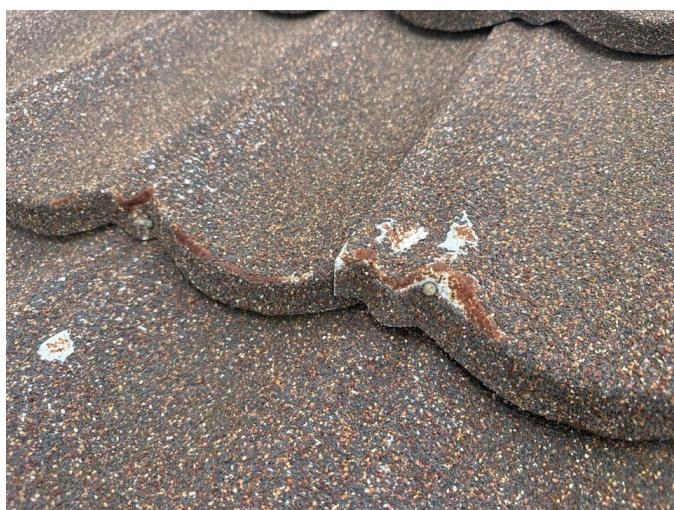
Example. Rust to the tiles at various locations.

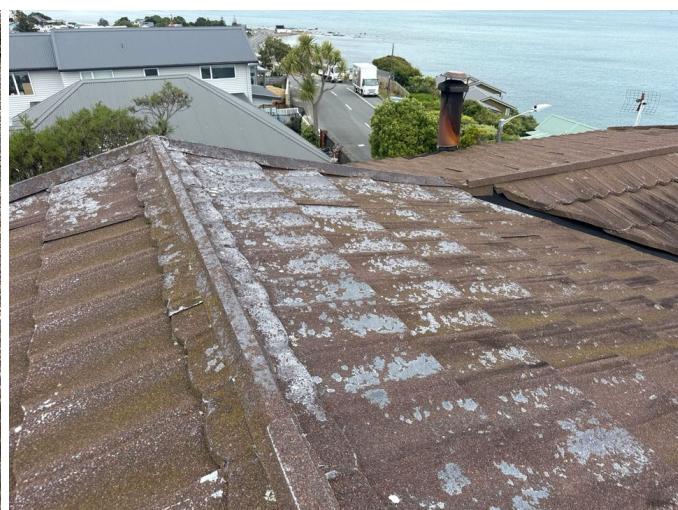
Surface wear to the chip coating

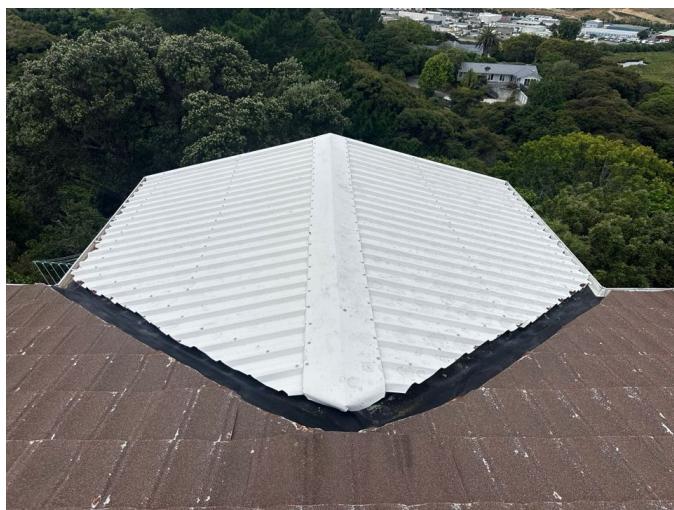
Rust to the edges of the steel roof. Rust treatment and paint touch up with slow the deterioration (recommended).

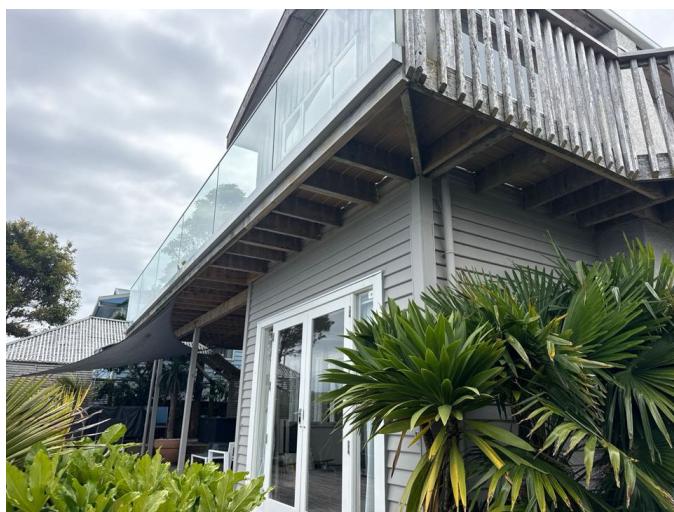
The front faces to the West

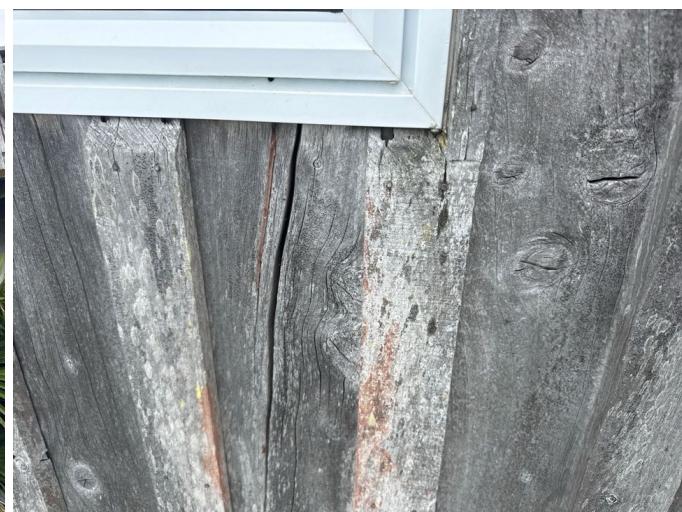
The cracked weatherboards are at risk of rot damage and water ingress issues. Thorough waterproofing improvements are required or the boards replaced.

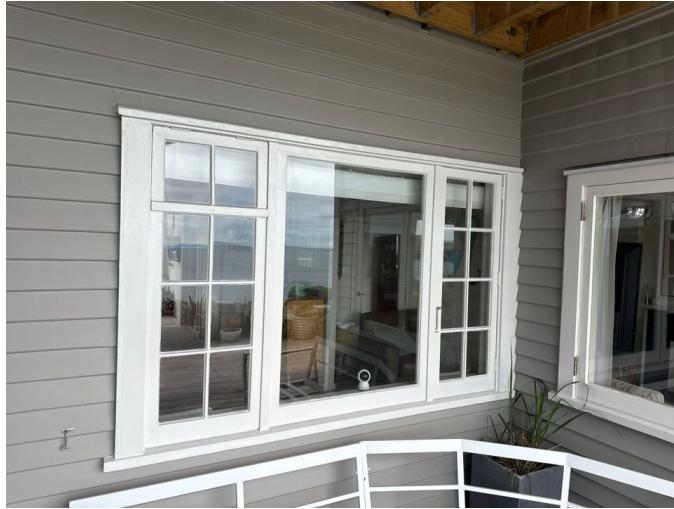
The typical single glazed timber joinery detail consists of a head flashing, timber facings, scribes and sill.

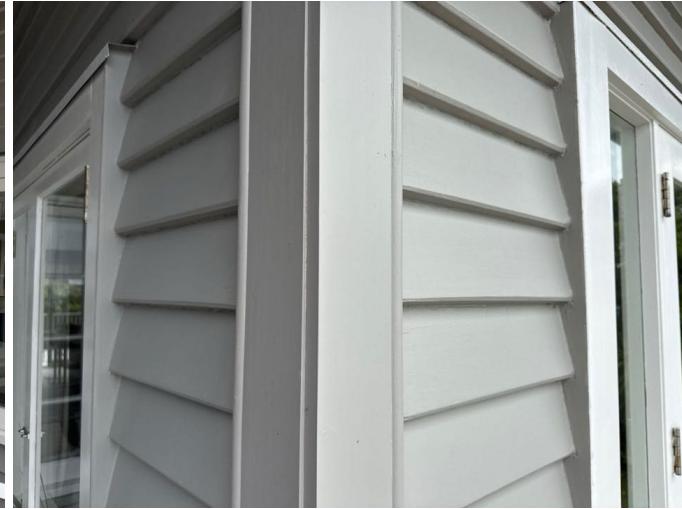
Timber box corner and scribe detail to the external corners. Box corners protect the external weatherboard joins from deterioration and is a second layer of weather protection. Well installed and sealed throughout.

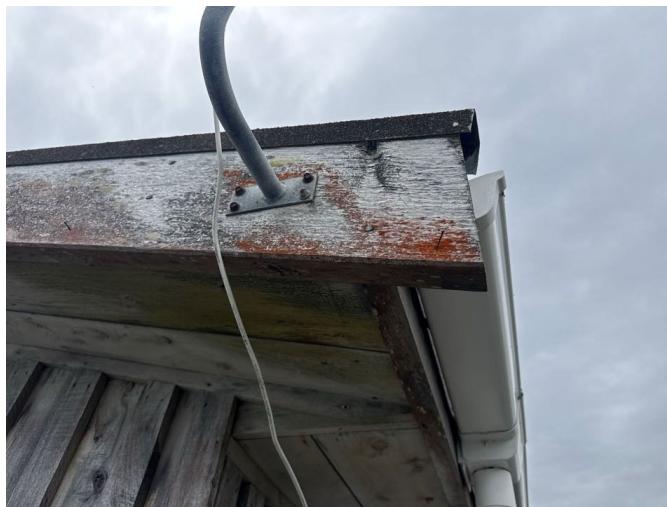
The unsealed barge boards and fascia are in an average overall condition

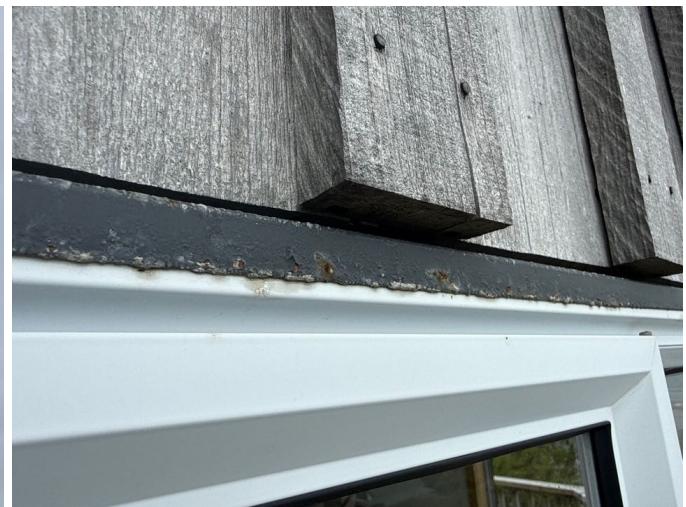
Some of the homes head flashings have superficial corrosion. This will get worse if left and requires the corrosion to be removed before sealing with rust converter and painting. Risk of water ingress issues if left to deteriorate.

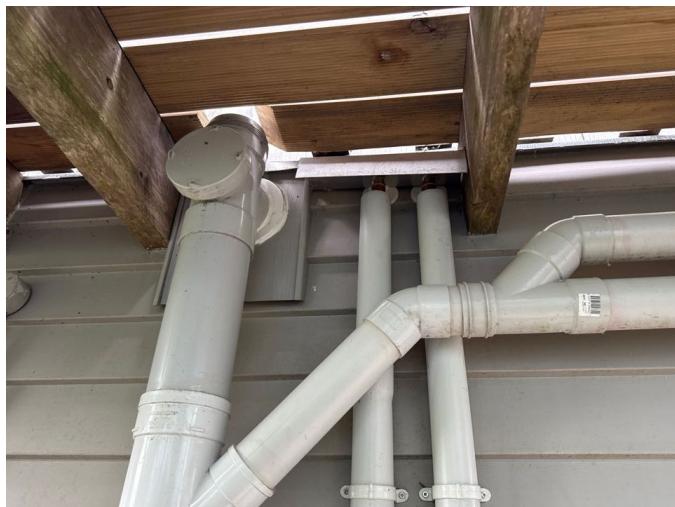
Cladding penetrations in general are a weather tightness risk area. Penetrations such as taps, screw fixings, gas or water pipes etc. A good seal must be maintained around all cladding penetrations over time to prevent issues.

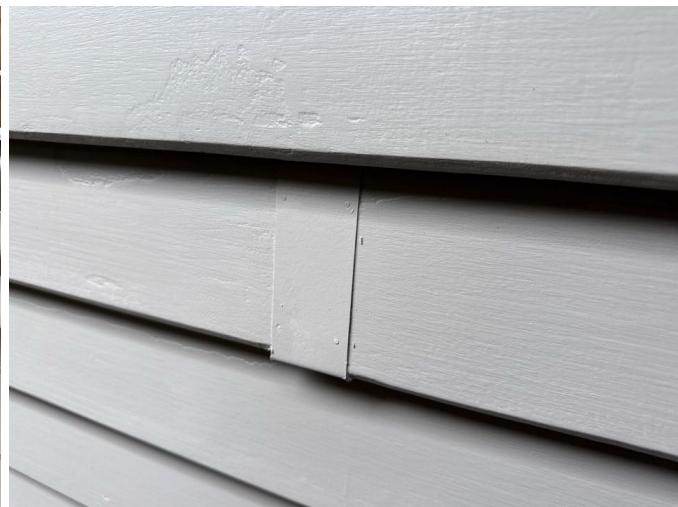
Face soakers provide weatherproofing to the weatherboard joins

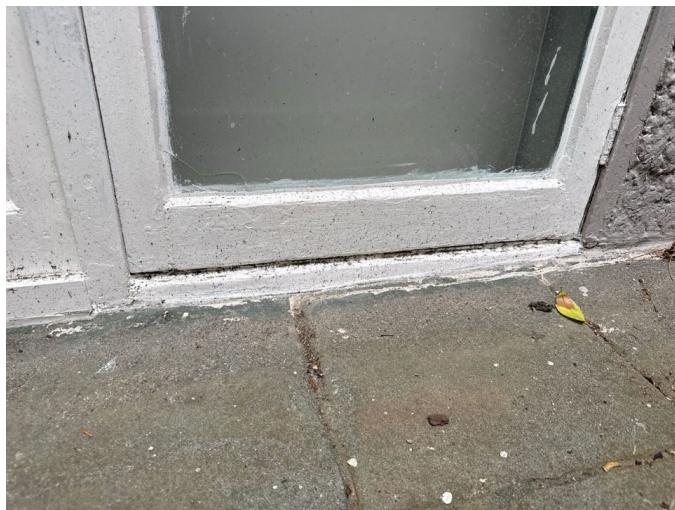
Timber in close contact with the ground is at risk of premature deterioration and must be kept thoroughly sealed. Paint improvements are recommended anywhere that surface wear is present.

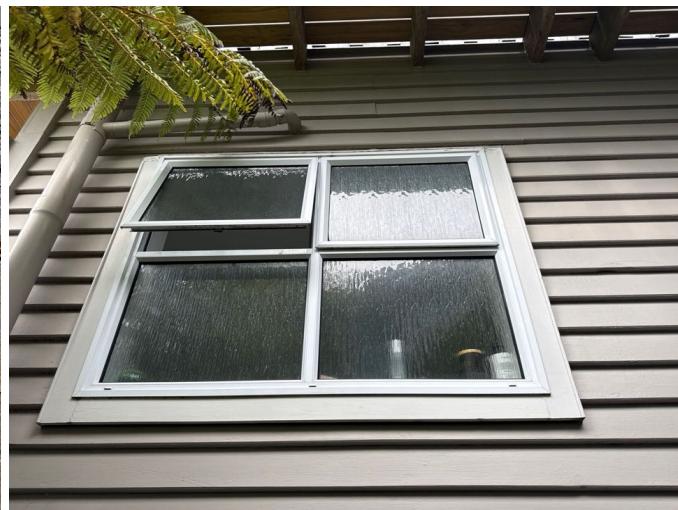
The single glazed aluminium joinery are effectively flashed and sealed

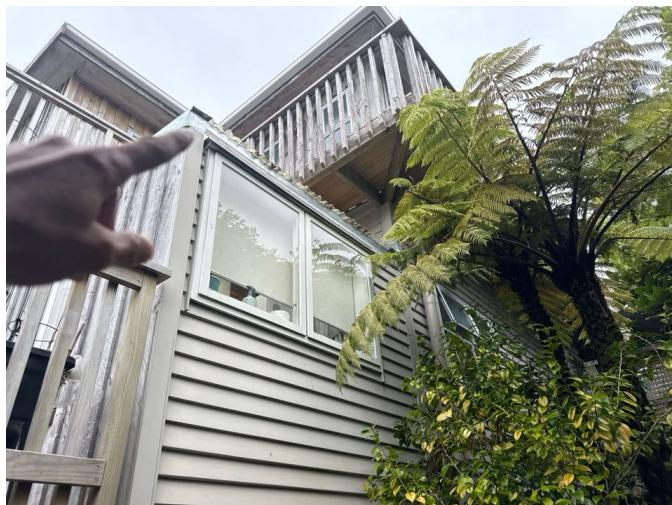
There is no spouting beneath the extended section.  
This has not caused any significant issues to date.

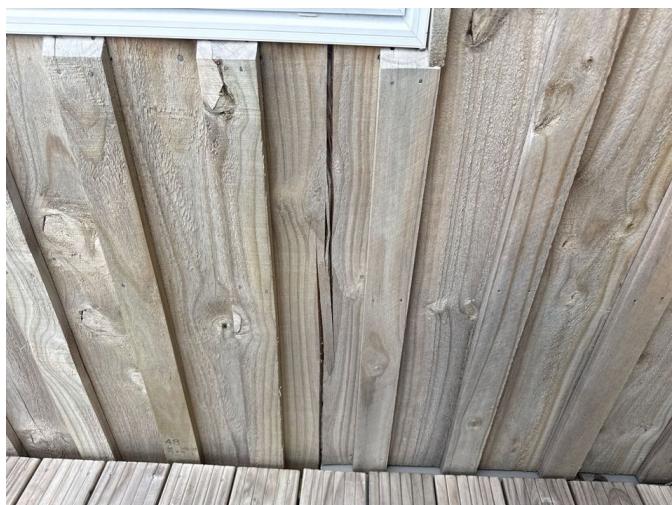
Significant crack to the new cladding. Waterproofing or replacement recommended.

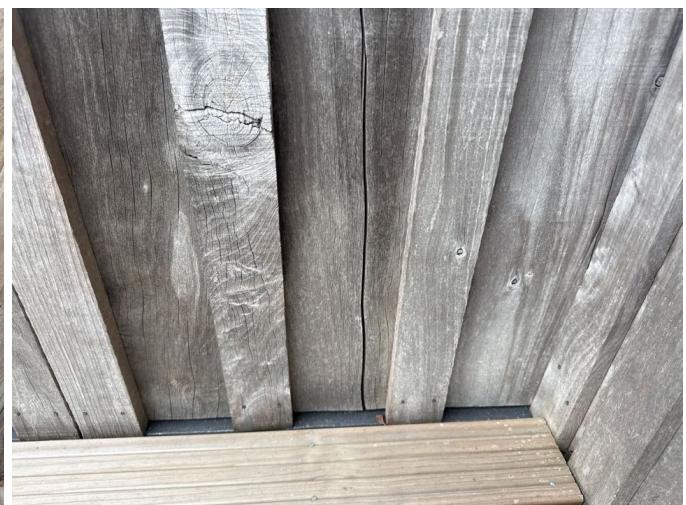
Cracks at various locations

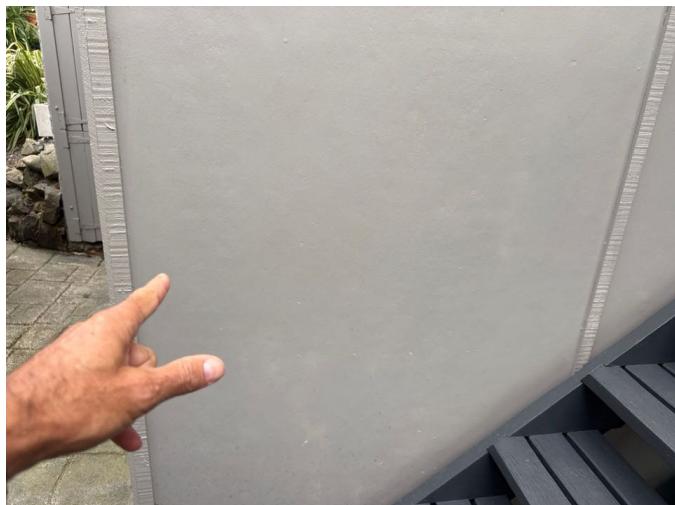
Due to the age of the home, some of the materials installed may contain elements of Asbestos. Please note this is safe in an inert state and must be kept well sealed. If any work is to be completed in areas that likely contain Asbestos then there are certain health and safety precautions that should be followed.

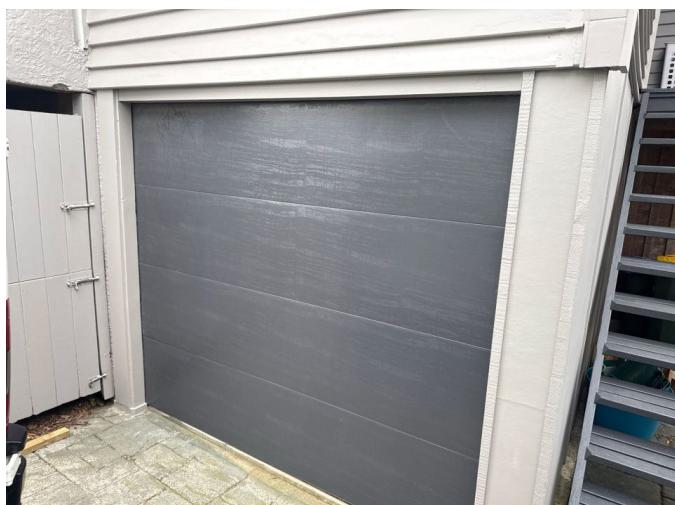
The surface condition of the garage door is good

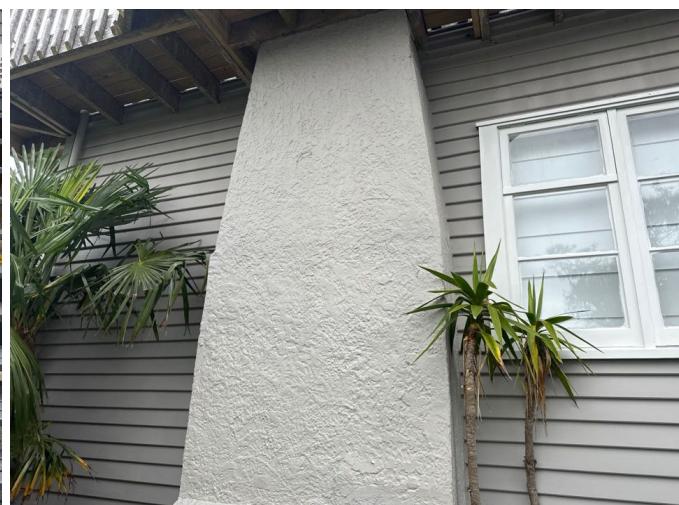
There was no evidence of damage to the concrete chimney base at the time of the inspection. The cladding junctions are effectively sealed.

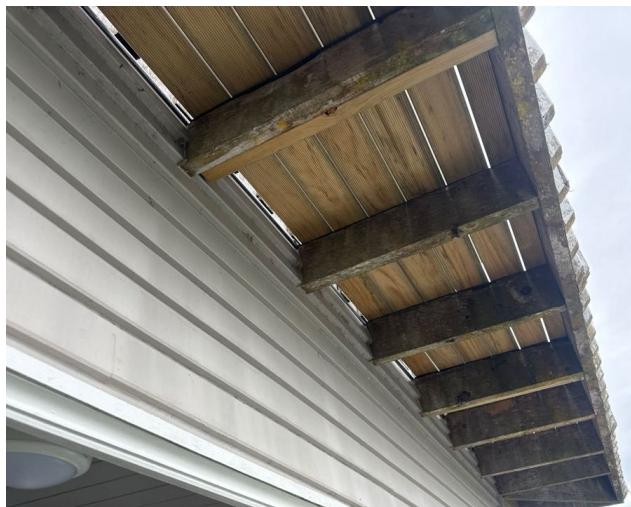
The cantilevered joists are effectively sealed

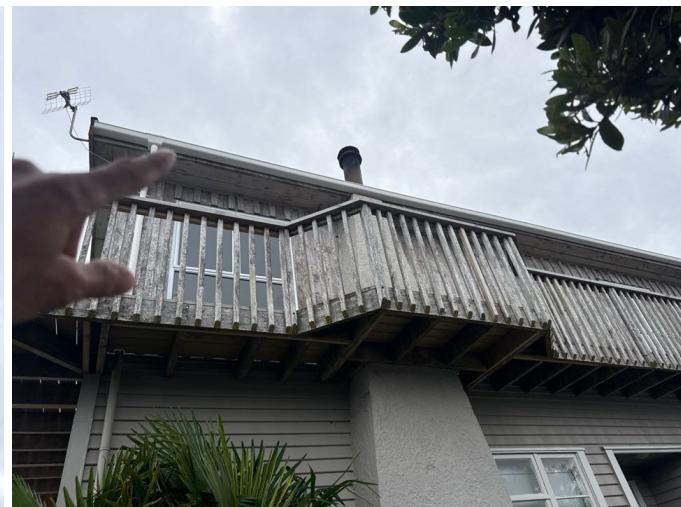
The cracked fascia board should be thoroughly sealed or the timber replaced

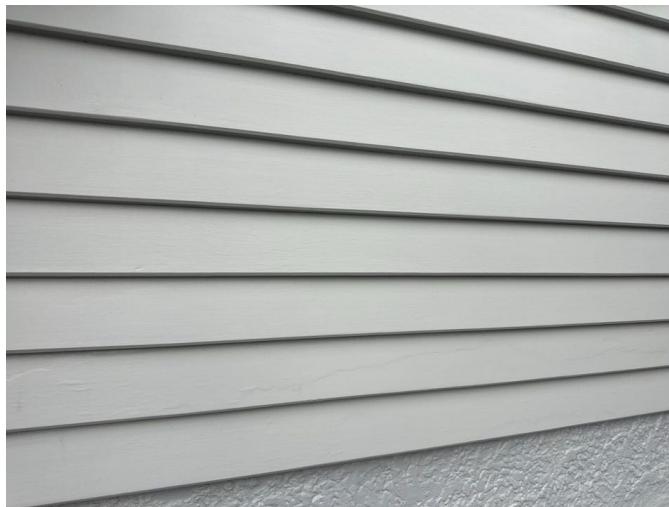
Good paint quality to the timber bevelback weatherboards

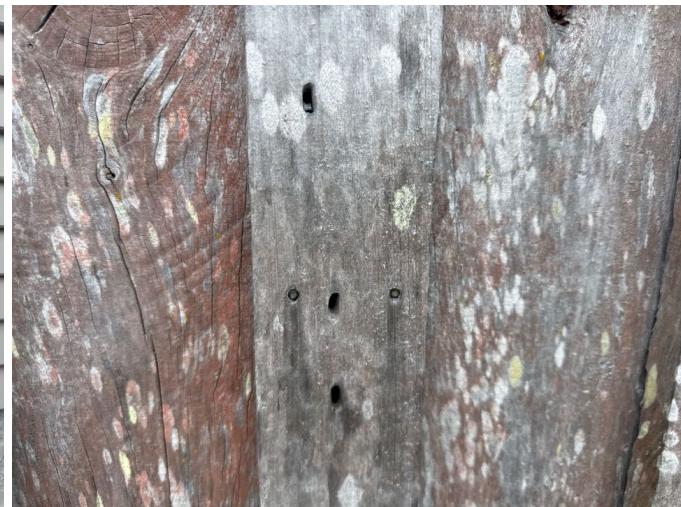
Example. Any holes in the cladding or battens should be sealed.

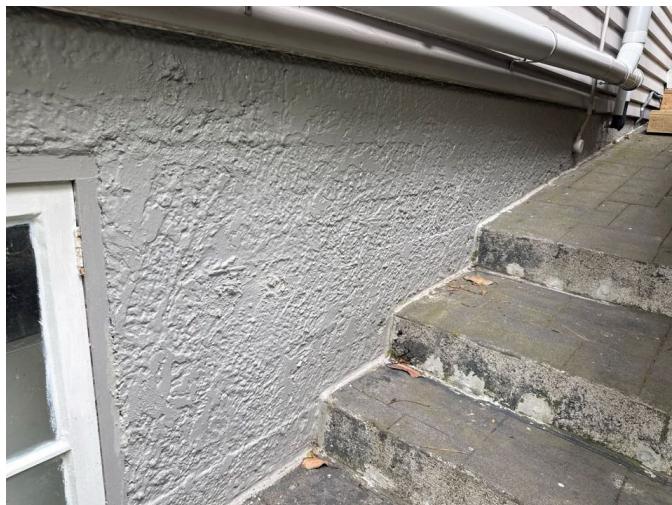
The concrete ring foundation is in a typical condition for the age. No sign of cracking or significant stress.

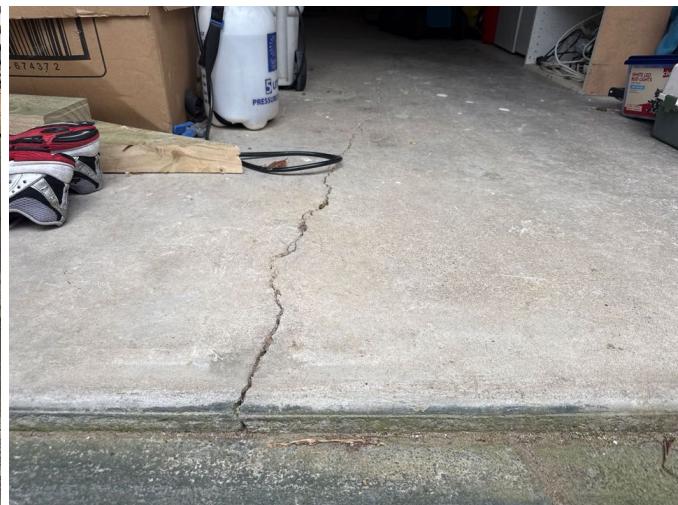
Common shrinkage cracking to the garage slab. This is not a structural concern and is commonly caused during the curing stage of the concrete hardening process.

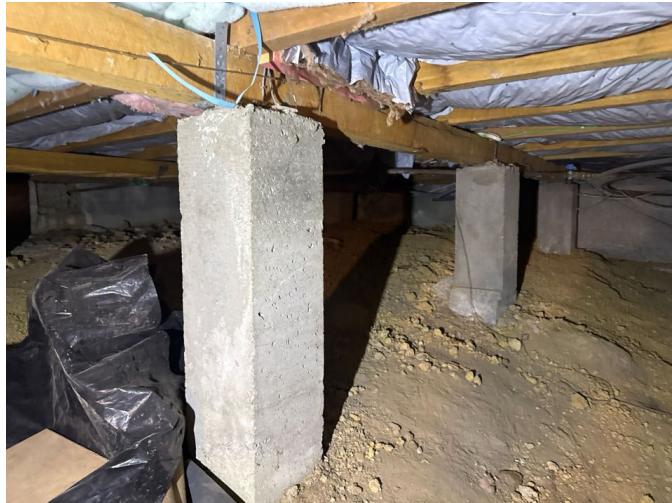
The concrete piles are solid at the time of inspection. Galvanised wire connects the bearers to the piles and anchors the structure to the ground.

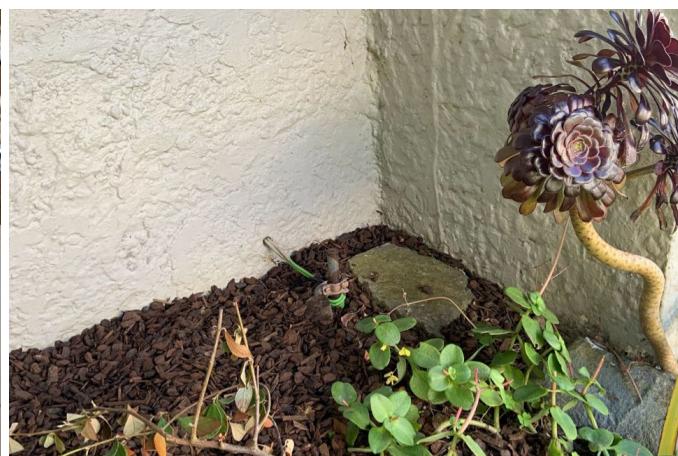
Left side of the chimney.

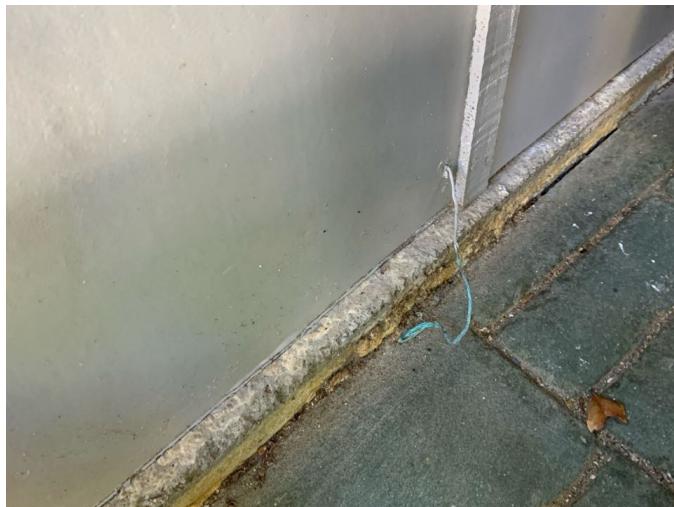
Earth wire under the back stairs. No rod sighted.

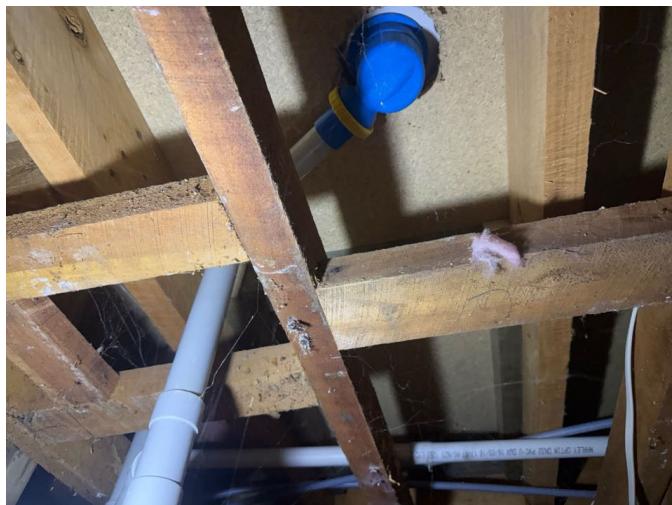
Example. There was no evidence of current leaks under the plumbed areas.

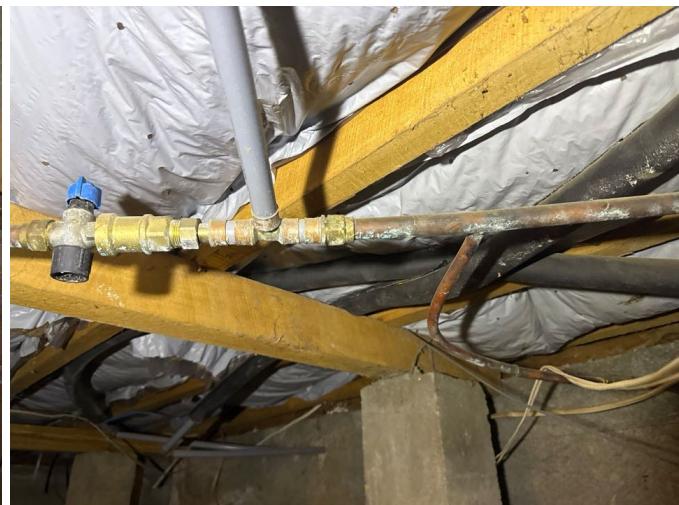
Only Buteline and Copper pipes sighted during the inspection

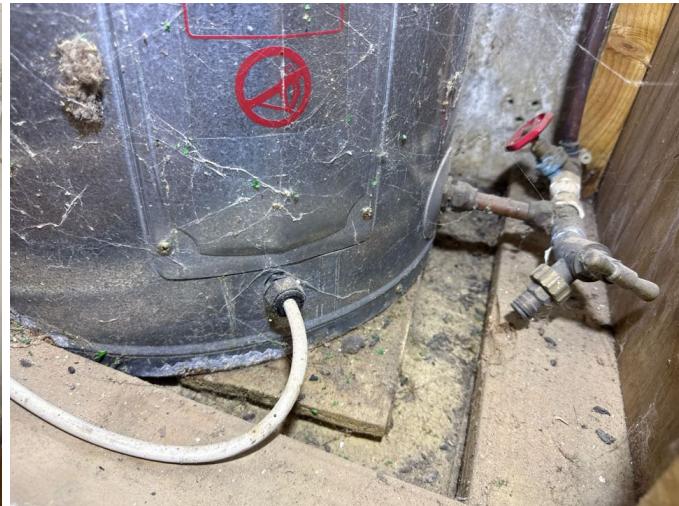
No sign of leaks at the base of the cylinder at the time of inspection

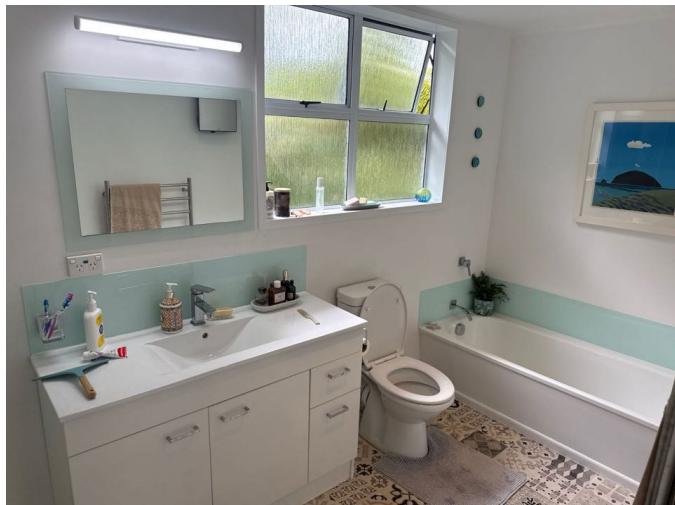
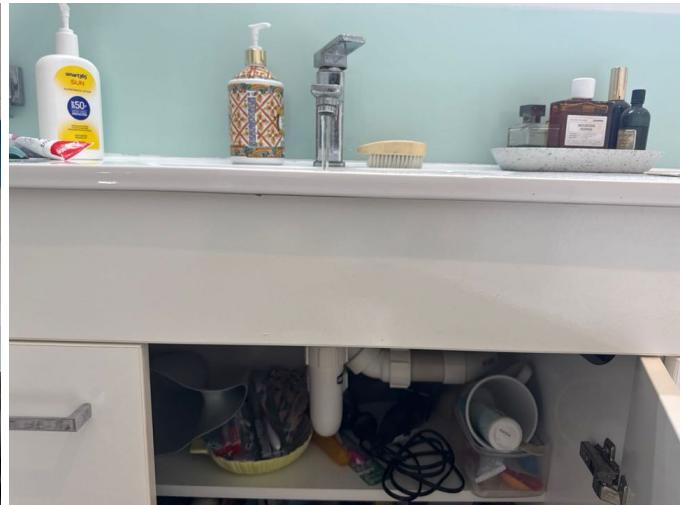
The rear edge of the vanity is well sealed. The tap is functioning well. No concerns with the water feeds or waste under the vanity

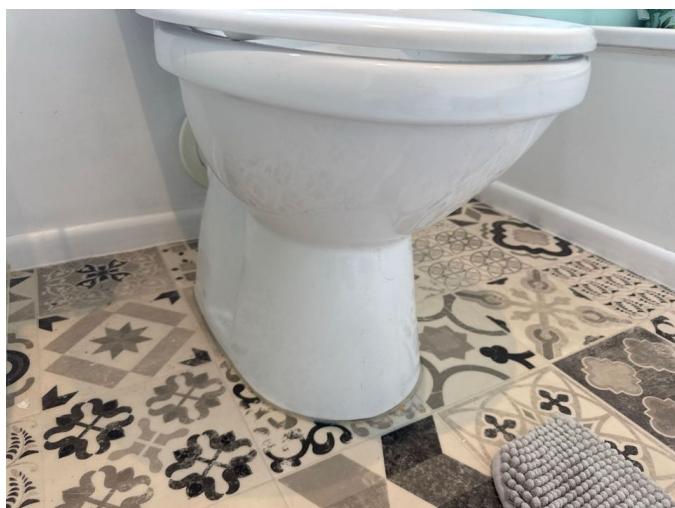
The base of the toilet is well sealed and secure. The toilet is in a functioning condition.

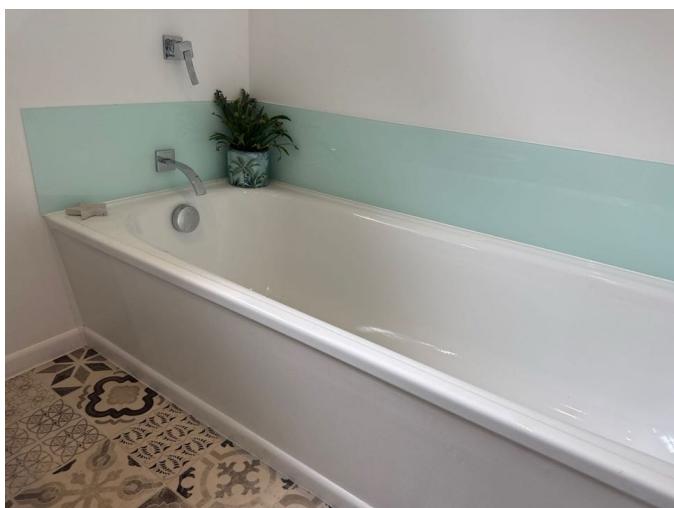
The perimeter of the bath is well sealed. The tap is functioning well.

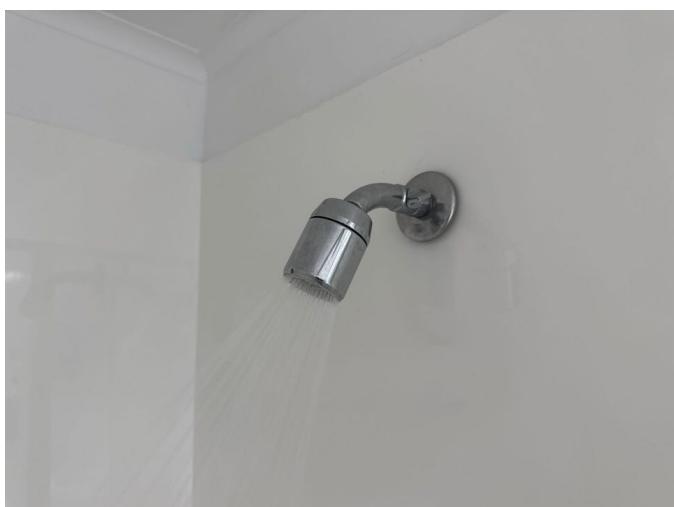
Good water pressure noted. No sign of current leaks from the shower frame during water testing.

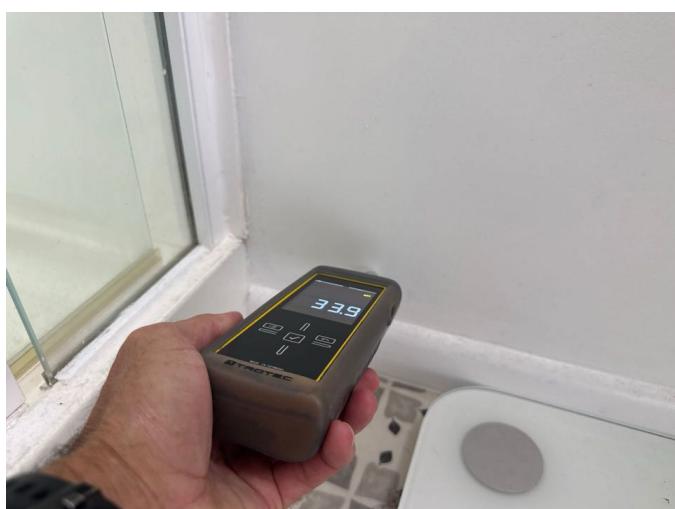
The common fail areas of the shower and plumbed areas were checked for elevated moisture. Moisture levels were within the normal range.

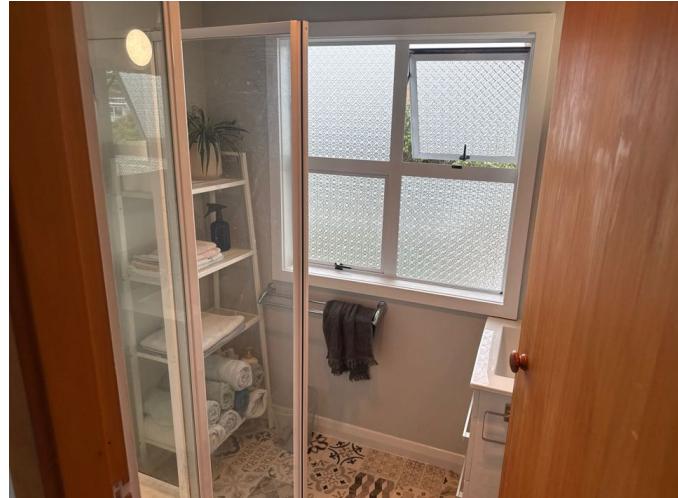
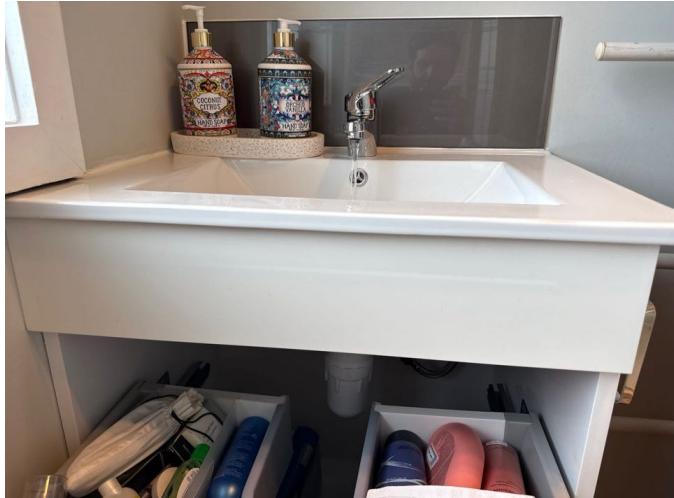
The rear edge of the vanity is well sealed. The tap is functioning well. No concerns with the water feeds or waste under the vanity

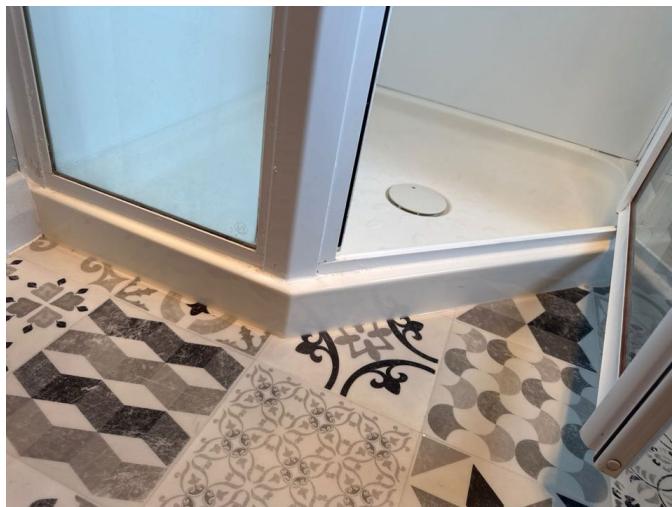
The base of the shower is well sealed.  
There was no evidence of damage to the shower base at the time of the inspection.

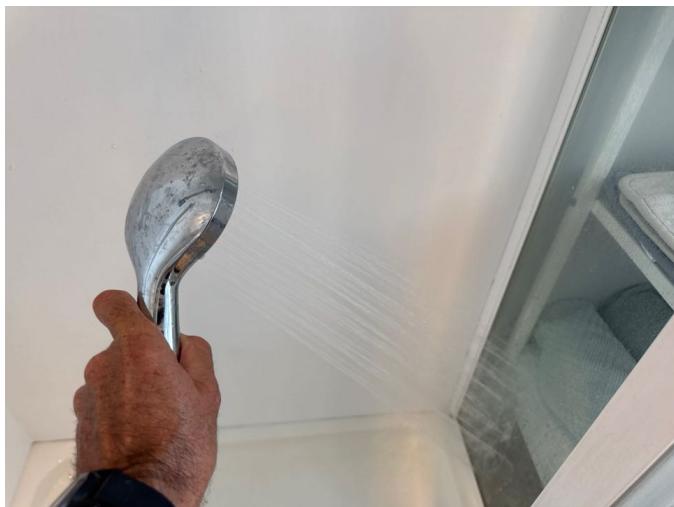
Good water pressure noted. No sign of current leaks from the shower frame during water testing.

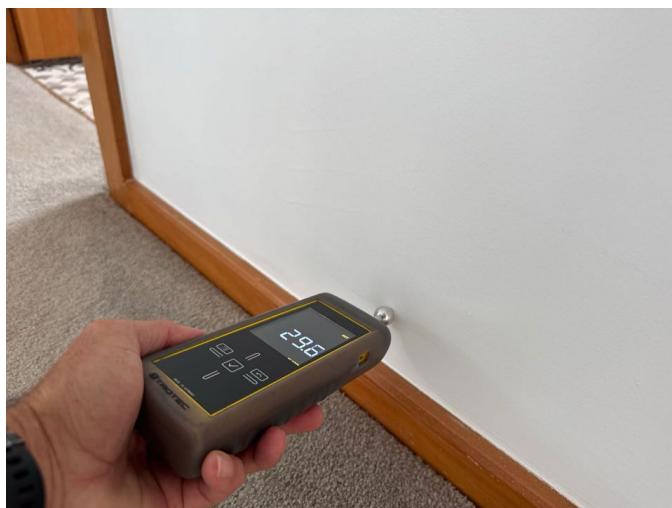
The common fail areas of the shower and plumbed areas were checked for elevated moisture. Moisture levels were within the normal range.

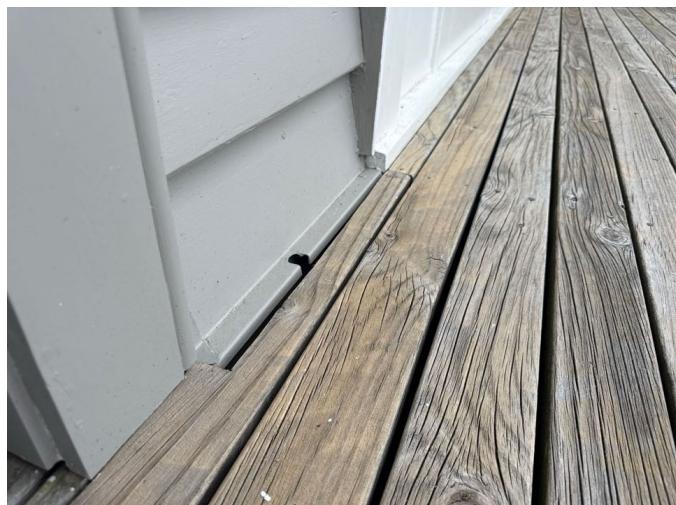
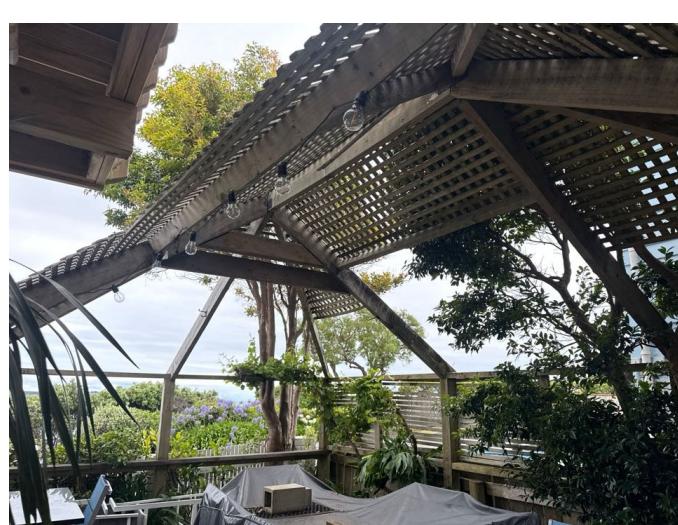
The timber pergola type roof was showing no evidence of significant deterioration

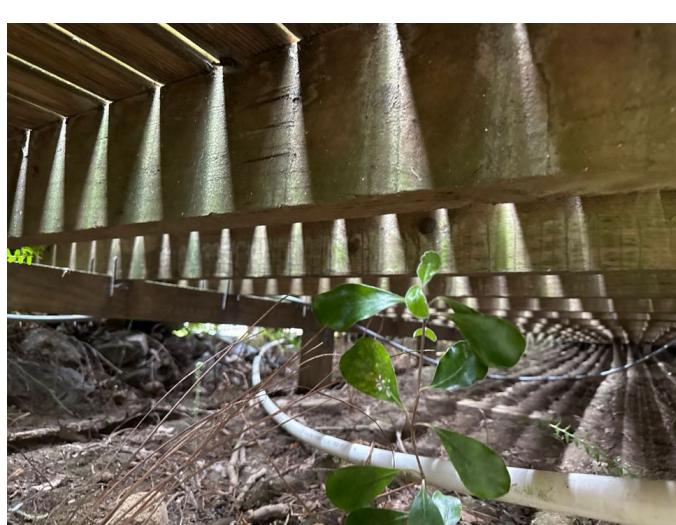
It was not practical to inspect all areas of the main structure due to the lack of room. There were no structural concerns sighted from the south side.

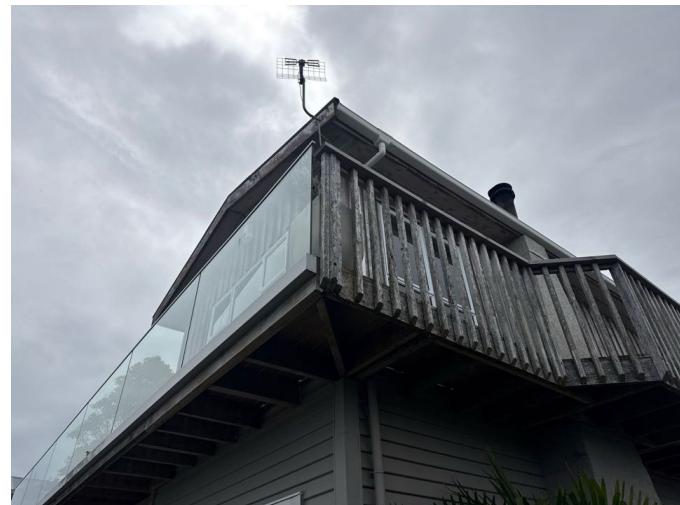
The balustrade is secure

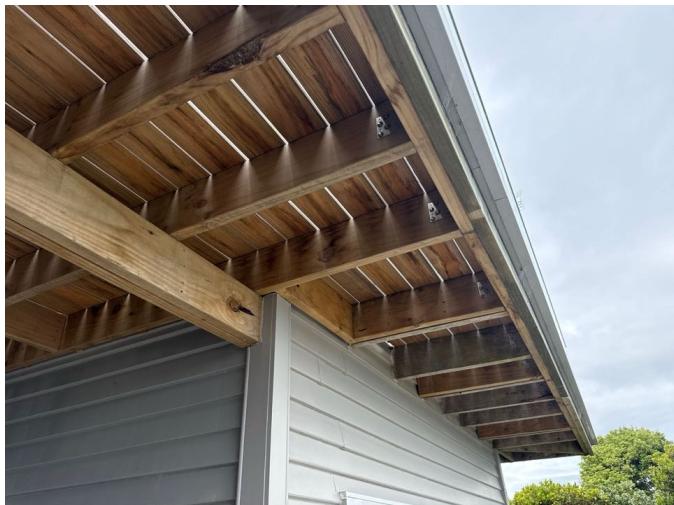
The deck structure has been strengthened and modernised at various locations.
