# Independent Builders Report

Total Home Inspection Services Porirua City Ltd

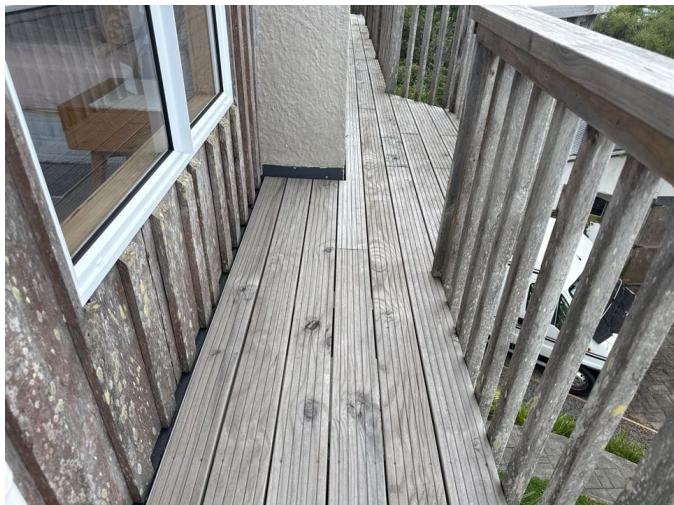
The decking is in good condition

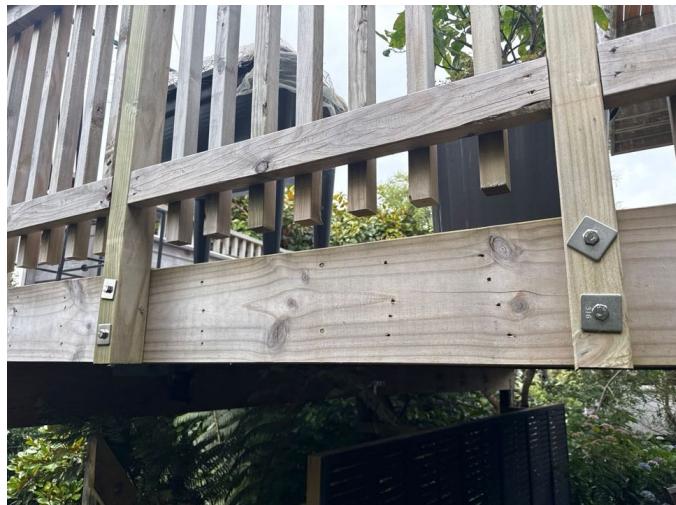
The balustrade is solid and connected sufficiently at the base

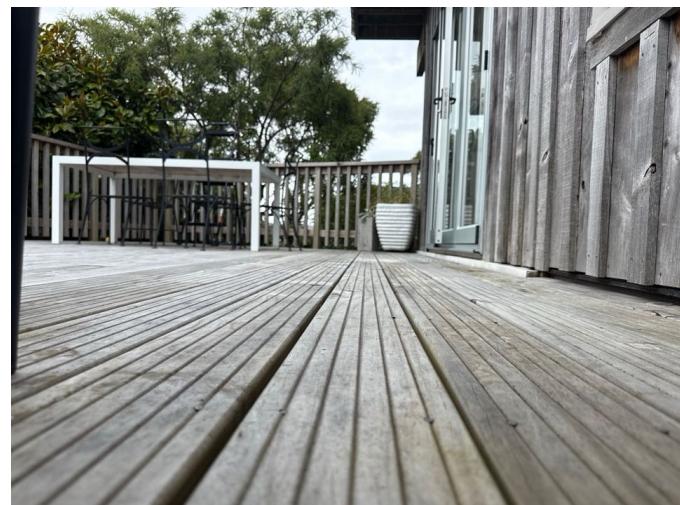
The decking is in good condition

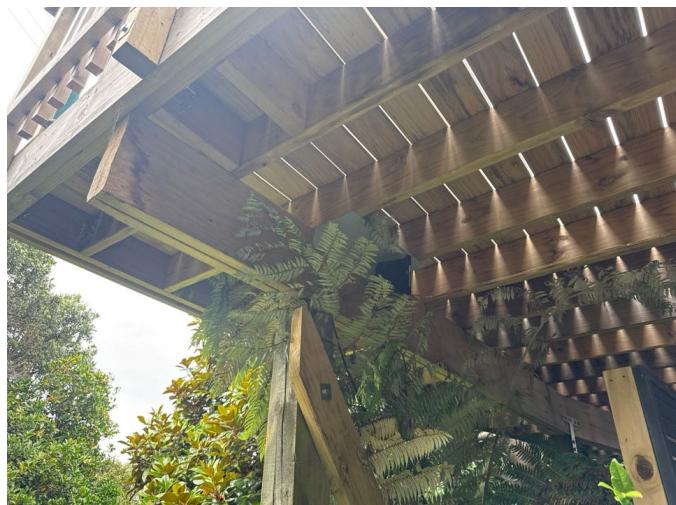
No concerns with the framing structure. Solid and well connected.

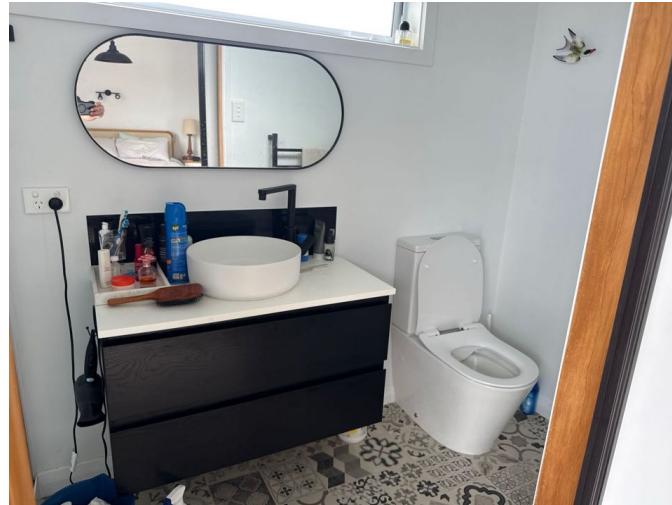
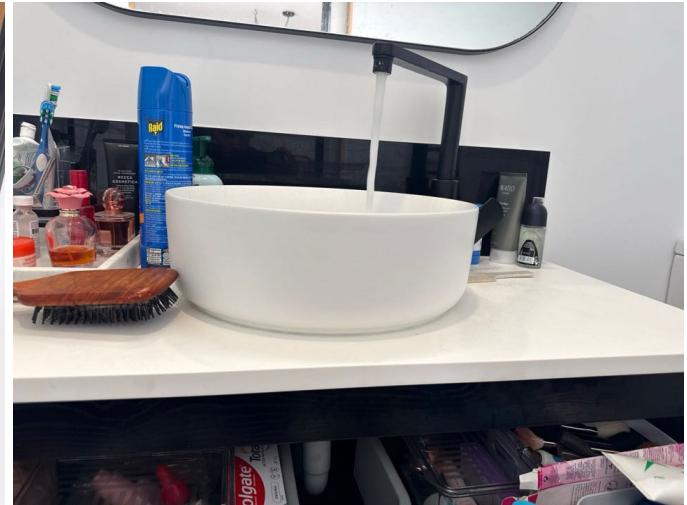
The rear edge of the vanity is well sealed. The tap is functioning well. No concerns with the water feeds or waste under the vanity

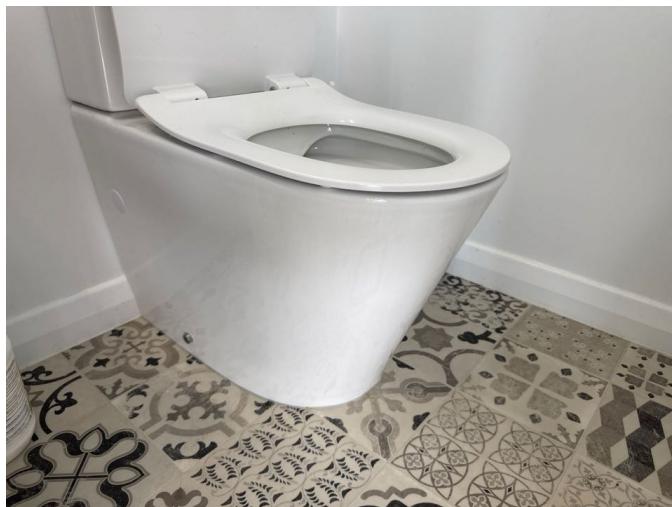
The base of the toilet is well sealed and secure. The toilet is in a functioning condition.

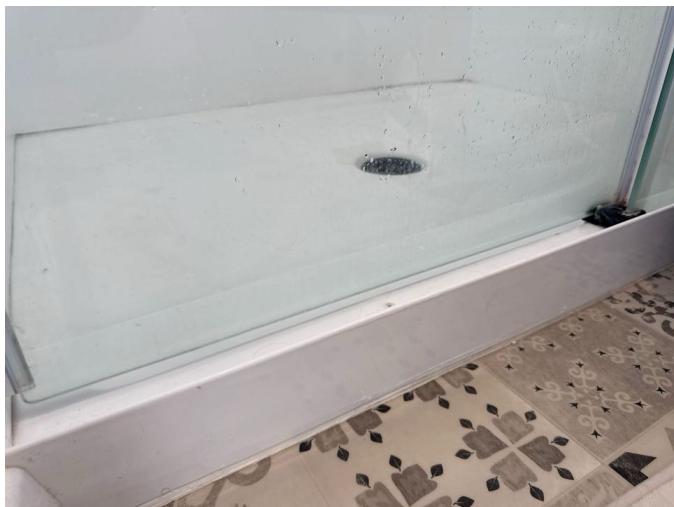
The base of the shower is well sealed. There was no evidence of damage to the shower base at the time of the inspection.

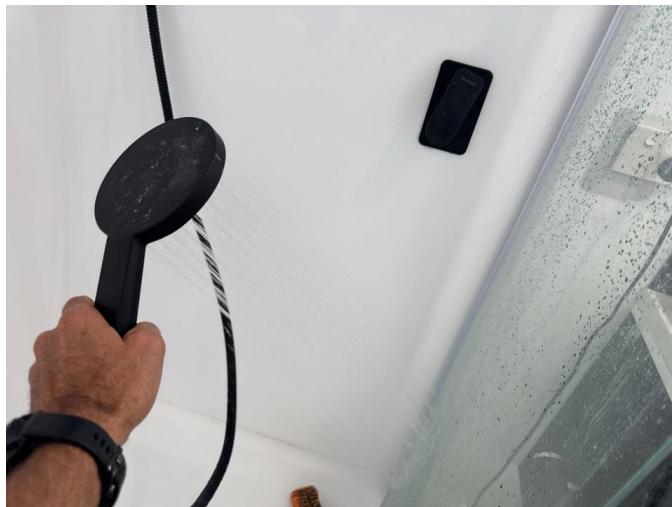
Good water pressure noted

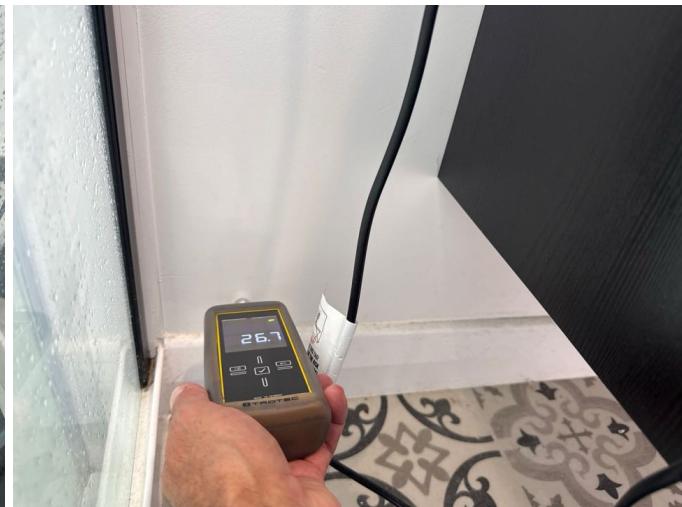
The common fail areas of the shower and plumbed areas were checked for elevated moisture. Moisture levels were within the normal range.

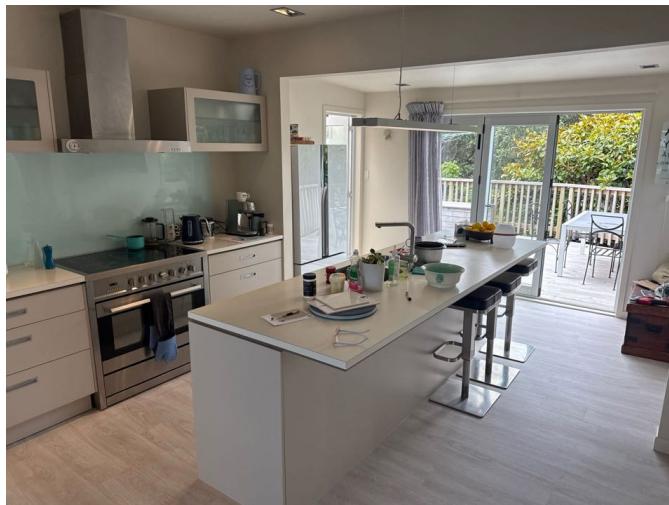
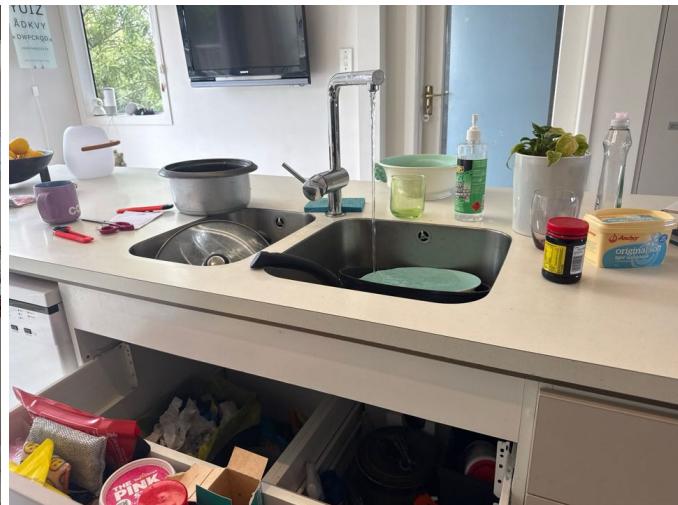
The sink and bench areas are in good condition. The tap is functioning well. No concerns with the water feeds or waste under the sink.

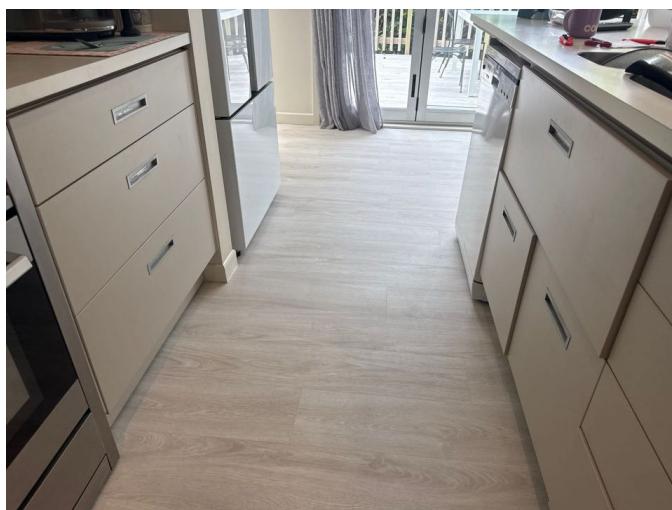
The kitchen cabinetry and vinyl plank floor are in good condition

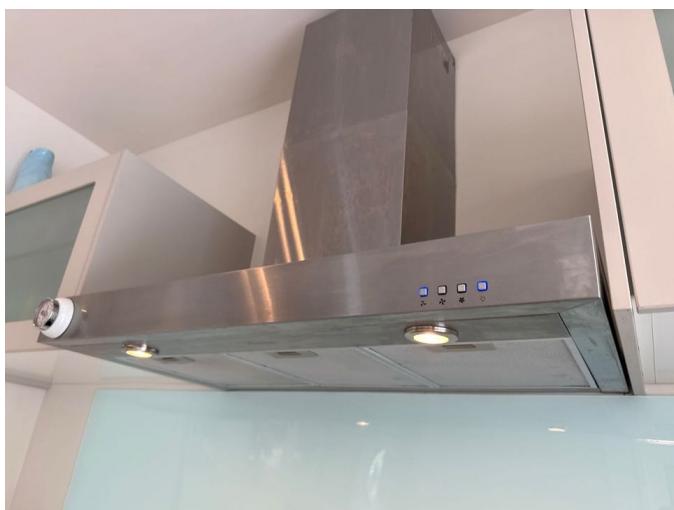
The range hood extraction unit is functioning

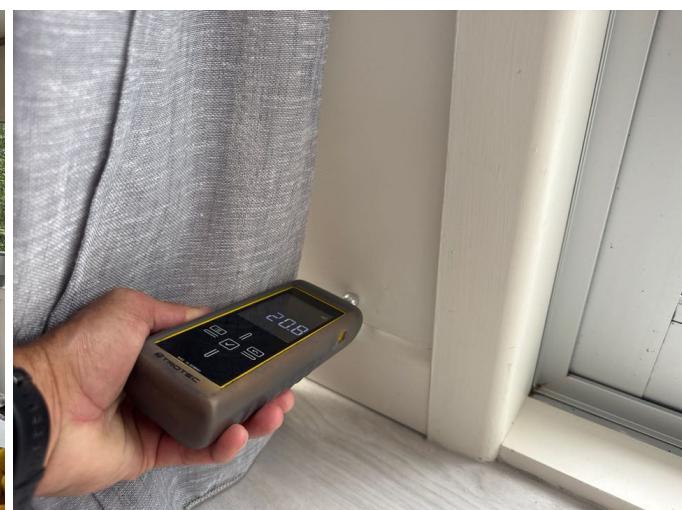
Moisture levels in the kitchen were within the normal range at all locations

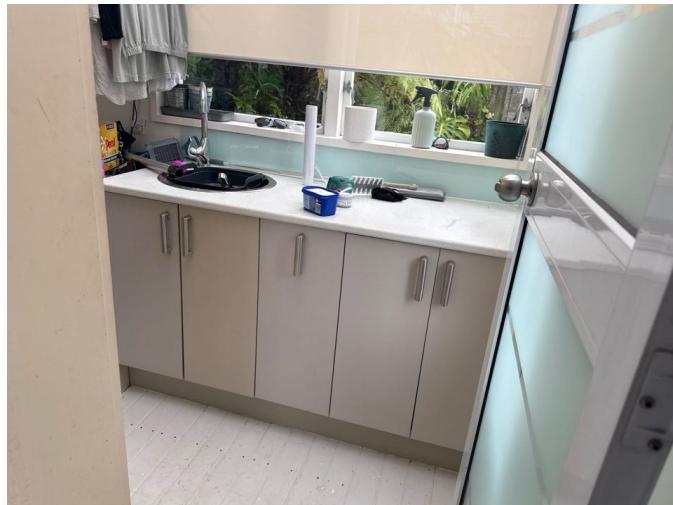
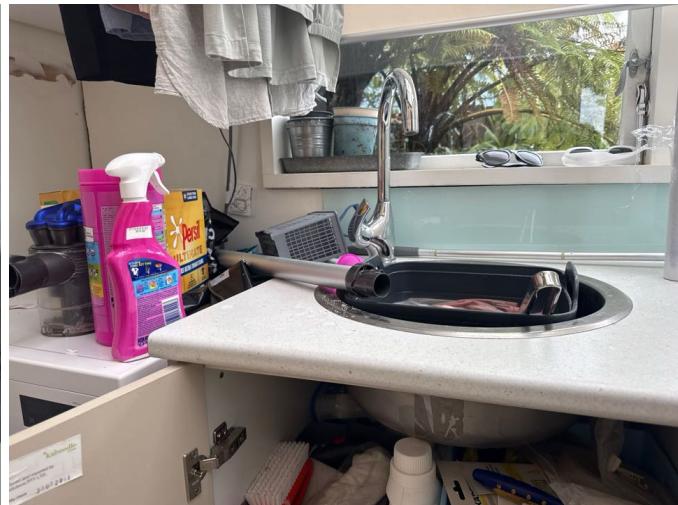
The tub is well sealed. The tap is functioning well. No visible concerns with the water feeds or waste under the tub.

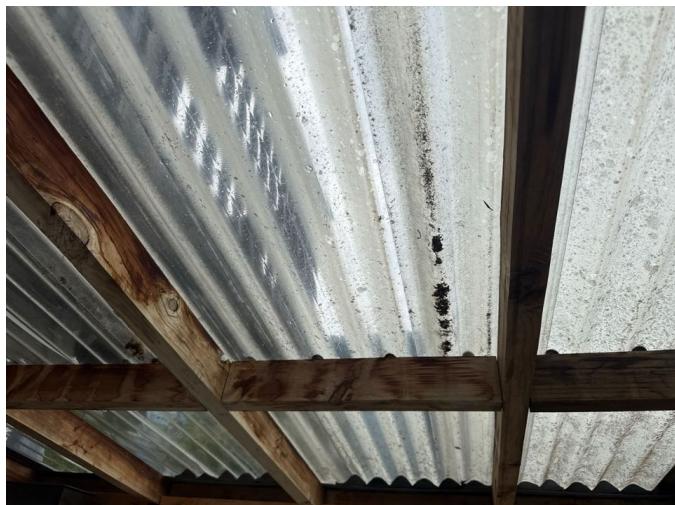
Moisture staining to the roof framing has likely been caused by condensation

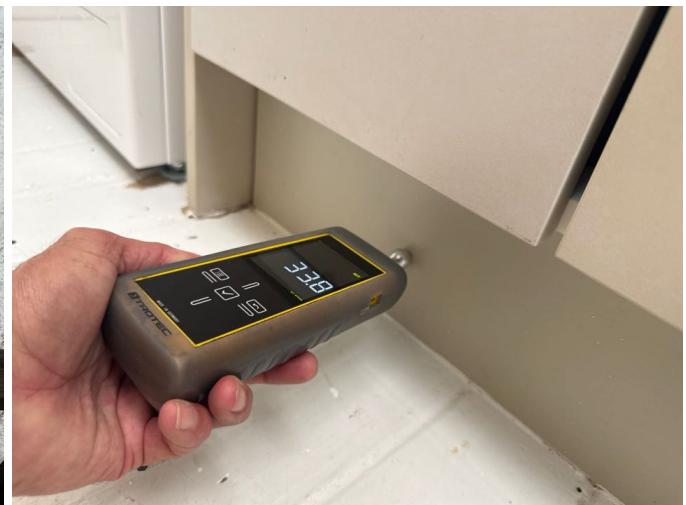
Moisture levels in the laundry were within the normal range at the time of inspection.

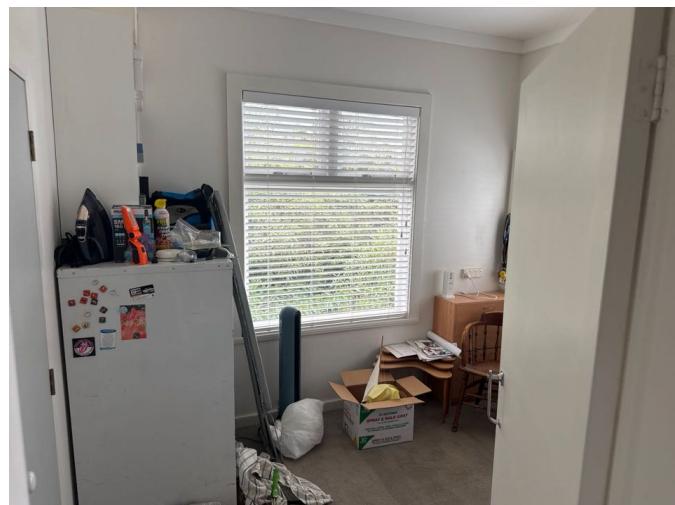
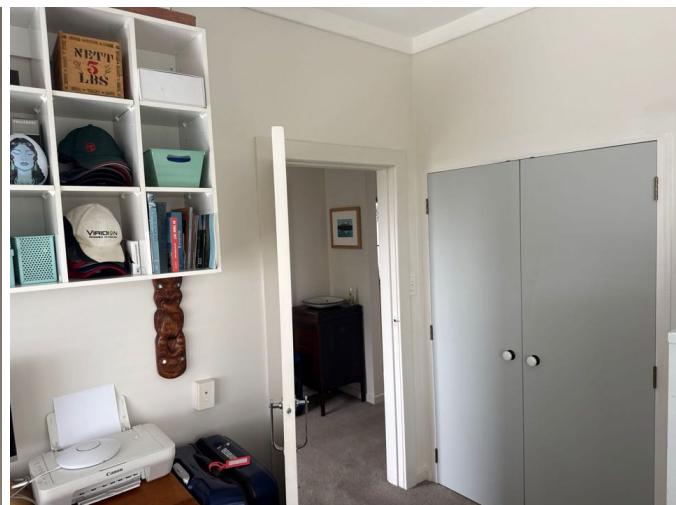
Storage and shelving noted

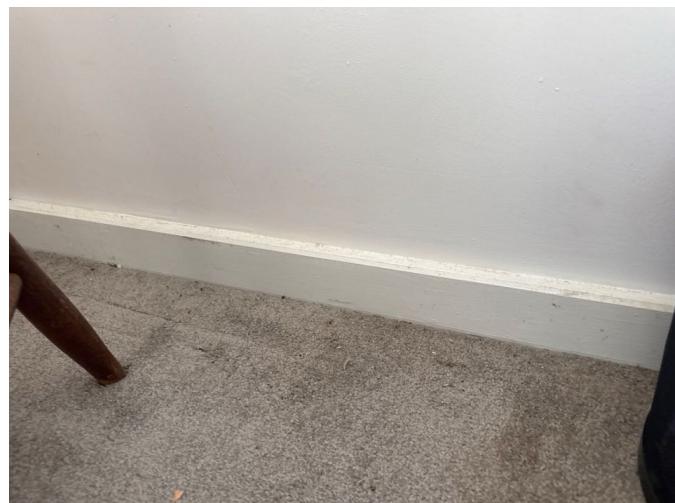
The wall and ceiling linings and carpet are in good condition

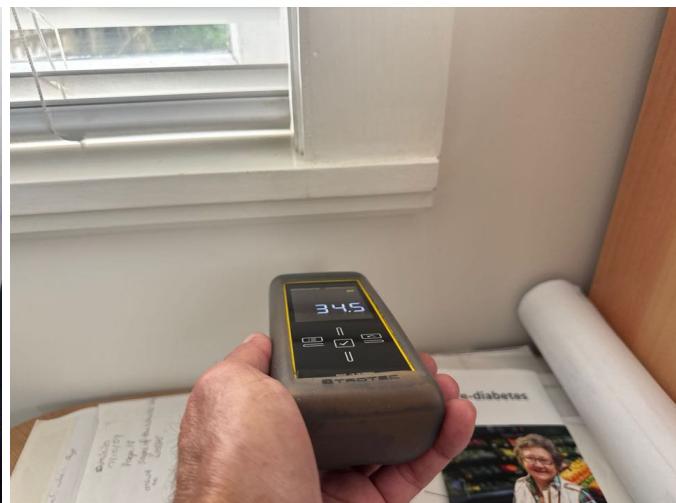
The moisture levels to the internal walls were within the normal range

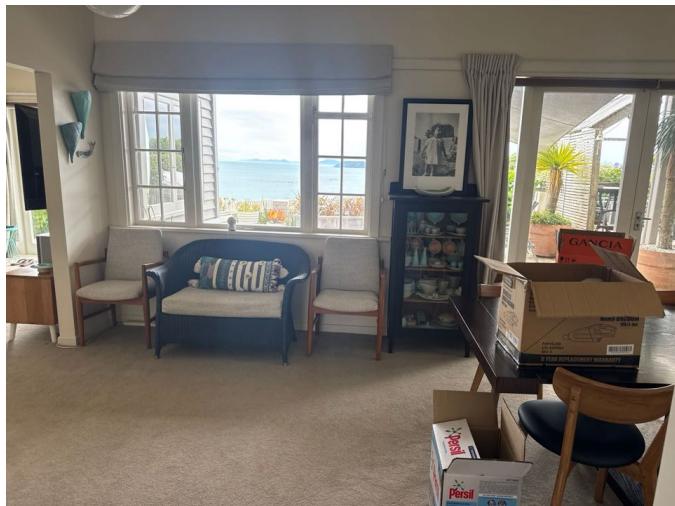
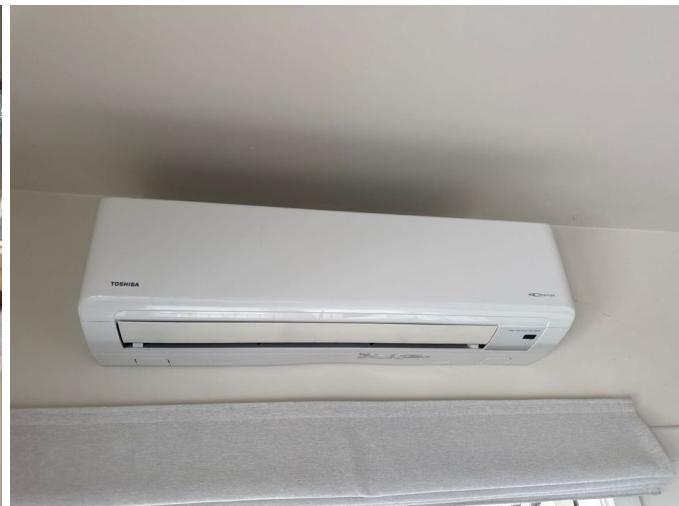
Heat pump installed, untested.

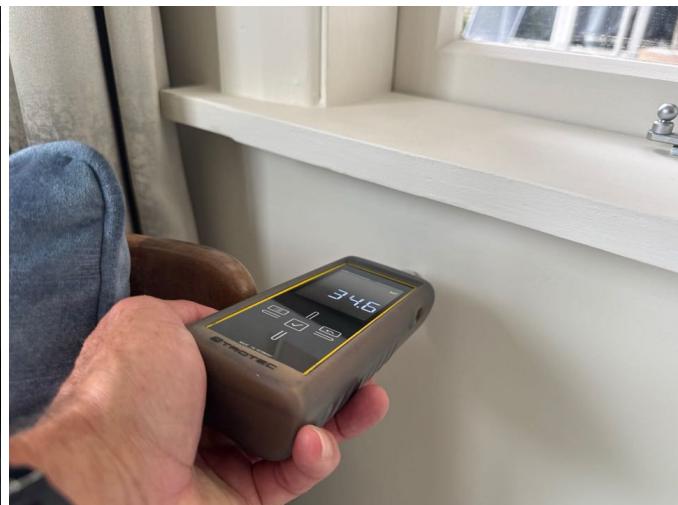
The moisture levels to the external walls were within the normal range

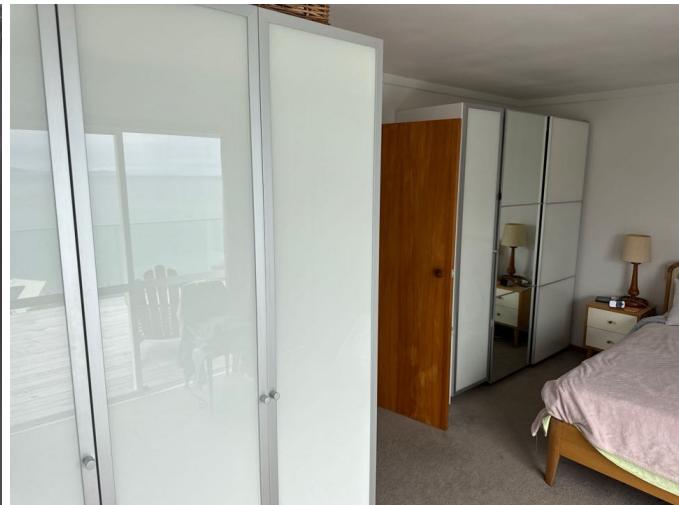
Double wardrobes noted

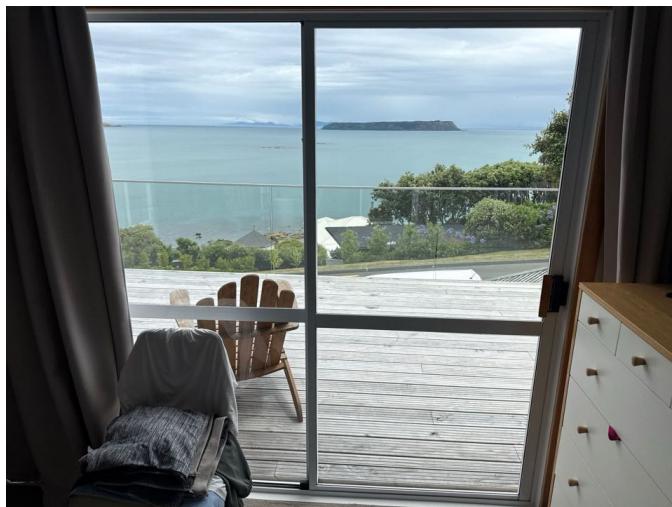
The sliding door is functioning well

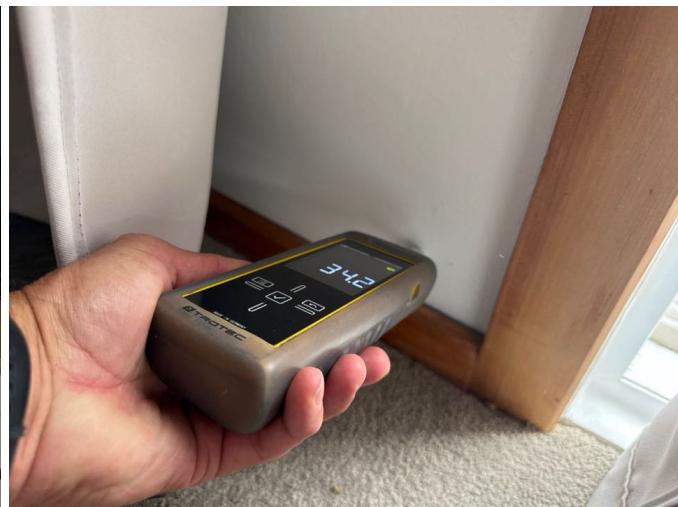
The moisture levels to the external walls were within the normal range

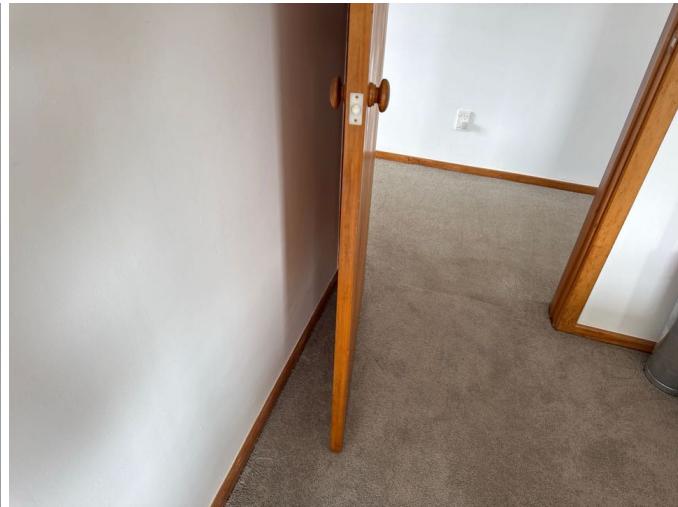
The internal doors are functioning well.  
Door stops should be installed where missing to prevent the risk of damage to the wall linings.

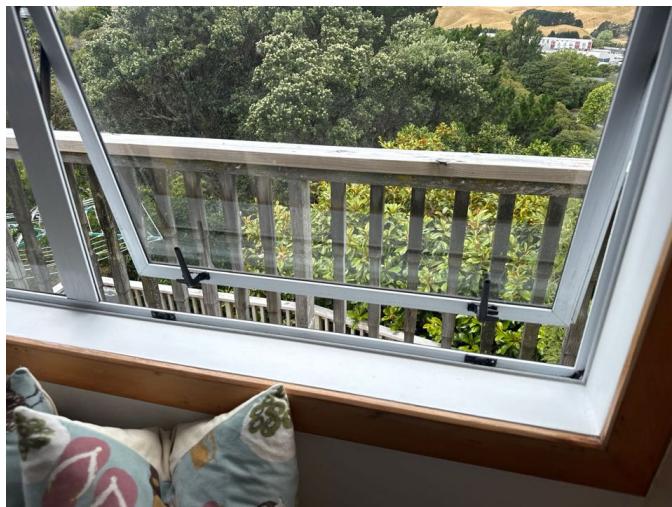
The windows are functioning throughout the home

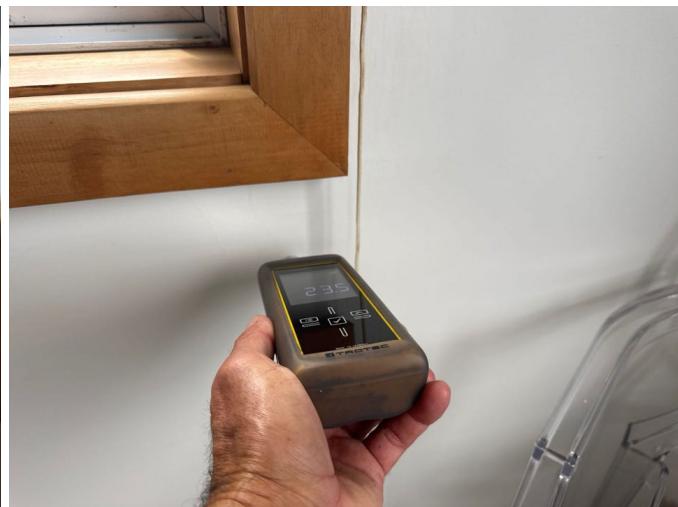
The moisture levels to the external walls were within the normal range

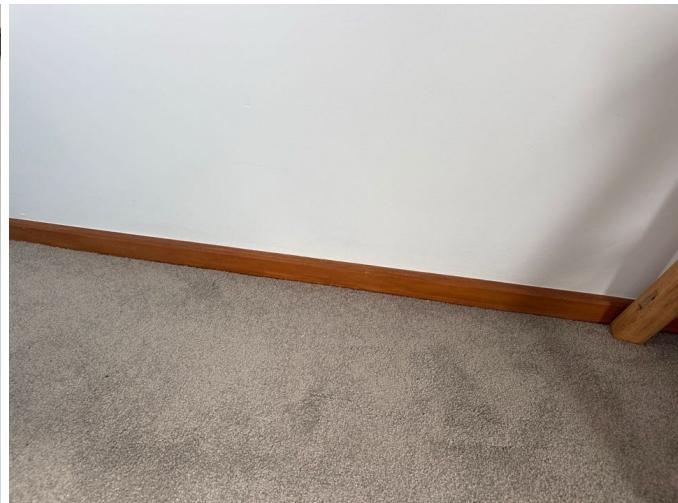
The wall and ceiling linings and carpet are in good condition

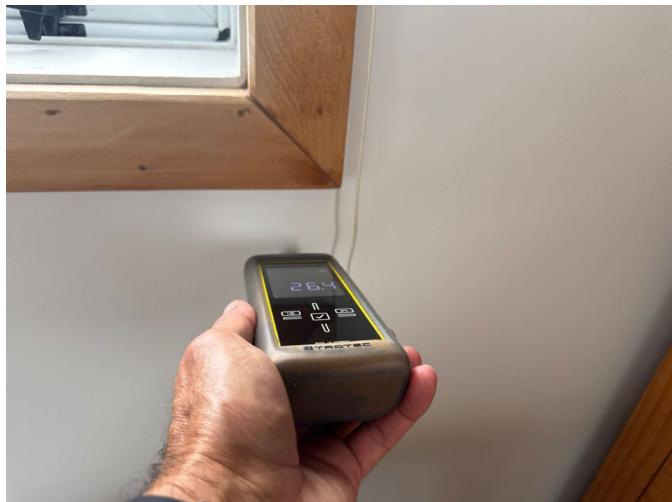
The moisture levels to the external walls were within the normal range

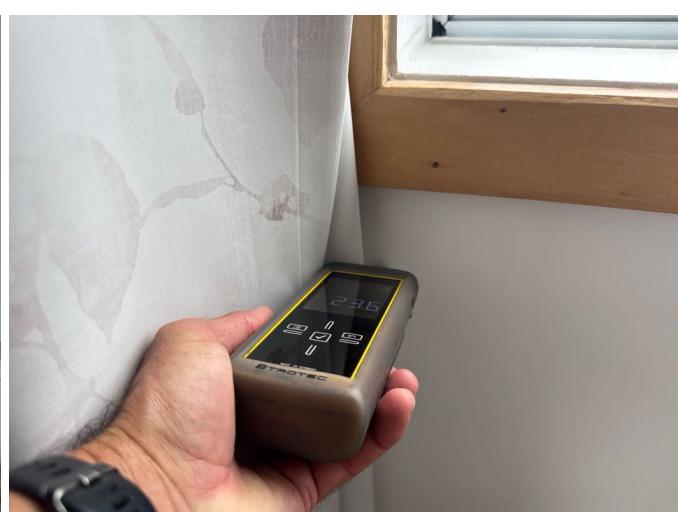
The moisture levels to the external walls were within the normal range

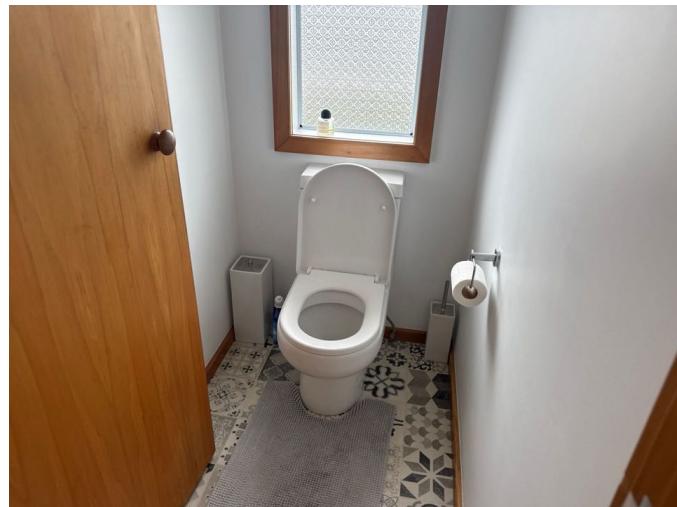
The base of the toilet is well sealed and is secure. The toilet is in a functioning condition.

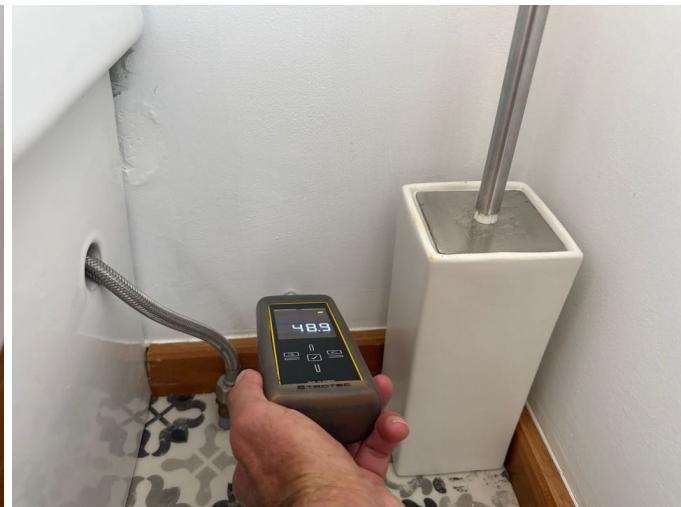
Moisture levels behind the toilet were within the normal range at the time of inspection

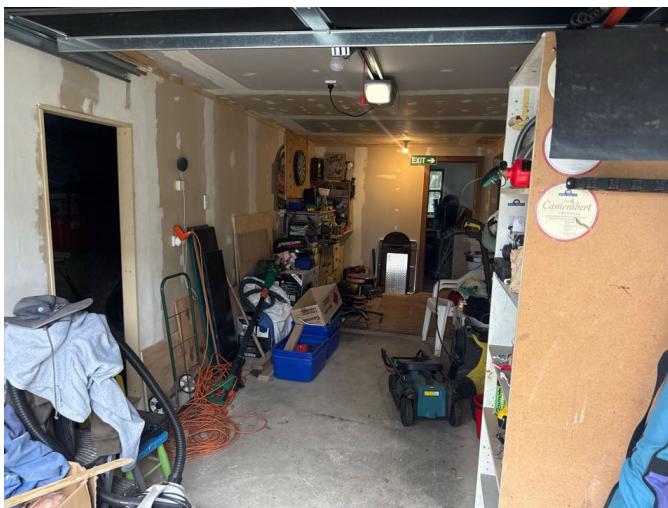
Not all areas of the garage could be fully inspected due to the presence of stored items. A full inspection is recommended once cleared. This applies to all concealed locations throughout the house.

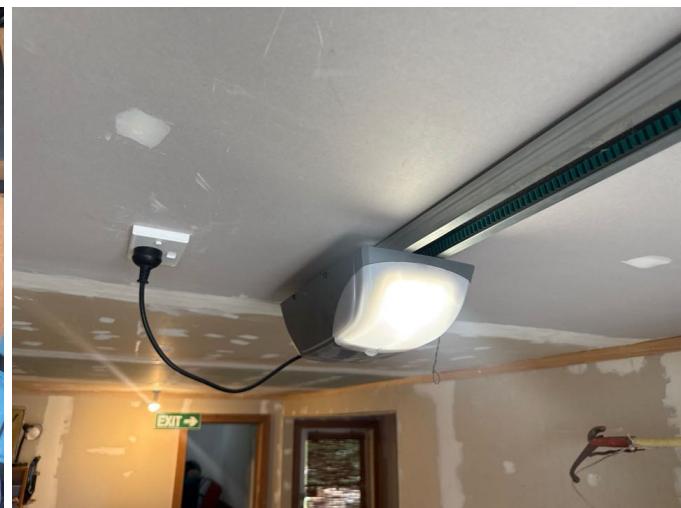
The electric garage door is functioning

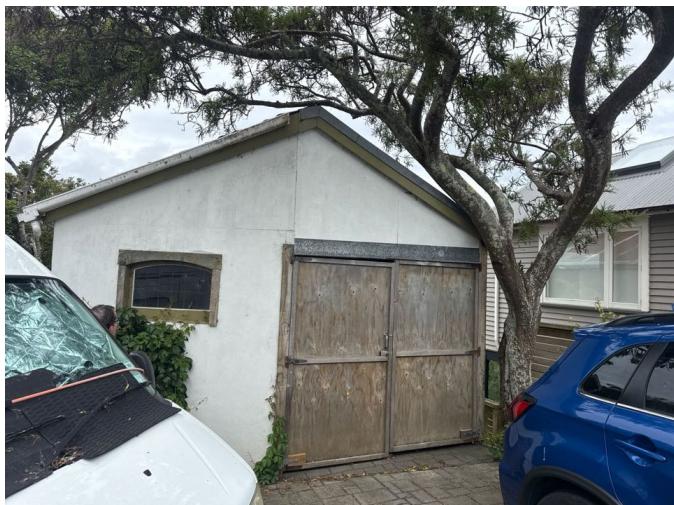
General age related wear to the garage. The manually operated timber doors are functional.

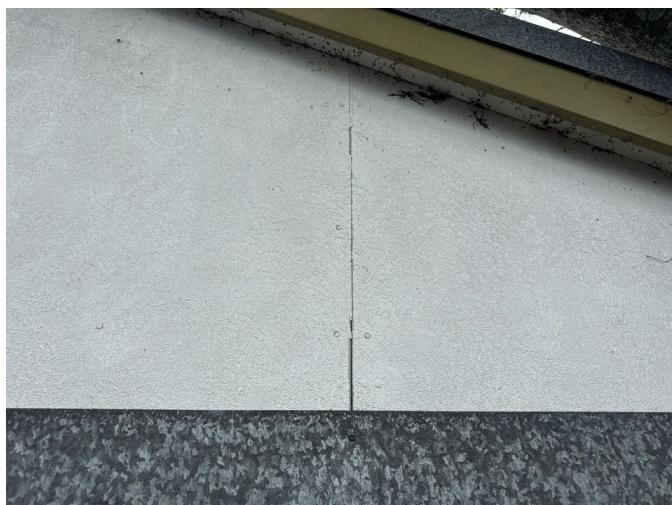
Example. Gaps in the cladding are a potential weather tightness risk and should be thoroughly sealed. A comprehensive paint upgrade is required to the exterior.

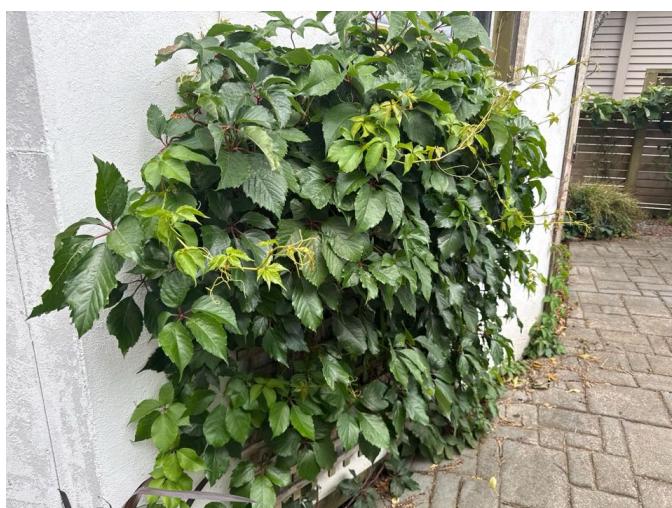
Vegetation should be removed from the cladding to prevent premature deterioration.

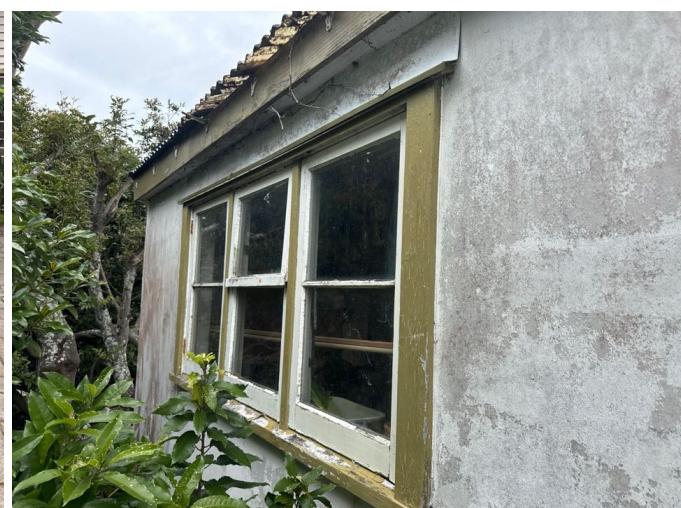
Deterioration to the timber joinery

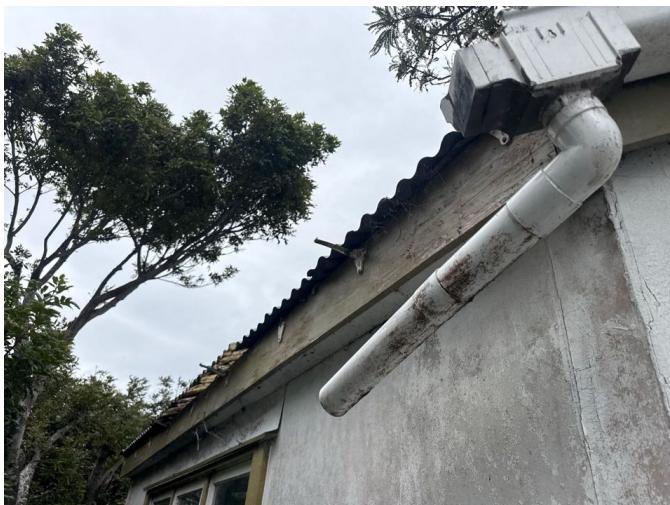
Spouting should be installed where missing

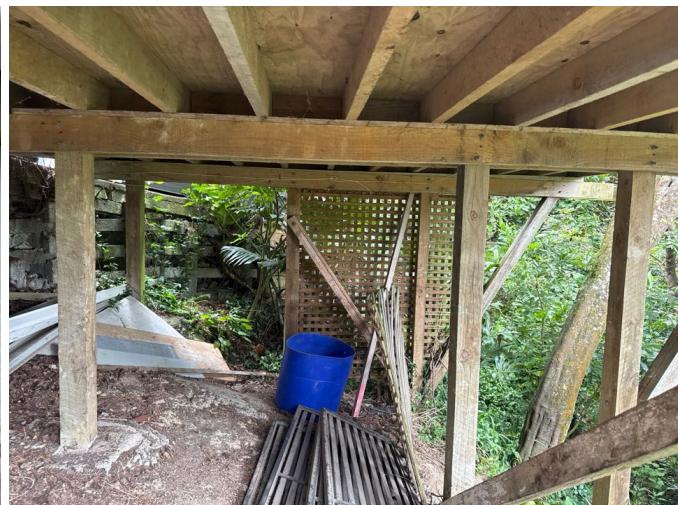
There were no concerns with the main deck structure

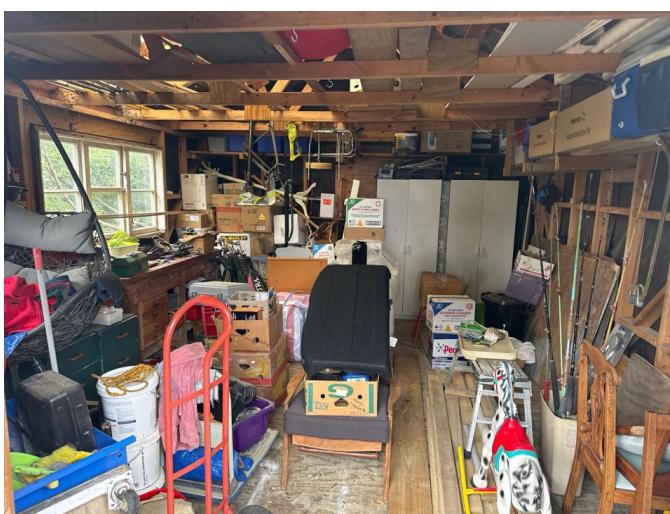
Not all areas of the garage could be fully inspected due to the presence of stored items. A full inspection is recommended once cleared. This applies to all concealed locations throughout the house.

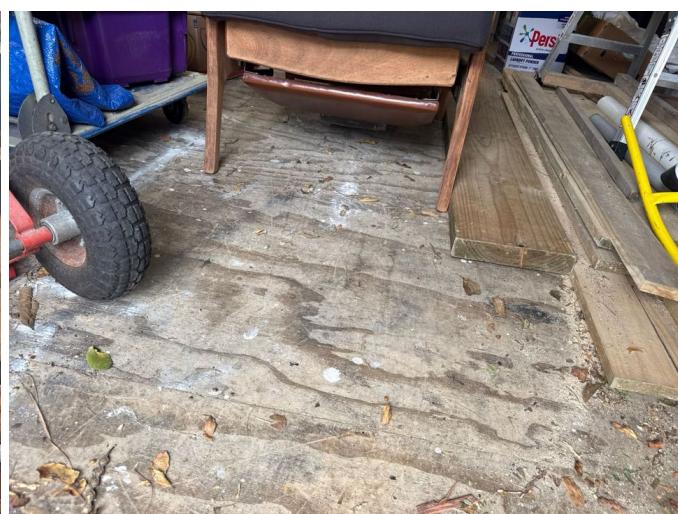
The plywood deck should be checked over once cleared

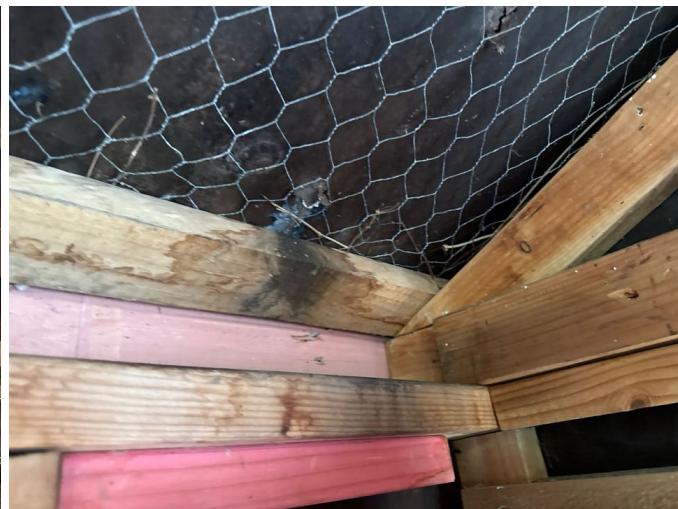
Moisture staining will need to be monitored until the roof is replaced

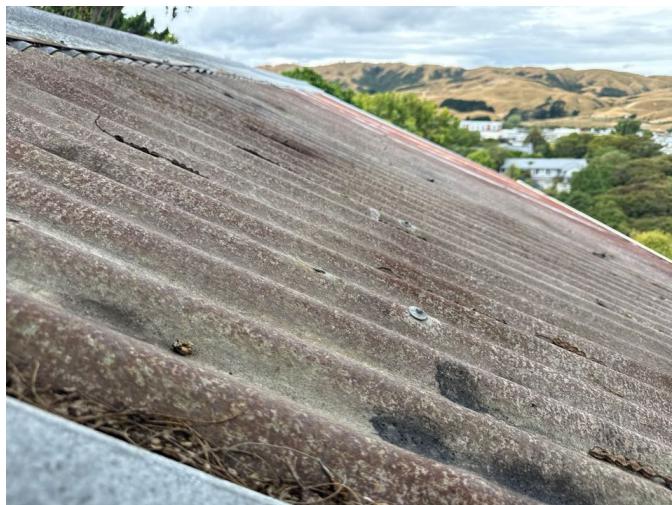
Rust deterioration to the roof. T.H.I.S recommends the roof be replaced in the short term.

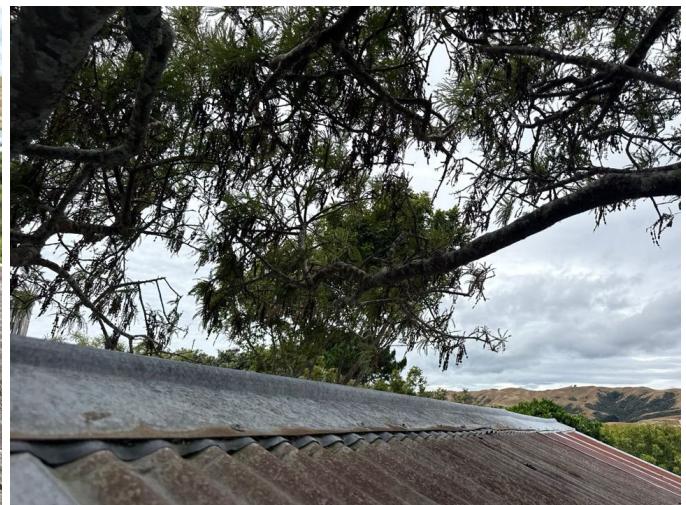
The tree branches should be trimmed back to prevent unnecessary maintenance.

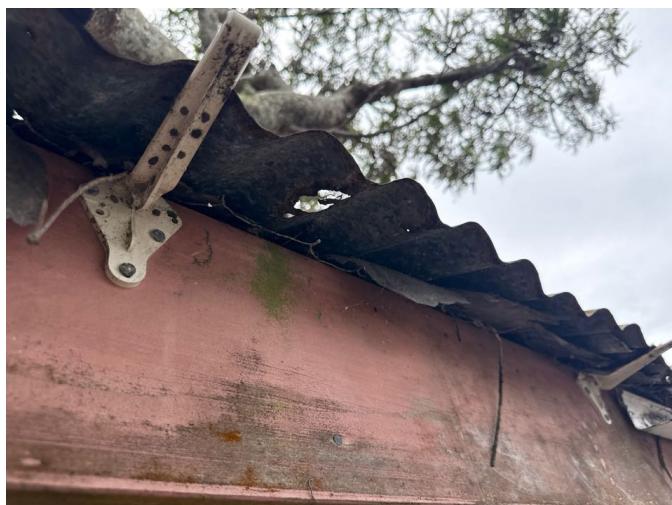
Another example of the rust deterioration to the roof

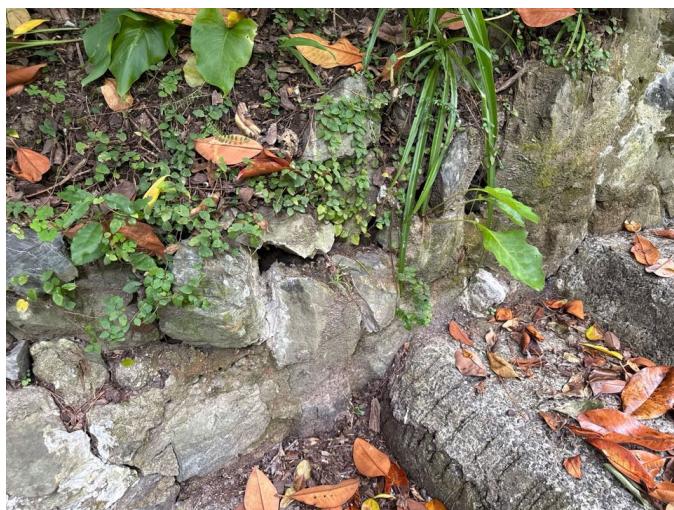
Deterioration to the original stone retaining wall on the steep east side. Retaining improvements are required where deterioration is present.

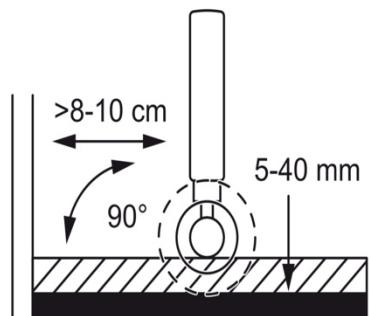
## GENERAL ROOF MAINTENANCE

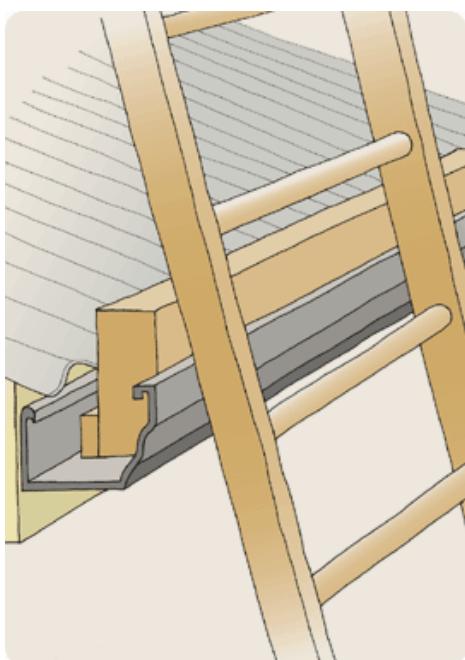
#### When working on a roof:

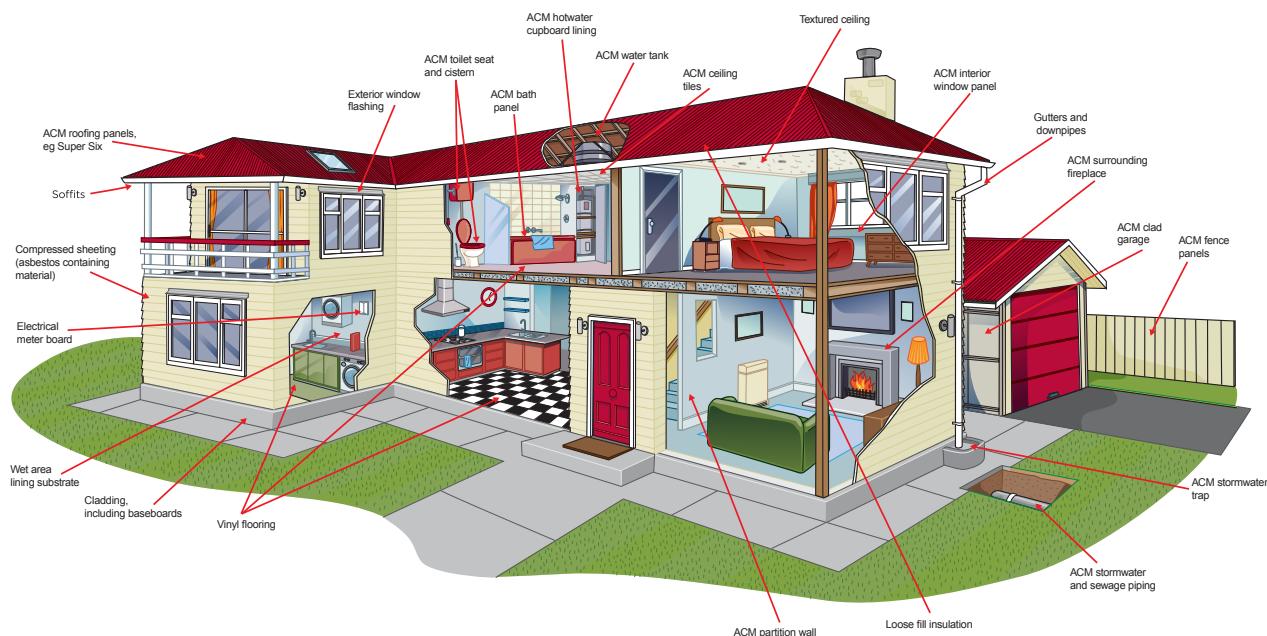
For further information visit:
