Independent Builders Report

Total Home Inspection Services Porirua City Ltd

Thu 26 Feb 2026

64 Airlie Rd, Plimmerton, Porirua, 5026, New Zealand

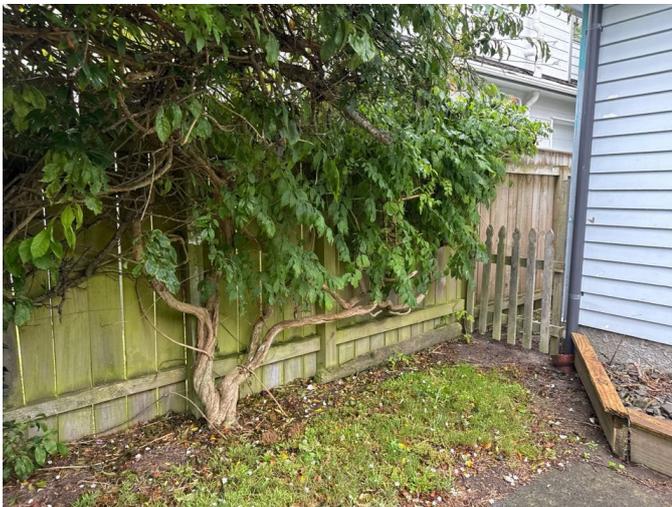
The wire fencing has some age related wear which will need to be monitored

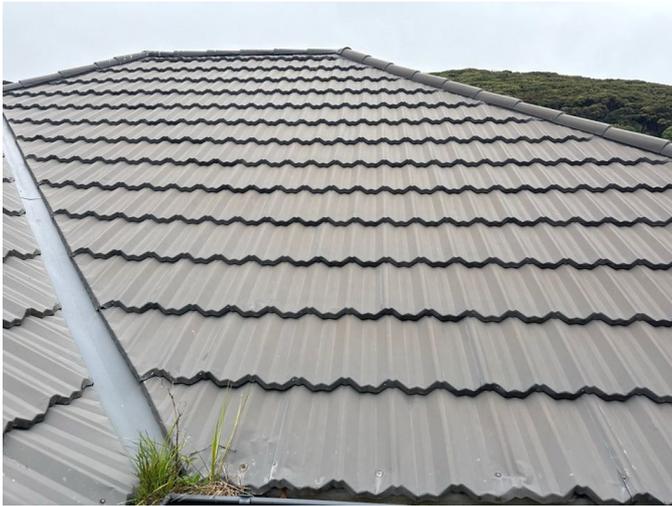
A once or twice yearly soft wash will help maintain the roofs surface condition and prevent premature deterioration. The roof surface would benefit from a paint upgrade in the near future.

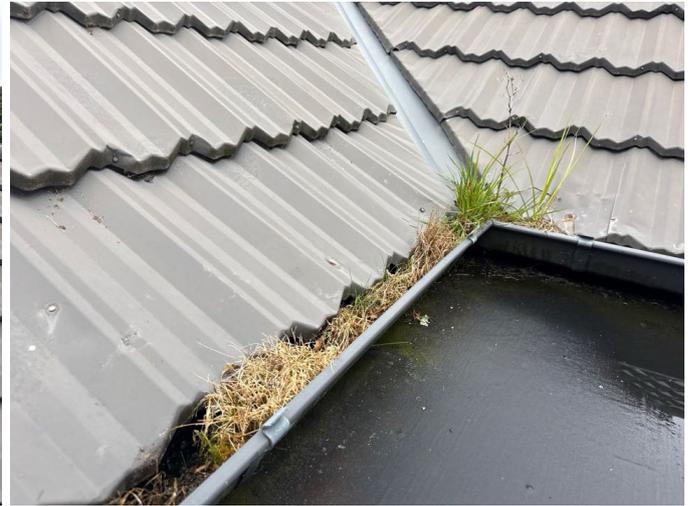
The spouting is in need of a clean out which will help prevent the risk of blockages and overflows. The effectiveness of the spouting will need to be checked during rainy periods. Due to the dry conditions that were evident on the day of our inspection we cannot comment on any leaks that maybe evident to the spouting or down pipes.

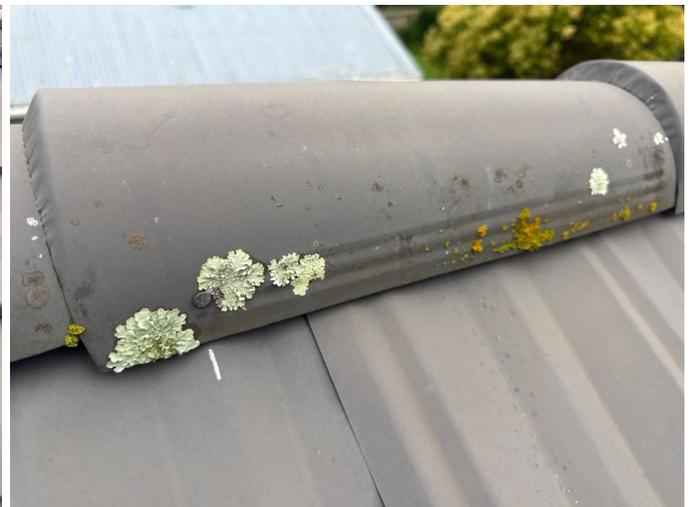
The Lichen should be chemically treated to prevent it spreading. A chemical treatment may be required every 2-3 years as part of ongoing roof maintenance. Lichen will speed up deterioration to the roof surface and will need to be monitored and treated as required.

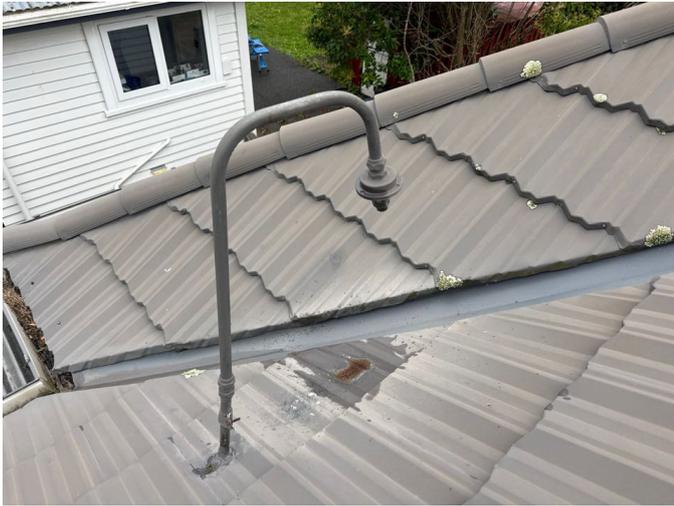
Rust to the tile beneath the hot water cylinder over flow pipe. The rust should be treated with rust converter and the tile painted to slow the deterioration.

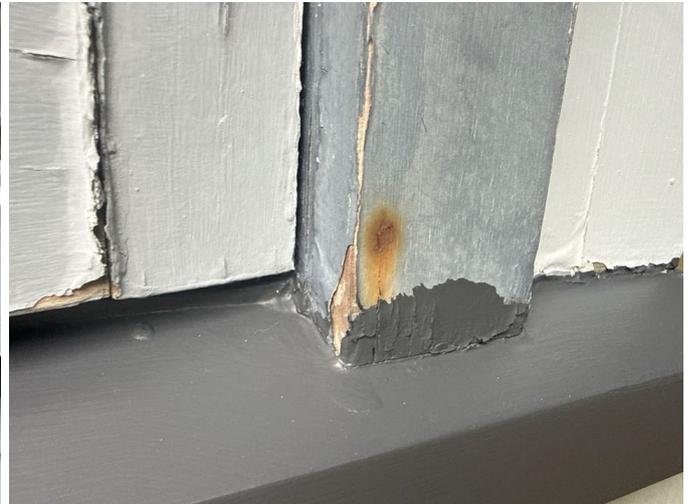
Rust affected nails need to be treated with rust converter and painted

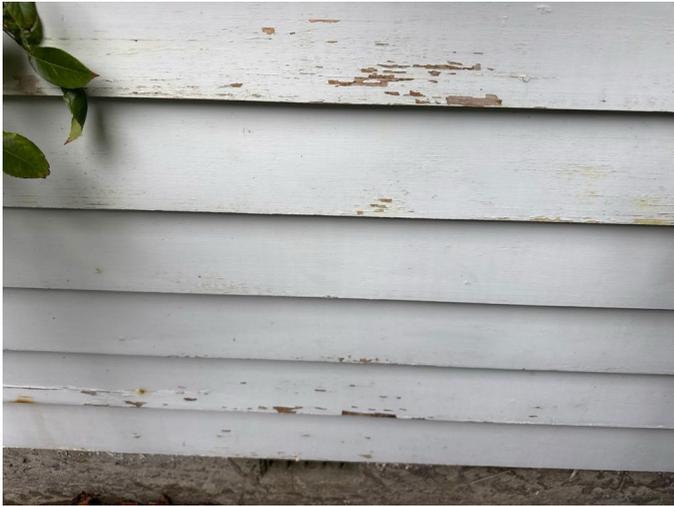
The current paint system is nearing the end of its functional life. Paint improvements recommended asap.

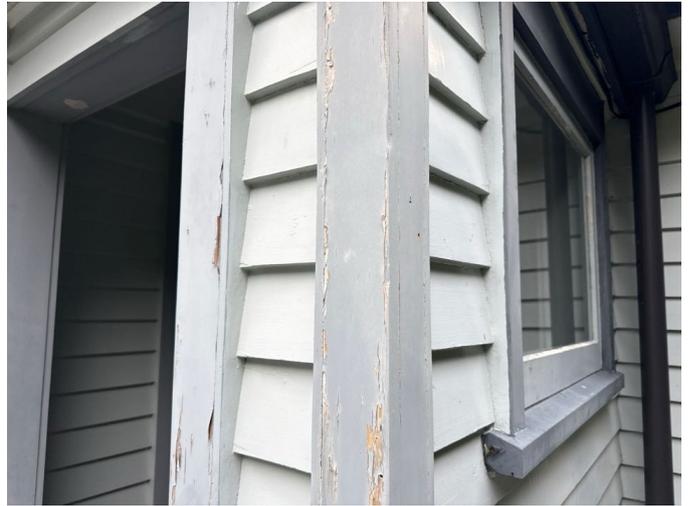
Timber facings and box corners require a thorough prep and paint upgrade

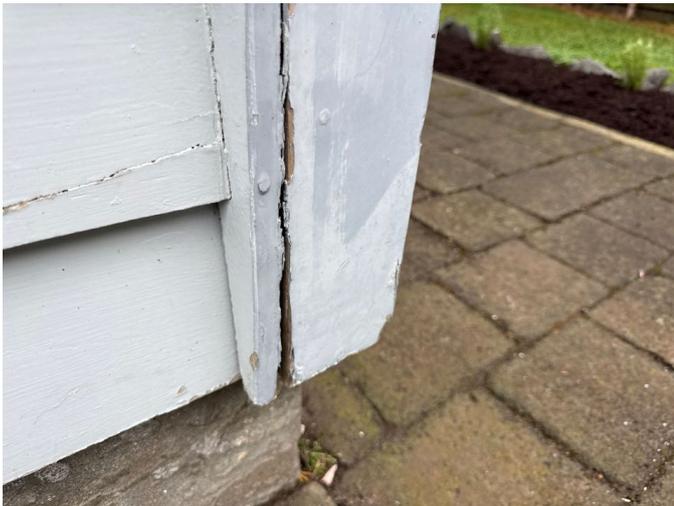
Box corners that are opening up should ideally be either fixed tight or sealed to prevent the possibility of moisture ingress.

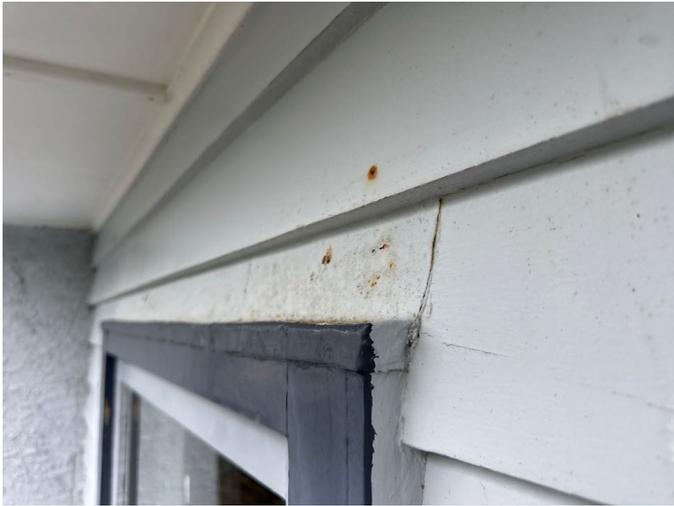
Some of the homes head flashings have superficial corrosion. This will get worse if left and requires the corrosion to be removed before sealing with rust converter and painting. Risk of water ingress issues if left to deteriorate.

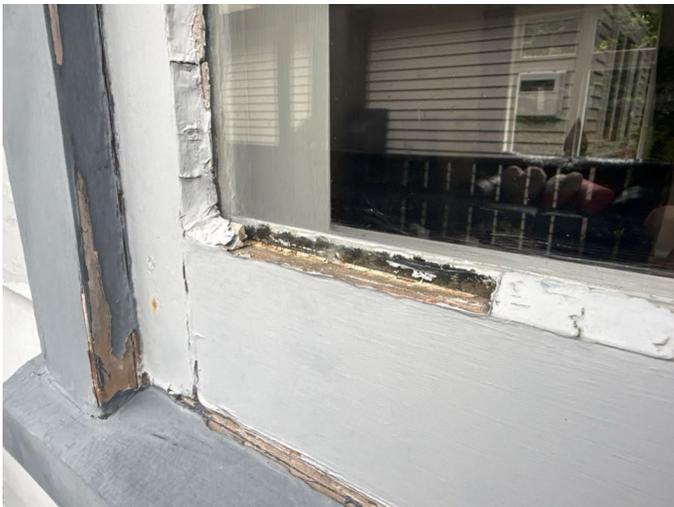
The window putty should be replaced where it is missing which will help keep the glass secure and the window water tight.

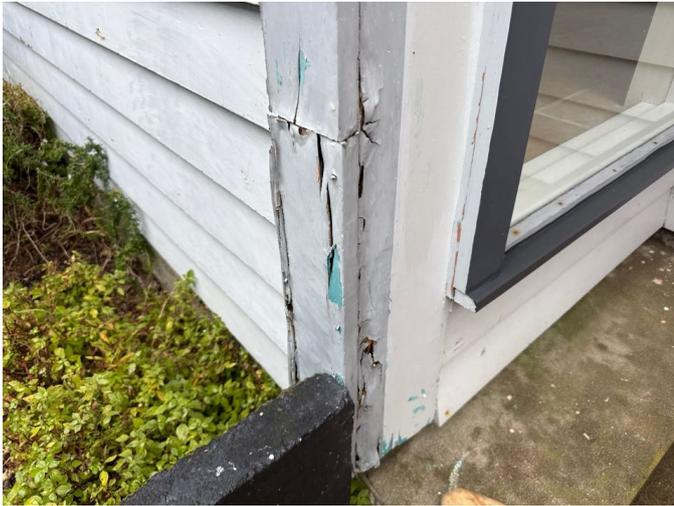
The damaged box corner should be replaced by a licensed builder

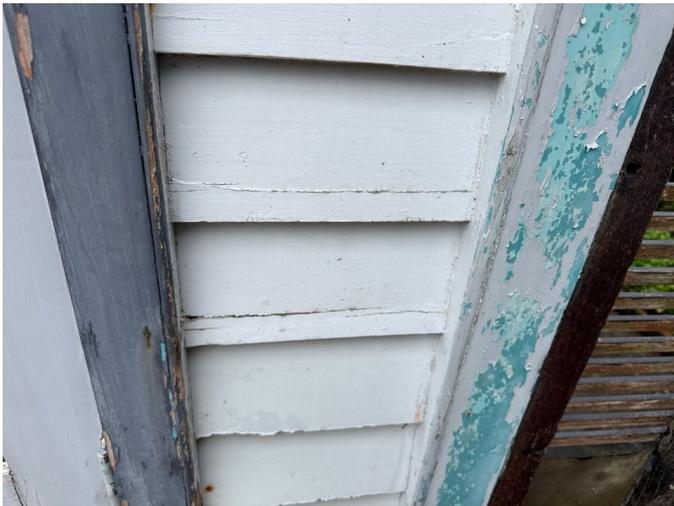
Any cracked weatherboards should be thoroughly sealed or replaced

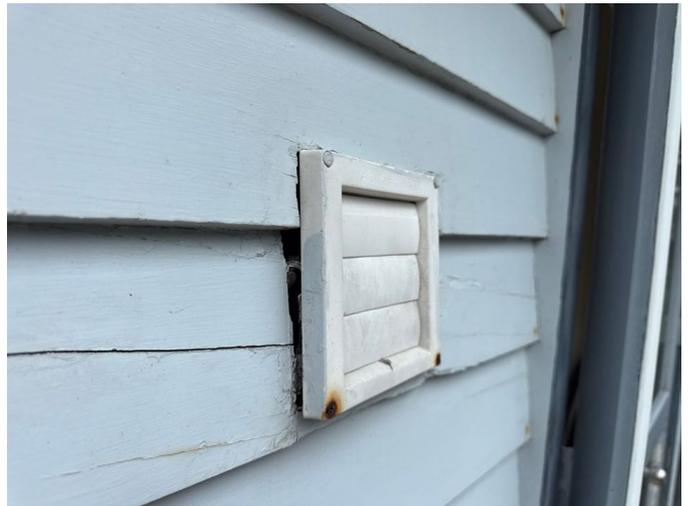
Poorly sealed penetration. Improvement required. Weather-tightness in these areas relies solely on a good seal between the item and the cladding. Sealing improvements recommended to prevent the risk of internal damage.

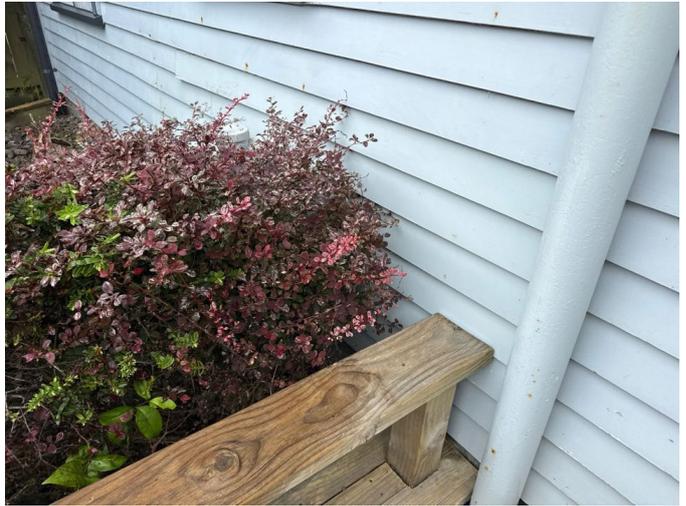
Plants in close contact with the cladding should be trimmed back to prevent the risk of premature deterioration

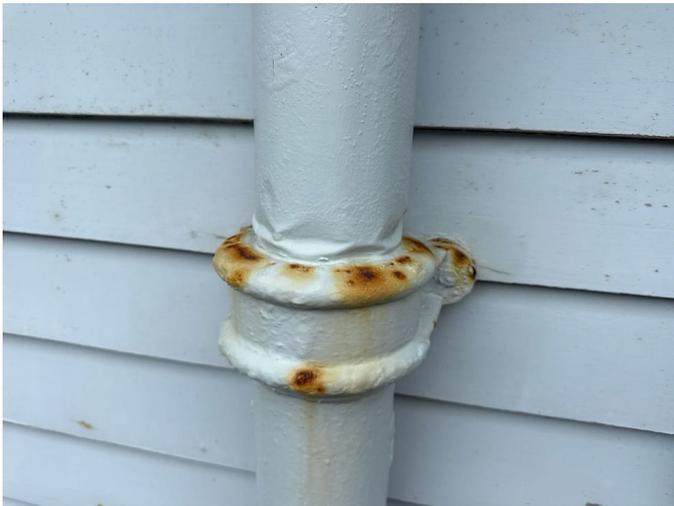
Another example of rust affected areas which require treatment

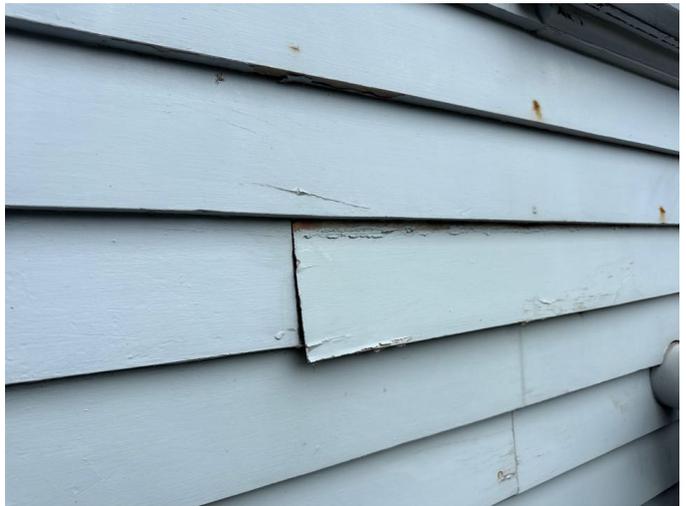
The loose weatherboard should be secured

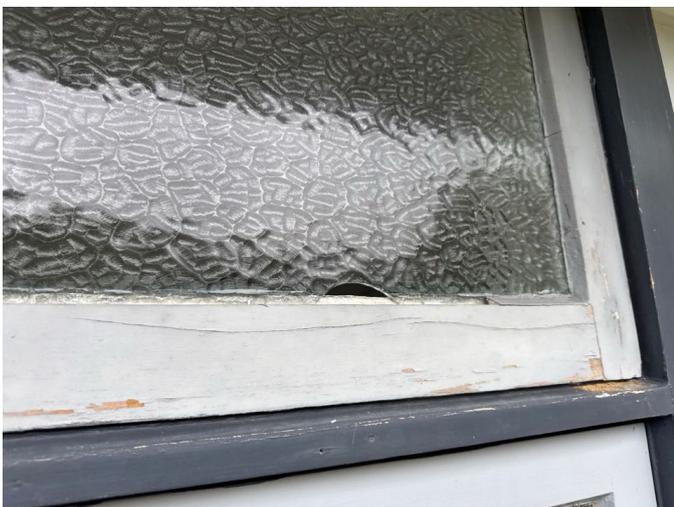
There is a hole in the bathroom window. The panel should be replaced.

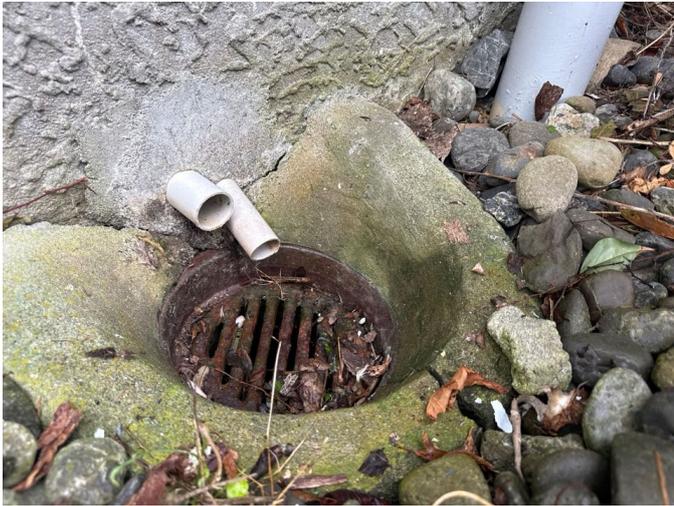
Earthenware pipes are prone to root damage. A camera inspection should be considered to determine the condition of the concealed drains.

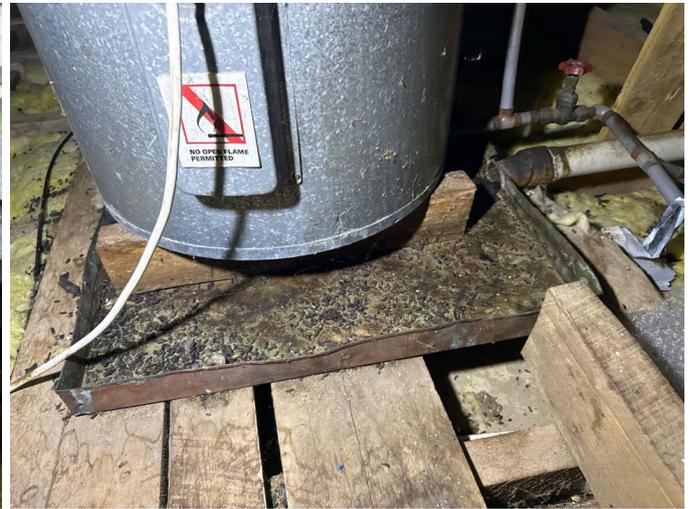
Ceiling cavity.
Rheem 180L Low Pressure Electric Hot Water Cylinder. Seismic restraint installed.

There was no sign of leaks at the base of the cylinder at the time of inspection. Rodent droppings should be cleared from the tray.

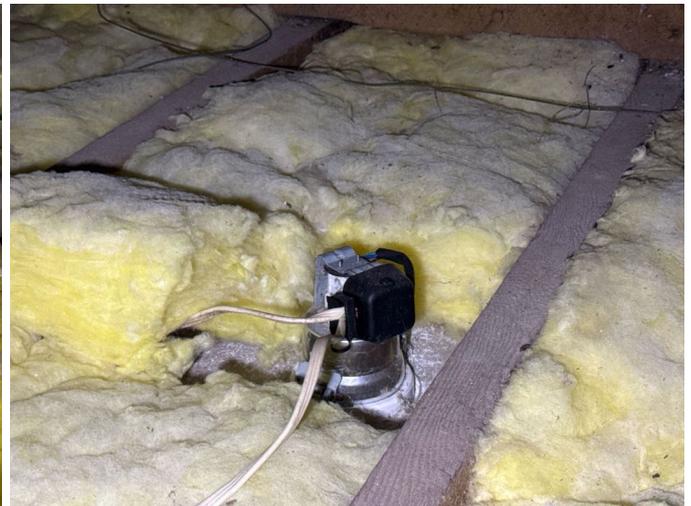
Where there are older types of recessed downlights, insulation must be kept 200mm away or 100 mm with a fixed guard to prevent the lights, ceiling materials or insulation from overheating. Recessed downlights labelled "CA80" or "CA90" can have insulation abutted against them. BRANZ recommends replacing older downlights with surface-mounted lights or with IC or IC-F recessed downlights that can have insulation placed over them.

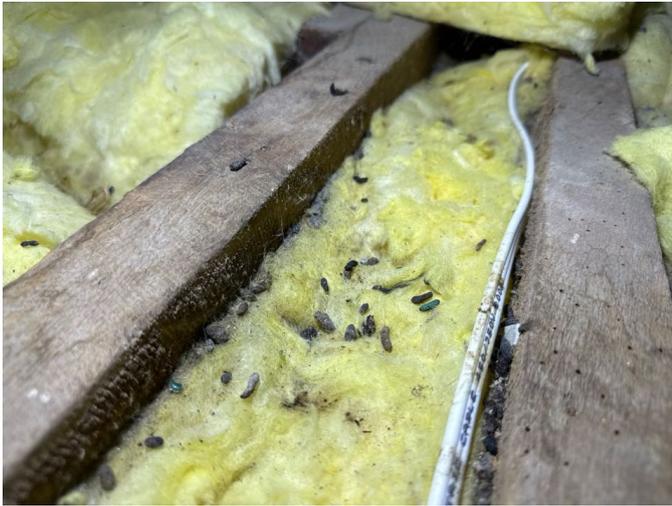
An example of the historic rodent activity in the ceiling cavity

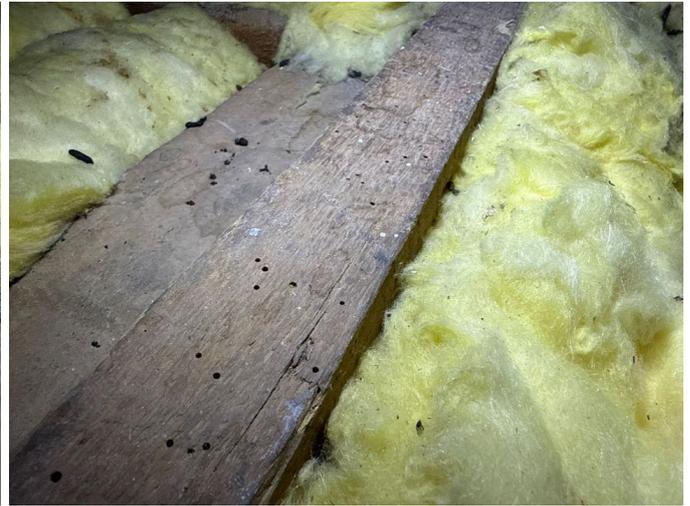
Historic borer activity in the ceiling cavity. There was no significant damage or current activity sighted.

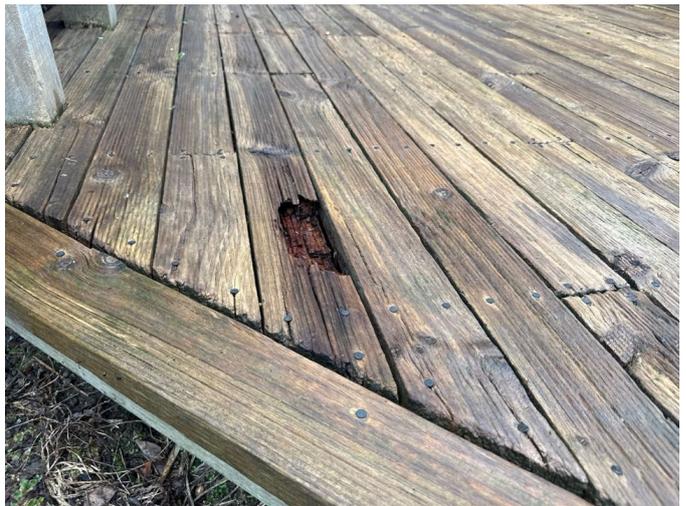
The damaged decking board should be replaced

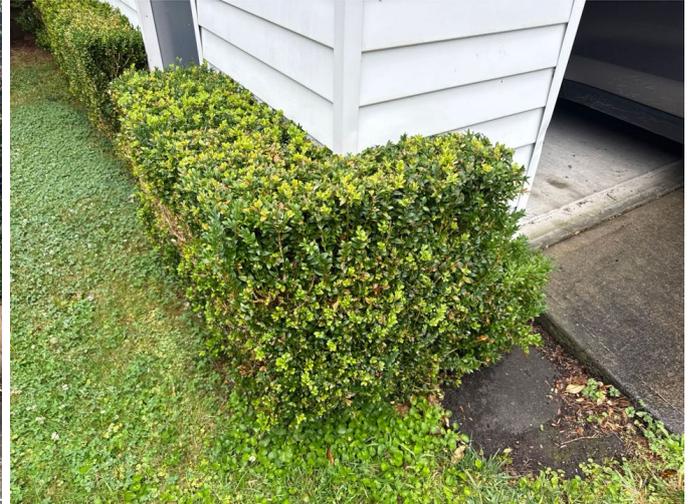
Plants should be kept clear of the steel cladding to prevent the risk of rust damage

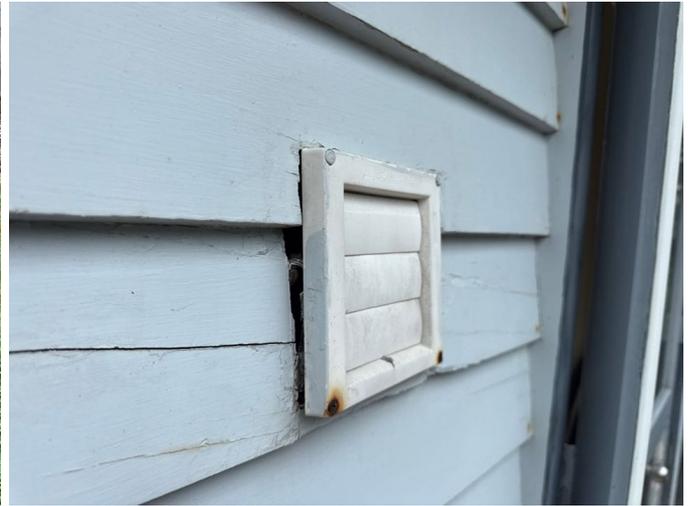
East side. Poorly sealed penetration. Improvement required. Weather-tightness in these areas relies solely on a good seal between the item and the cladding. Sealing improvements recommended to prevent the risk of internal damage.
