RED LBP PRE-PURCHASE REPORT

PRE-PURCHASE

PRE-PURCHASE BUILDING REPORT

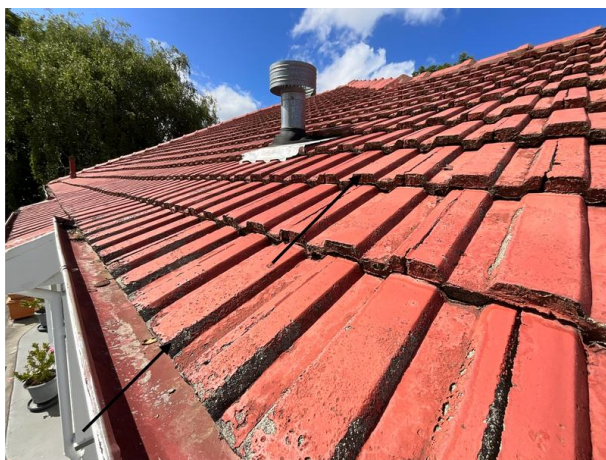
Photo 1

Tile condition - Areas requiring maintenance, refer to photos below.

Masonry tile roof. Areas of damage to the surface of the masonry tiles viewed on the northern side of the roof.

It is recommended to engage a Licensed Building Practitioner (LBP) specialising in roofing to undertake a comprehensive assessment of the roof's condition and provide a detailed report. Without proper evaluation and timely repairs, undetected or unresolved roofing issues could lead to leaks, water intrusion, and subsequent damage to the underlying structures, insulation, and interior spaces. Over time, this could result in costly repairs, reduced energy efficiency, and compromised structural integrity. A thorough inspection ensures potential issues are identified and addressed promptly, safeguarding the long-term durability and performance of the roof system.

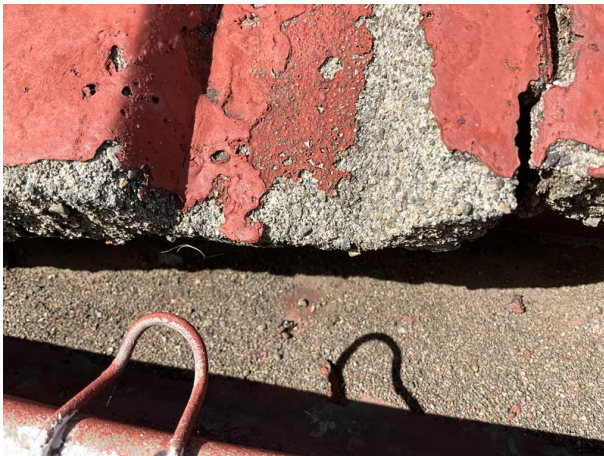
Photo 2

Corrosion to the surface of the tiles on the north eastern corner.

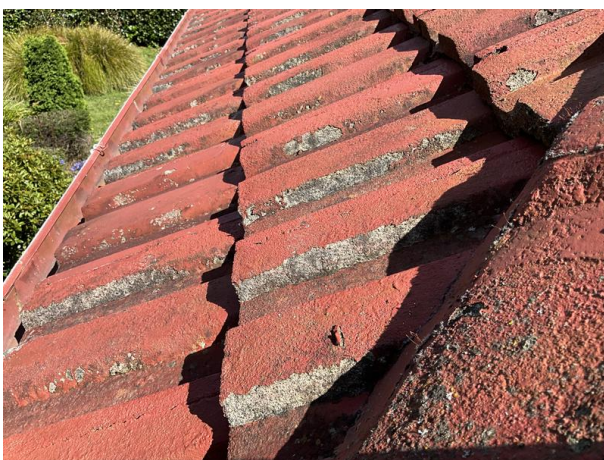
Photo 3

Corrosion to the surface of the tiles on the southern side of the roof.

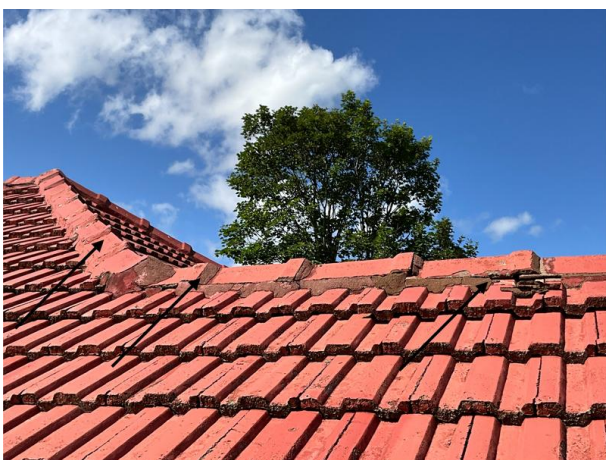
Photo 4

Masonry tile capping to the ridge and hips. Area of damage to the mortar. Viewed on the northern side.

While minor hairline cracking in the roof mortars is normal, there are areas where the cracks have widened and/or displaced. To ensure proper repairs, it is recommended that a suitably qualified LBP in roofing be consulted, and that correct materials are used for the job.

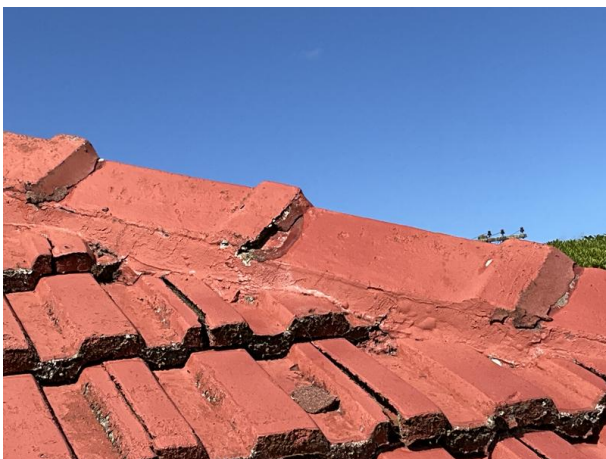
Photo 5

Damaged mortar to the tile roofing located on the northwestern side of the roof.

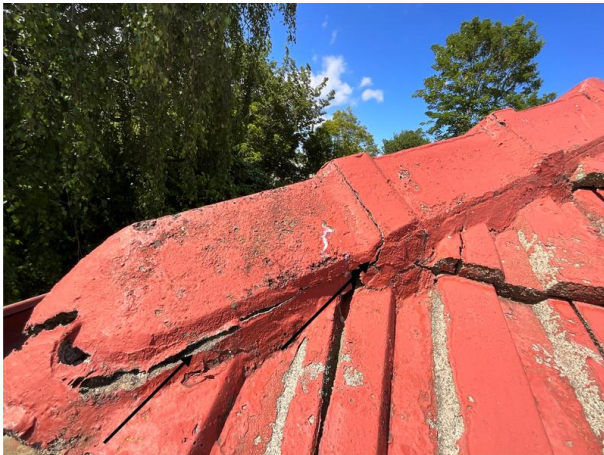
Photo 8

Cracking and damage to the tile capping on the north east corner of the roof.

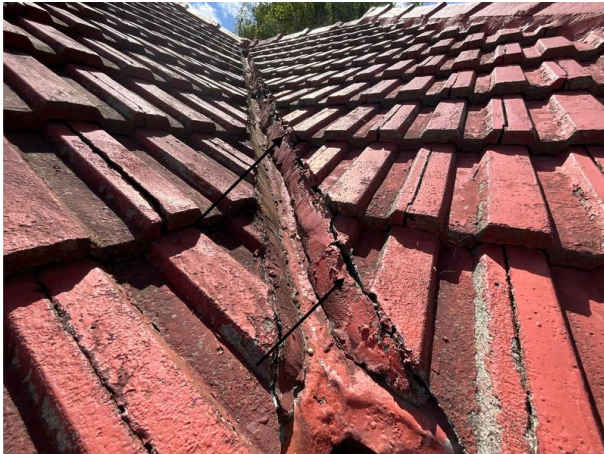
Photo 9

Profiled metal valley tray located on the southern side of the house. Areas of cracking to the mortar.

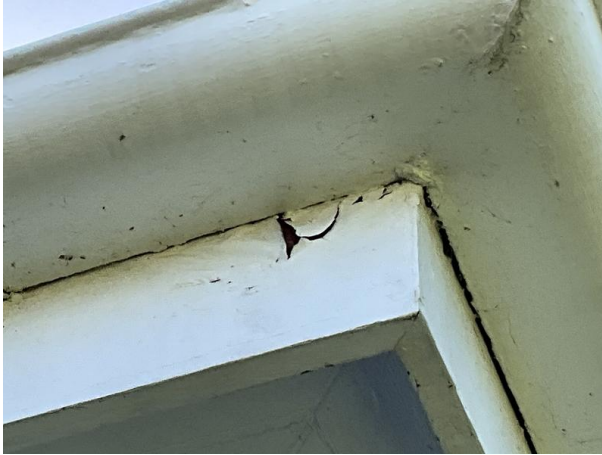
Photo 12

Finish - Paint - Paint flaking and missing.

Moisture damage to the painted timber fascia on the southwestern corner.

There are areas of the timber fascia that require sanding back any loose flakey paint, apply a sealer coat then redecoration to prevent further deterioration.

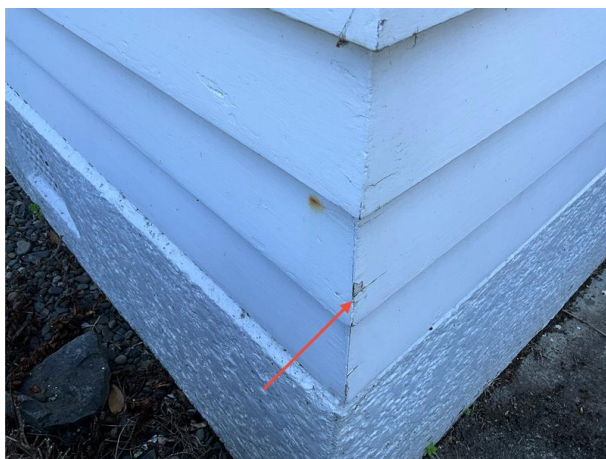
Photo 14

Moisture damage to the painted timber weatherboards on the southwestern external corner.

Some areas require maintenance as they are weathering due to either being more exposed to the elements or from generally being on the south side of the home.

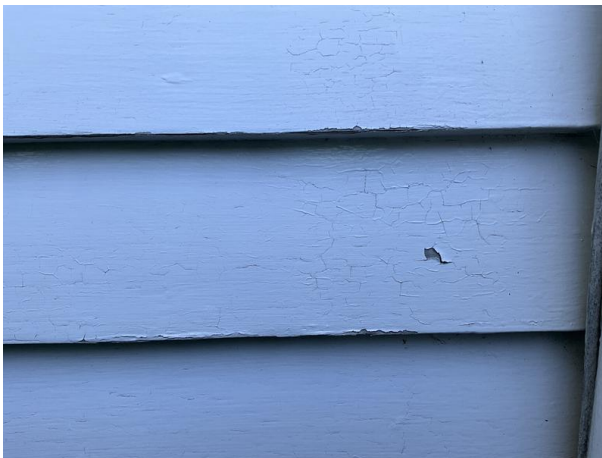
Photo 16

Moisture damage to the timber weatherboard cladding beside the chimney on the western side of the house.

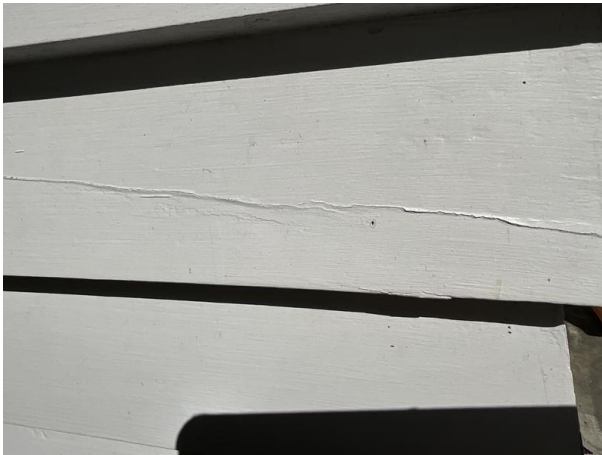
Photo 17

Splitting to the timber weatherboard on the north eastern corner.

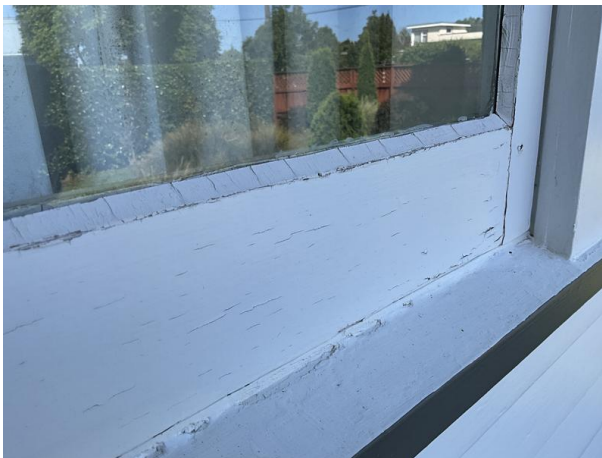
Photo 23
Cracking to the putty beadings and moisture damage to the painted timber surface of the window at the front entrance.

Painting should be maintained in accordance with normal exterior maintenance schedules.

Some repairs required to the opening sashes of the windows in order to restore functionality and to reduce draughts.

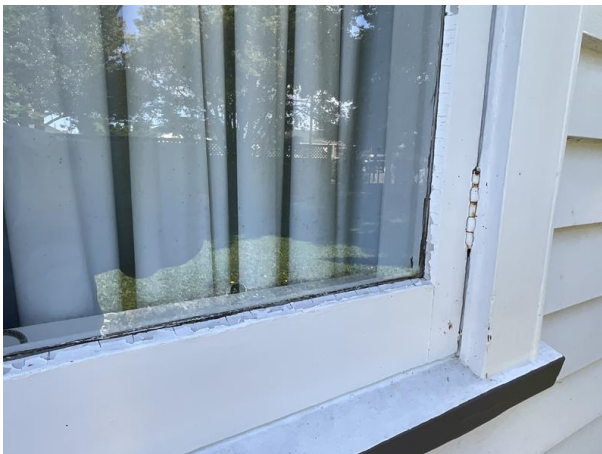
Photo 24
Cracking to the putty beading and corrosion to the hinges of the window on the southeastern corner.

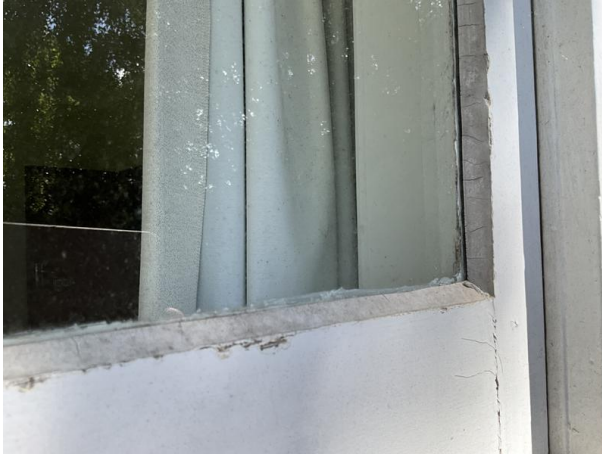
Photo 25

There is no decoration to the putty beadings of the windows on the eastern side.

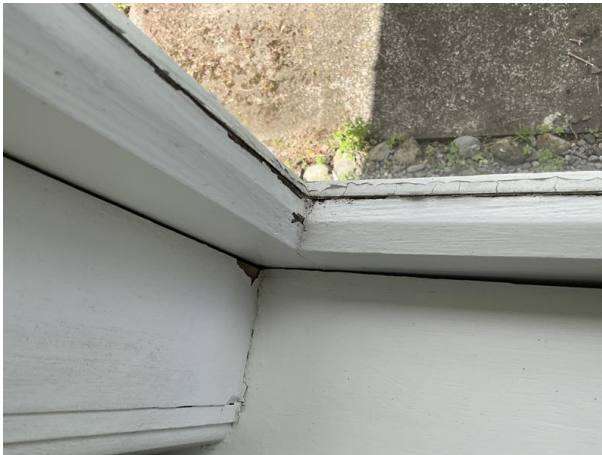
Photo 27

Moisture damage to the painted timber window surfaces of the southern window in bedroom 1.

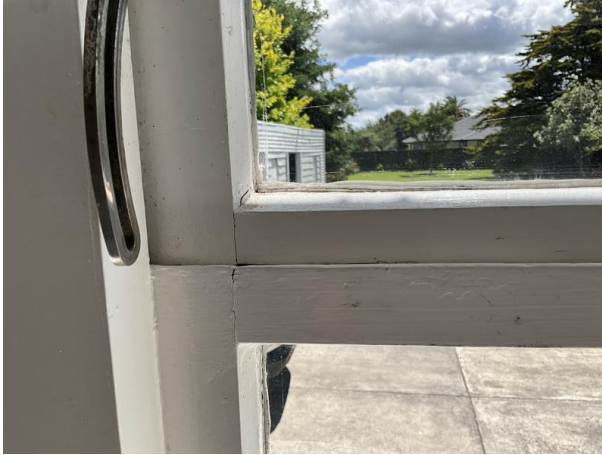
Photo 28

The fan light window sash in the kitchen on the northern side is binding.

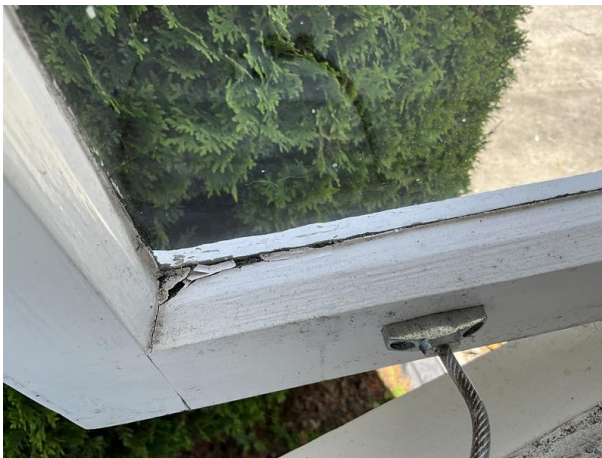
Photo 29

The damage to the painted timber window surfaces in the lounge.

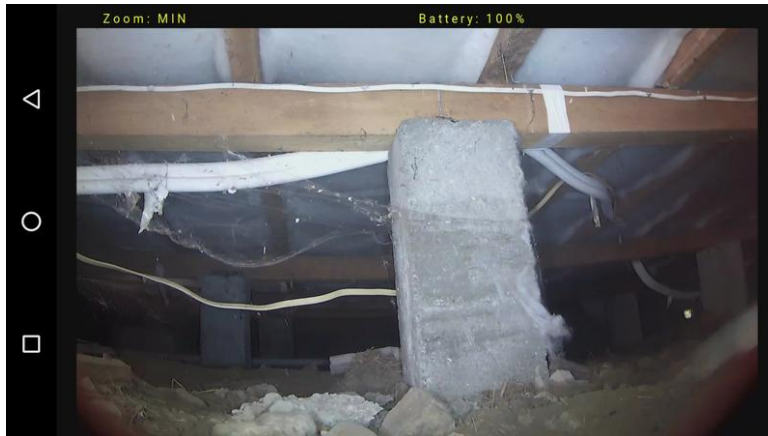
Photo 30

Pre-cast concrete piles with native timber subfloor framing. No polyethene pound moisture is installed. TPS wiring and heat pump piping.

It is recommended to install a ground moisture barrier over any exposed soil in the subfloor area. This barrier helps to reduce moisture levels, minimising the risk of dampness, mold growth, and timber decay. Proper installation in accordance with best practices and building standards will improve overall subfloor ventilation.

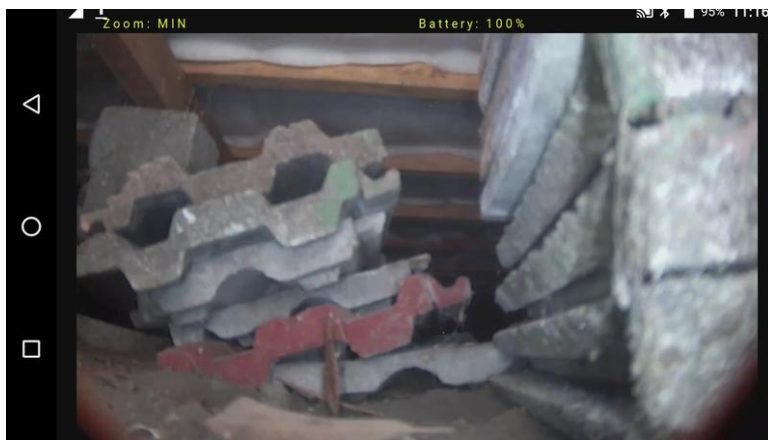
Photo 31

Building debris.

Remove all building materials from the subfloor area, as their presence can attract vermin and create a breeding ground for pests. Keeping the subfloor clean and free of obstructions is essential to maintaining proper ventilation and reducing the risk of pest infestations or damage to the building structure.

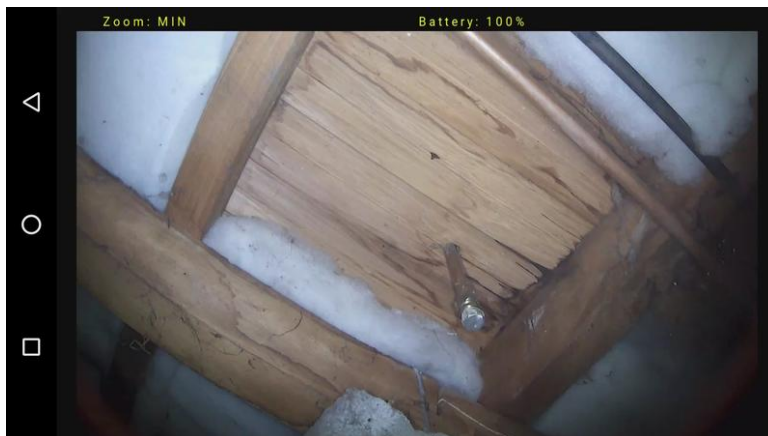
Photo 32

Moisture staining below the hot water cylinder.

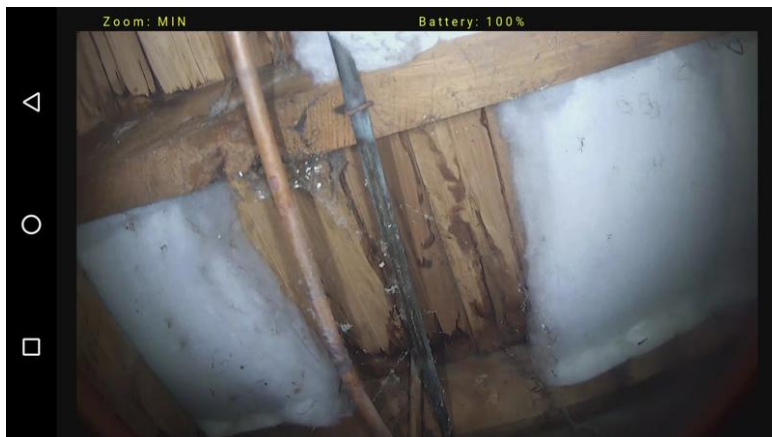
Photo 33

Moisture staining below the hot water cylinder. Example of nissing under floor insulation.

It is recommended to install a code-compliant subfloor insulation.

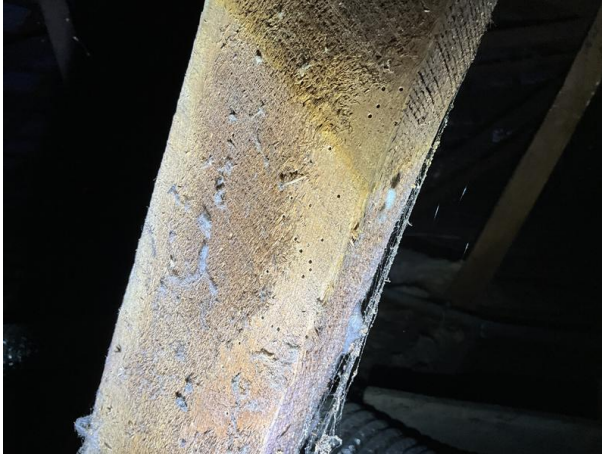
Photo 35

Borer activity has been identified within the roof space, with the level of infestation indicating potential deterioration to structural timbers. Evidence of borer damage was also visible in adjacent framing elements. It is recommended that a pest-control specialist undertake a full assessment to determine the extent of the infestation and provide appropriate treatment. As this was a non-invasive inspection, the full extent of any internal timber damage cannot be confirmed. Refer to the Roof Space section of this report for further details.

Condition - Evidence of wood boring insect infestation.

Borer damage to the framing timbers.

Borer-infested timber can be treated, but if timbers are severely weakened you should strengthen the timber or ultimately the timber may need to be replaced.

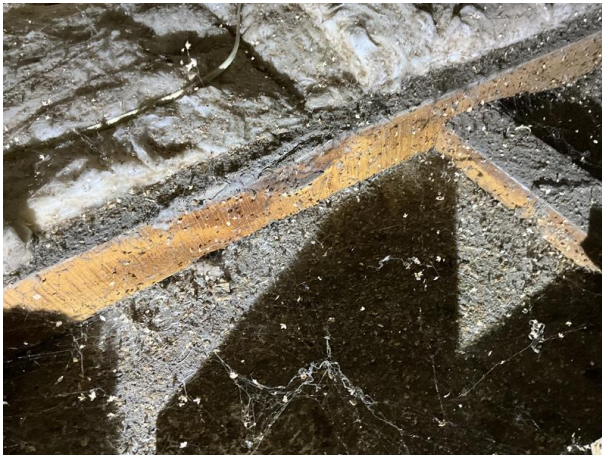
Photo 37

Thickness of insulation visible - 150 mm. Areas missing insulation.

Area of missing glass wool insulation
above the laundry area.

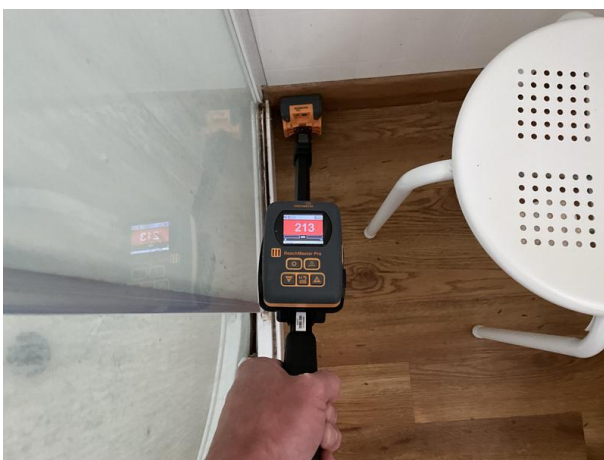
Photo 39

Indications are about elevated moisture level of 213 was recorded to the right hand side of the shower in the bathroom.

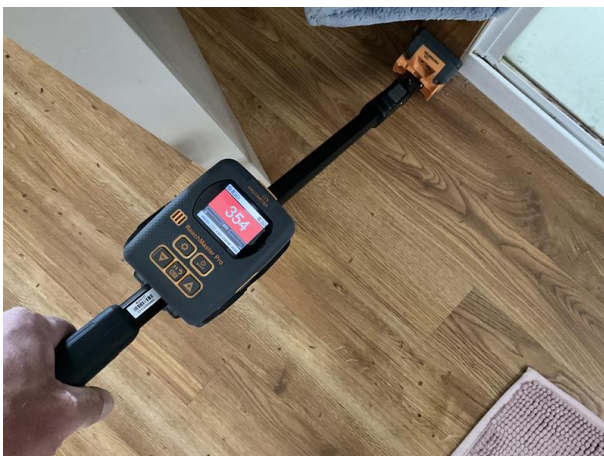
Photo 40

Indications of an elevator moisture reading level of 354 was recorded to the left-hand side of the shower in the bathroom.

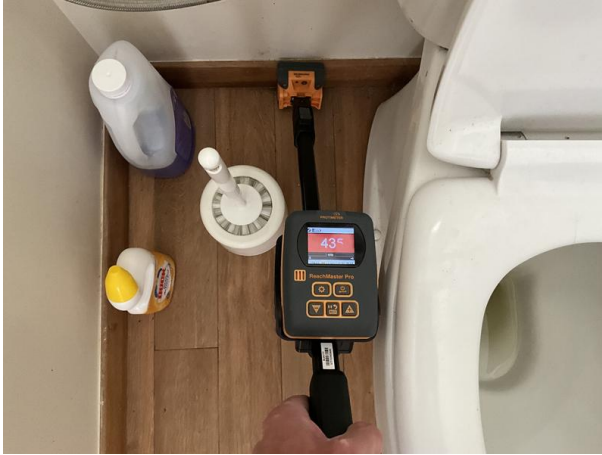
Photo 41

Indications of an elevated moisture reading level of 435 was recorded to the toilet.

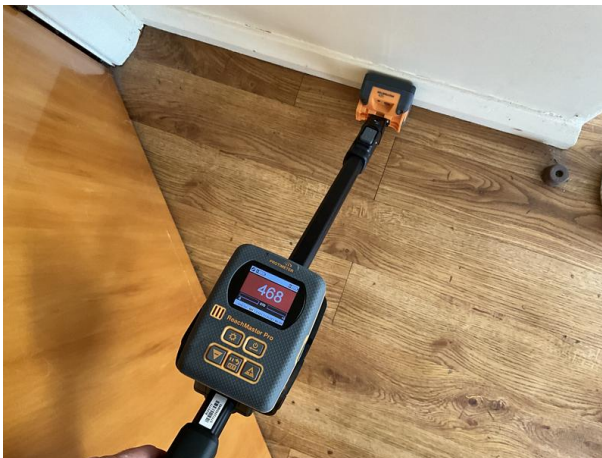
Photo 42

Indications of an elevated moisture reading level of 468 was taken to the hot water cylinder cupboard in the kitchen.

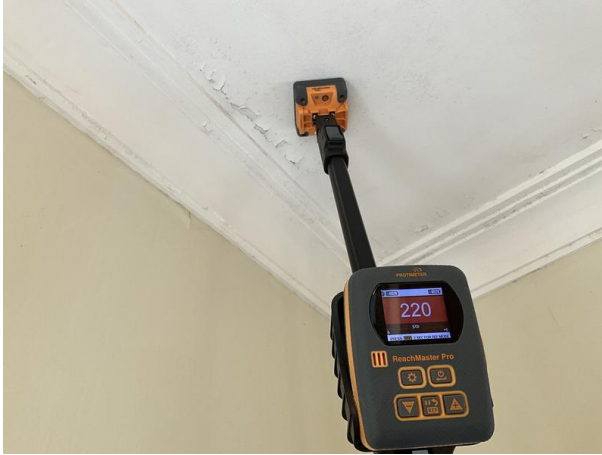
Photo 44

The indications of elevated moisture readings to the ceiling in bedroom 1 could indicate a failure of weathertightness, further investigation is recommended to establish the reasons for indications of elevated moisture. Followed by suitable remediation work as required.

Indications of an elevated moisture reading level of 220 were recorded to the bedroom 1 ceiling.

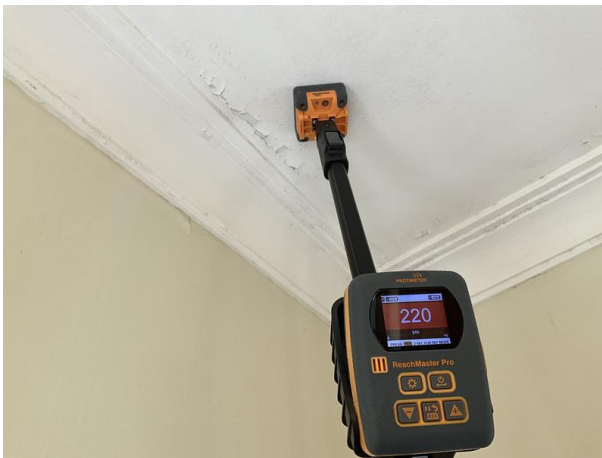
Photo 47
Indications of an elevated moisture reading level of 230 was taken to the southwestern corner of bedroom 1.

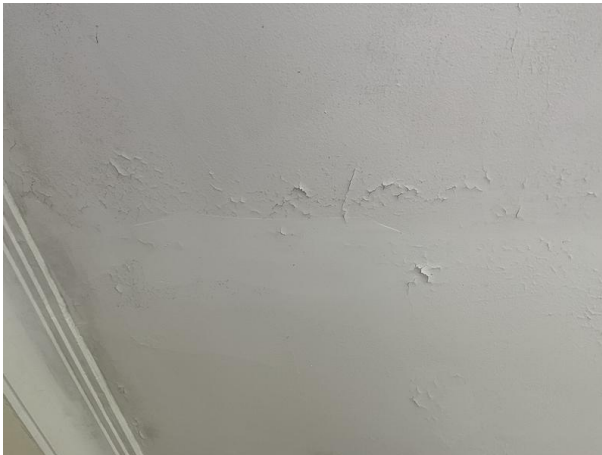
Photo 48
Moisture damage to the plasterboard ceiling.

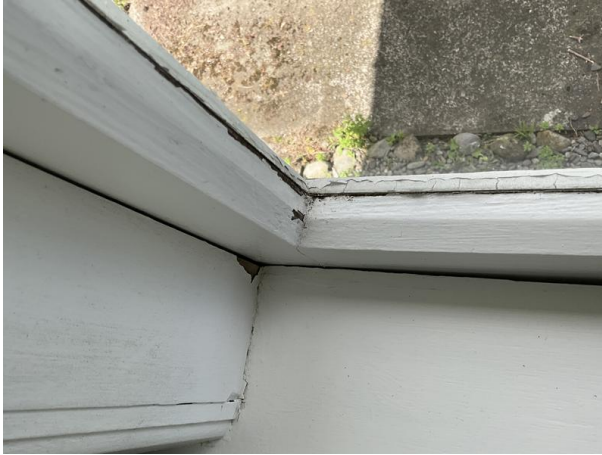
Photo 49

Moisture damage to the painted timber window surfaces on the southern side.

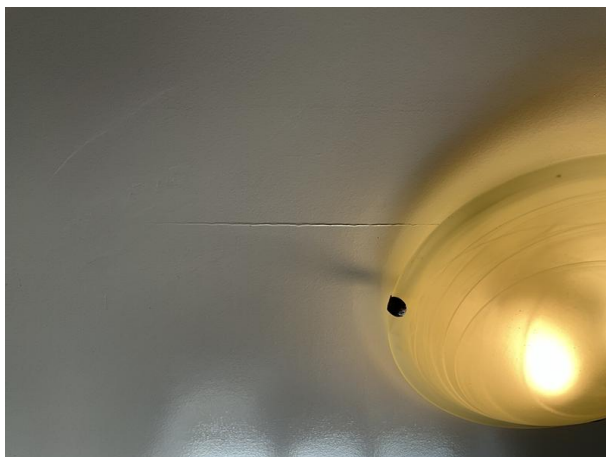
Photo 57

Cracking to the plasterboard ceiling.

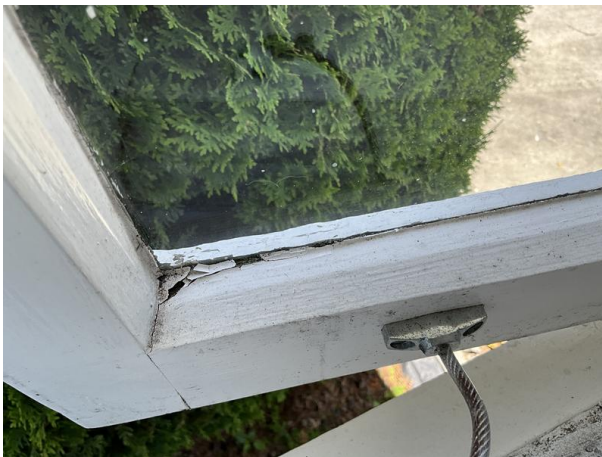
Photo 60
Moisture damage to the painted timber window surfaces.

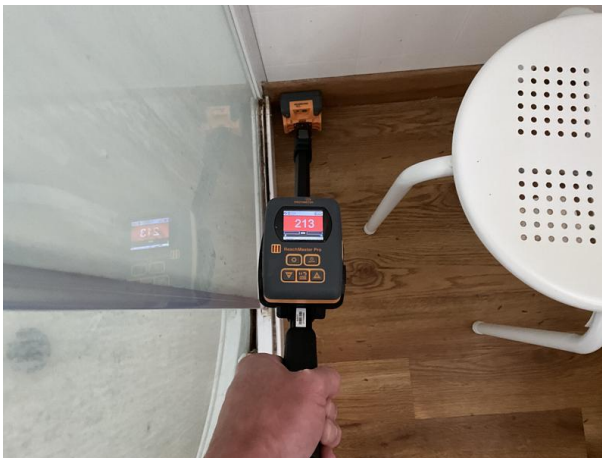
Photo 64
Indications of a elevated moisture reading level of 213 was recorded to the right hand side of the shower.

The timber trims and wall linings to each side of the shower will continue to show moisture damage until the shower is replaced or repaired and installed by a certified shower installer, the level of moisture and subsequent damage around this area is not a structural issue and will not cause structural damage nor is this likely a leaking water pipe or damaged wastewater pipe.

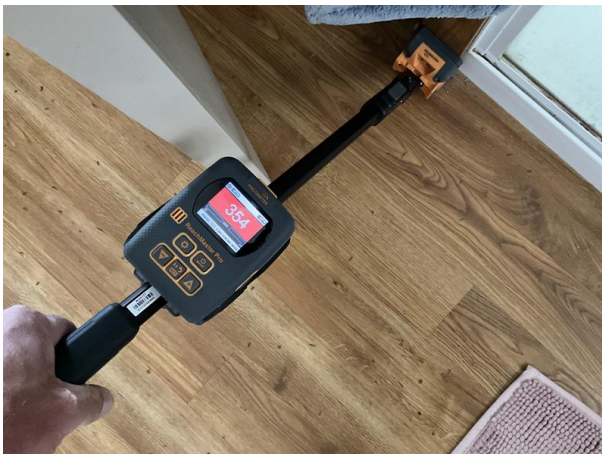
Photo 65
Indications of an elevated moisture reading level of 354 was recorded to the left-hand side of the shower.

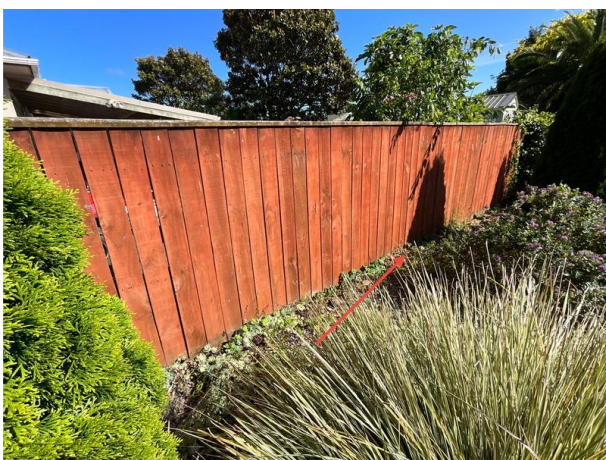
Photo 70

Western boundary fence. Painted timber palings with timber rails and posts. Areas of palings are in direct contact with the ground and vegetation.

Ensure regular upkeep and maintenance by keeping vegetation and soil away from exterior timbers. These timbers are treated for external exposure but are not designed for prolonged contact with vegetation or soil, which can trap moisture and accelerate rot. Periodically inspect the area and clear any overgrowth or soil buildup.

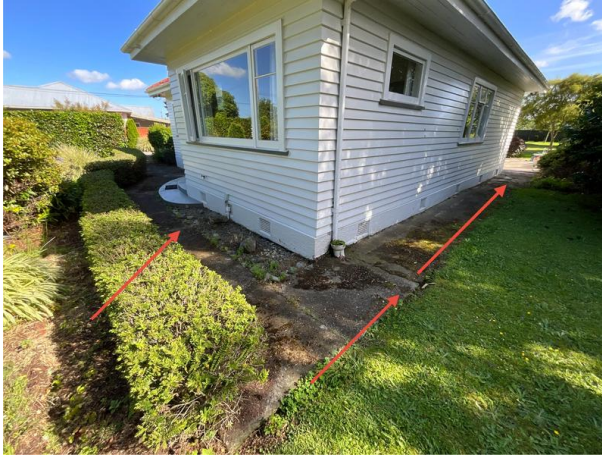
Photo 74

Concrete pathway located on the southern and eastern side of the house. Areas of cracking and vegetation growth.

Clean down to remove moss and reduce slip hazard as part of regular maintenance.

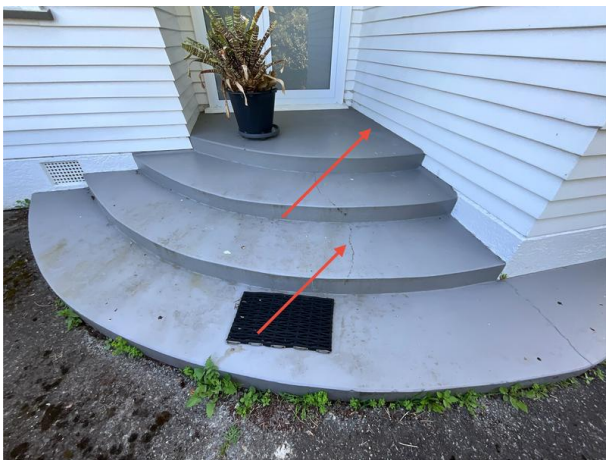
Photo 75

The concrete patio has no clearance to the exterior cladding, While there was no issues observed during the inspection. This configuration may lead to moisture issues due to capillary action. It is advisable to regularly monitor this area for potential issues and ensure it remains free of debris.

Concrete patio located at the front entrance. Visible cracking to the plaster coating. The patio is in direct contact with the timber weatherboard cladding.

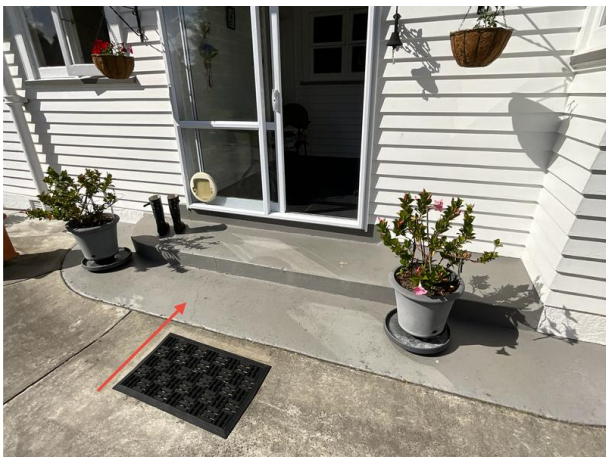
Photo 76

Concrete patio located on the northern side. Area of cracking to the plaster covering.

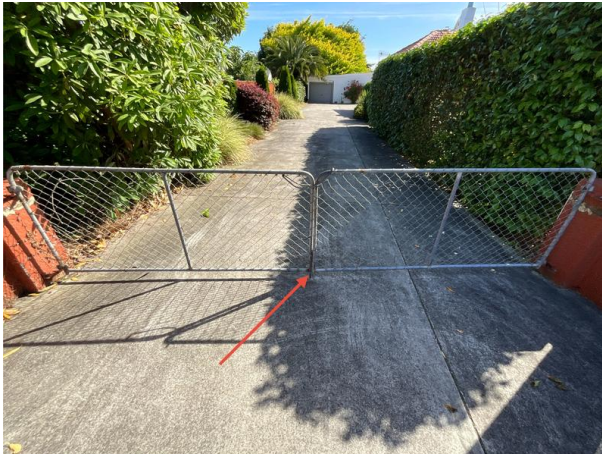
Photo 78

Metal framed gate with a wire mesh covering. The latch is out of alignment.

It is recommended to apply regular lubrication to the hinges and latch to maintain full function.
