RED LBP WEATHERTIGHT REPORT

WEATHERTIGHT REPORT

Property Address	15 Compass Court Paraparaumu
Client	Sitha Than
Date of Inspection	3rd March 2026
Time	8:00 am
Inspector	Trevor Garrett MSc, LBP, Advanced Trade Cert Carpentry, Nat Diploma Construction Management. Member of NZIOB.
LBP Number	131790
People Present	Inspector
House Occupied	No

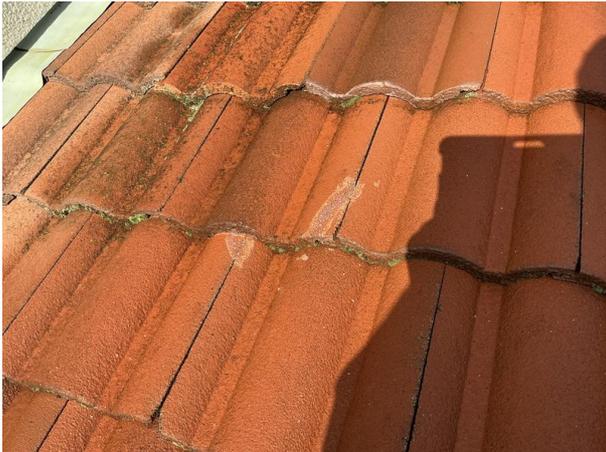
Photo 4
East side crack repairs.

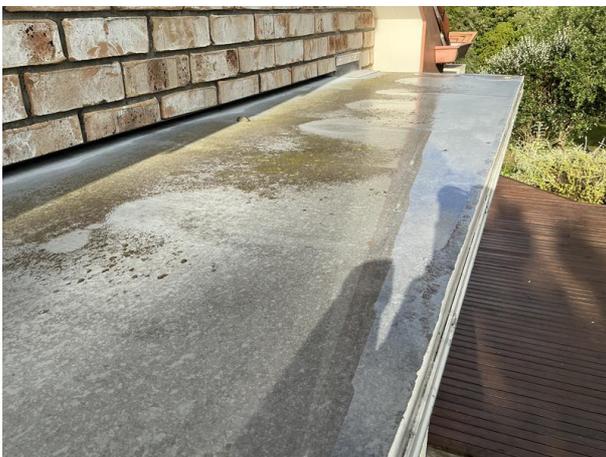
Photo 5
Northside membrane roof.

Recommend a roofer specialising in membranes, review the condition of the west side roof and the balcony roof for deterioration repair as required.

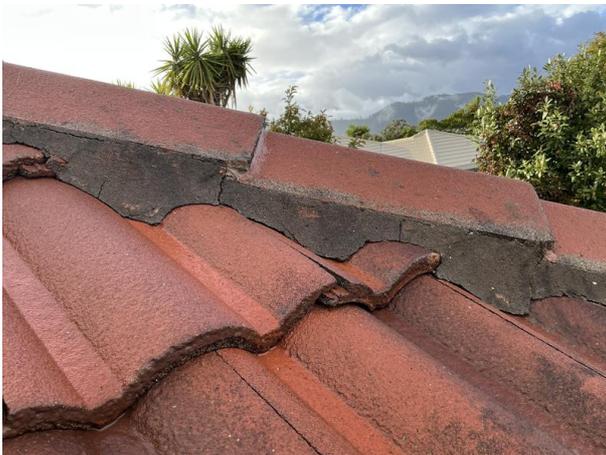
Photo 9
South side cracked hip mortar.

While minor hairline cracking in the roof mortars is normal, there are areas where the cracks have widened and/or displaced. To ensure proper repairs, it is recommended that a suitably qualified LBP in roofing be consulted, and that correct materials are used for the job.

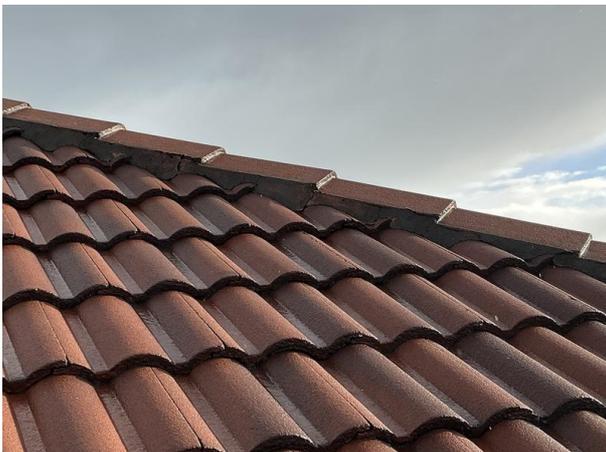
Photo 10
South side cracked hip mortar.

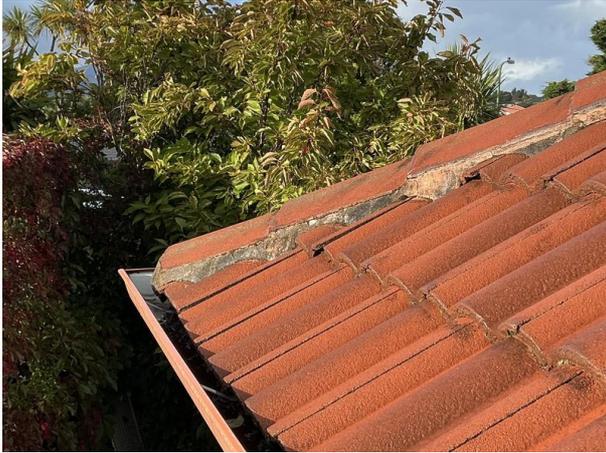
Photo 11
East side cracked hip mortar.

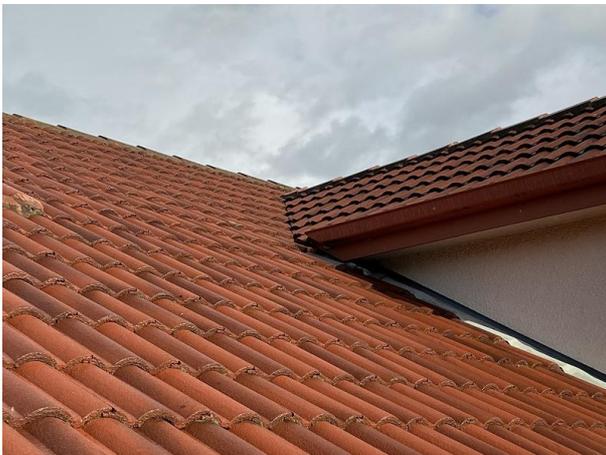
Photo 12
East side valley tiles are in contact, valley is not visible.

The roof tiles over the valleys conceal the valley gutter. This will allow debris to build up between the tiles and have the potential to cause the valley gutter to overflow. It is recommended to cut the tiles back to have a 50-75mm gap between them to allow free discharge of rainwater.

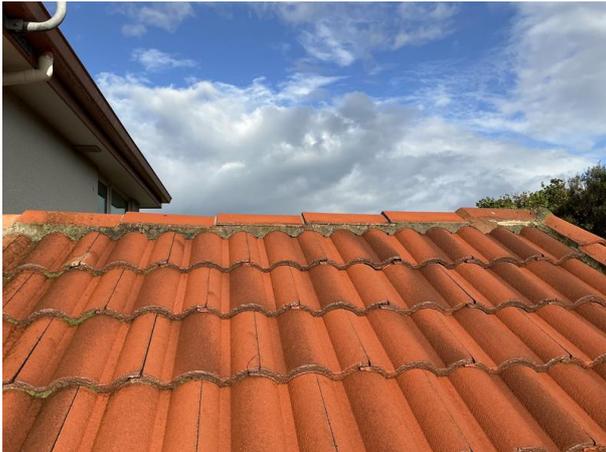
Photo 14
North side cracked and detached mortar.

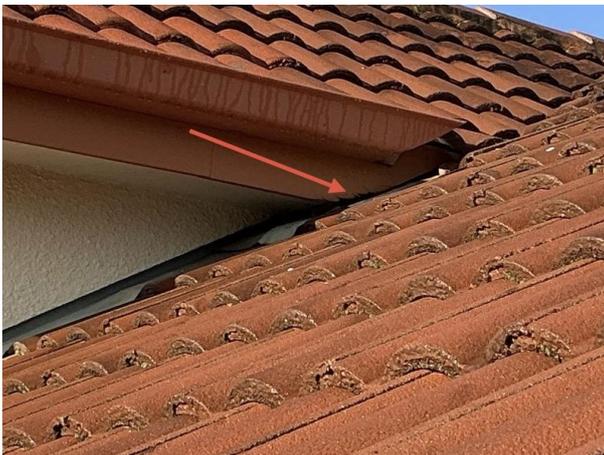
Photo 18

East side rot to fascia.

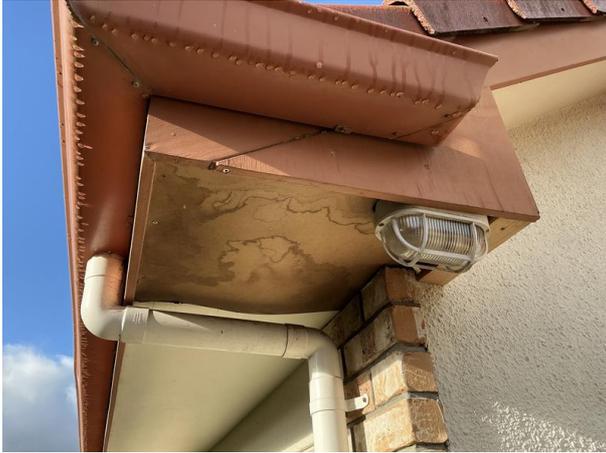
Photo 19
East side hardboard soffit in lue of fibre cement with moisture stains visible.

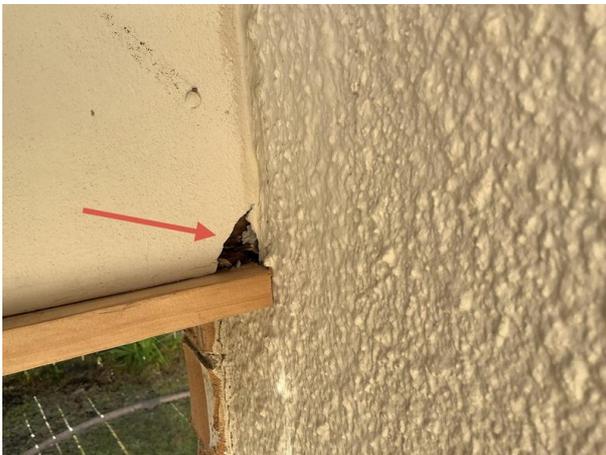
Photo 20
Rot visible beside hardboard soffit.

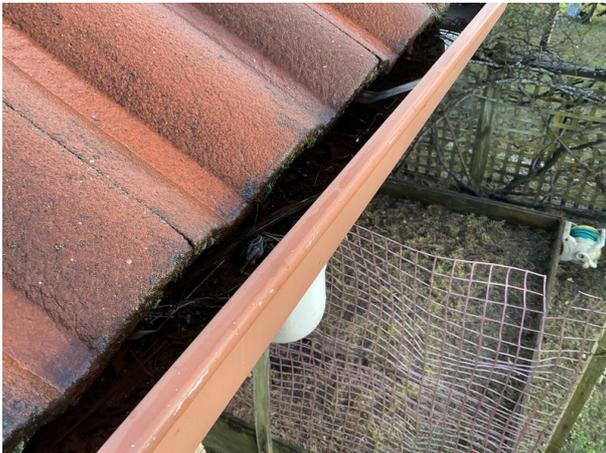
Photo 21
Gutter/downpipe blocked on the east side over the hardboard soffit.

It is recommended to clear the gutters regularly to ensure proper drainage and prevent potential issues. When gutters become clogged with debris such as leaves and twigs, water can overflow and accumulate on the roof or other parts of the building. This can lead to water damage and leaks. Keeping the gutters clean ensures efficient water flow away from the roof, protecting the property from moisture-related damage. Recommend further investigation to the east side soffit with the hardboard soffit to establish the causation and damage to the timber framing.

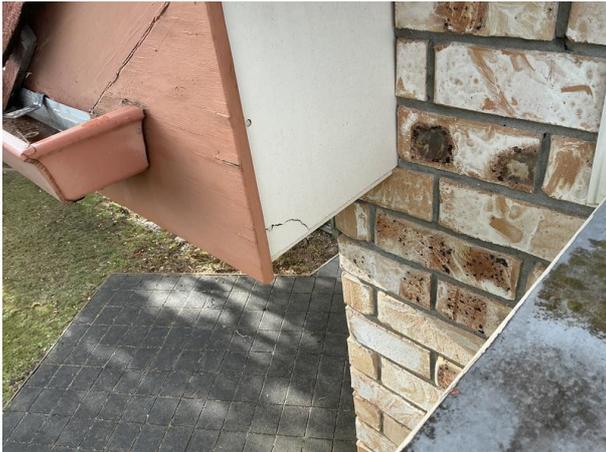
Photo 22
North side cracked soffit.

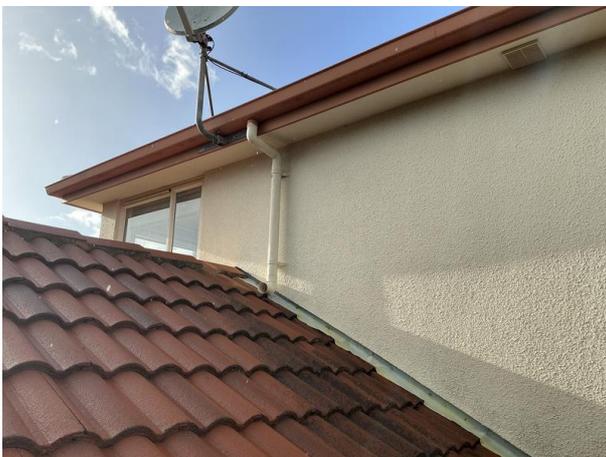
Photo 23
Upper level downpipes don't have spreaders.

It is recommended to install spreaders to downpipes that discharge onto lower roofs. This installation helps to distribute the flow of water evenly, preventing excessive water concentration in specific areas and reducing the risk of damage to the lower roofs.

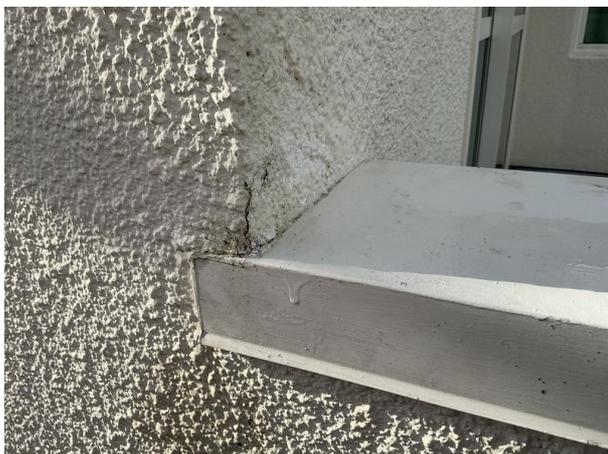
Photo 28
Crack to plaster to the north side.

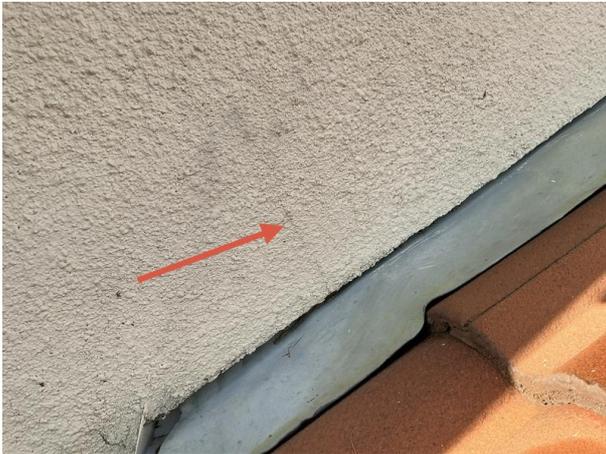
Photo 31
East side sheet crack.

There are cracks to the exterior cladding, in our view these need to be professionally repaired, as any cracks can allow moisture in behind the cladding and into the timber framing. Some of the cracking may relate to the lack of control joints and this can be determined by a exterior cladding specialist before carrying out the repairs.

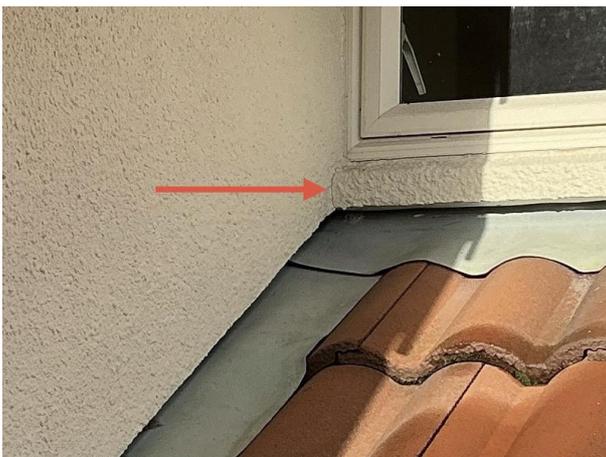
Photo 32
East side crack.

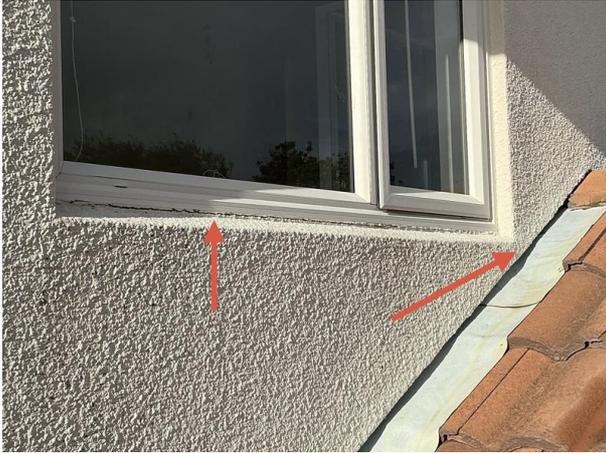
Photo 33
North side gap to the bottom of the window and crack to sheet.

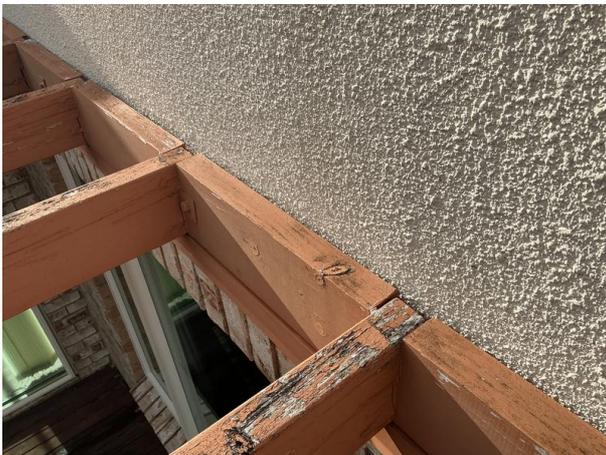
Photo 34
Northside pergola is fixed through the cladding.

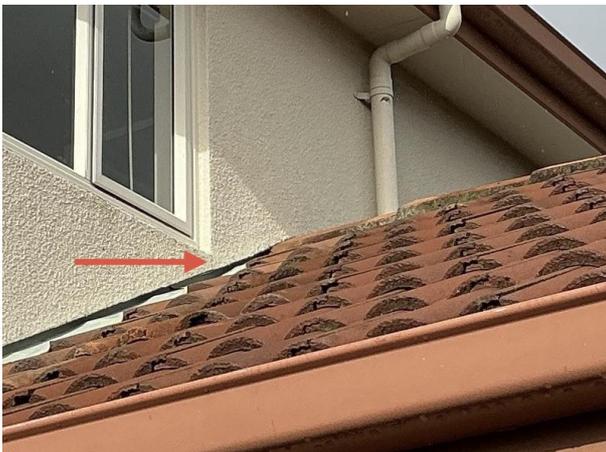
Photo 35
North side crack to plaster.

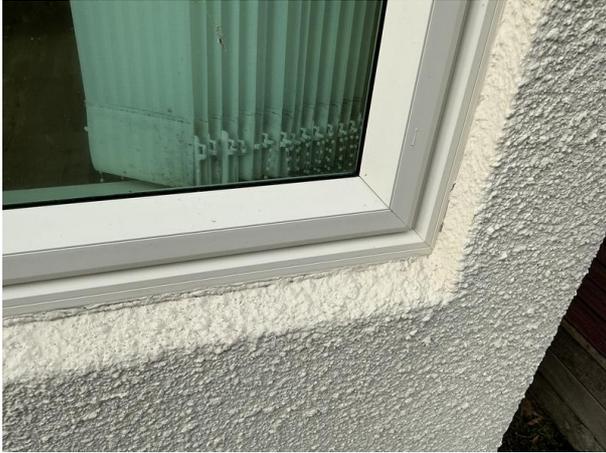
Photo 36
North side crack around window.

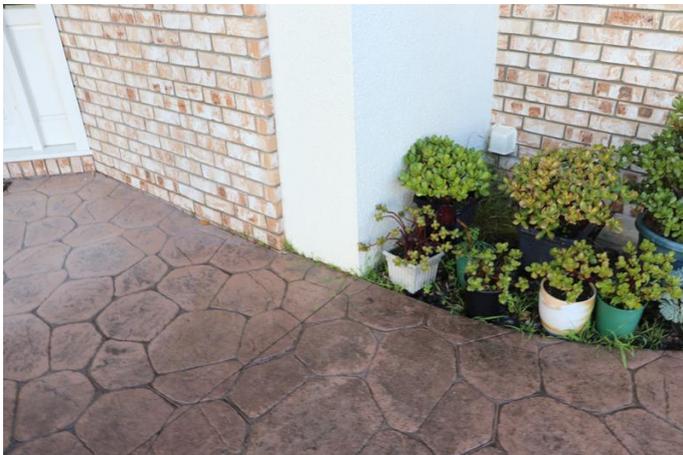
Photo 37
West side reduced ground clearance.

Some areas around the dwelling, the minimum ground clearance have been compromised due to hard landscaping or gardens. This reduced clearance can lead to accelerated weathering of the cladding and increase the risk of moisture-related damage. To mitigate this, it is recommended to lower the ground levels where feasible or install strip or channel drains. These measures will help protect the cladding by minimising exposure to moisture.

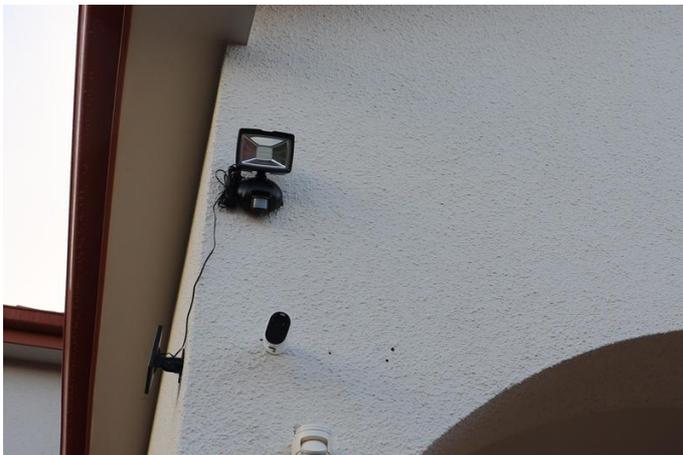
Photo 38
West side services penetrations with some screw holes in the cladding.

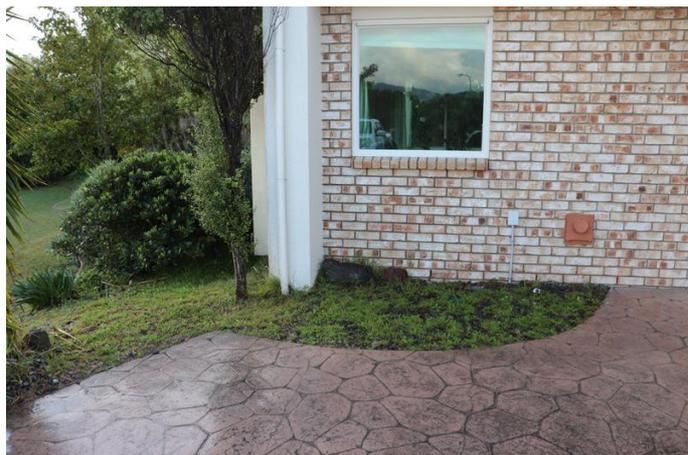
Photo 39

West side reduced ground clearance and change of cladding type junction.

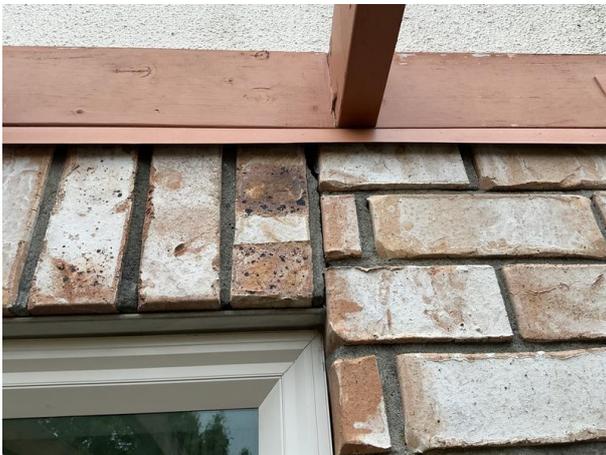
Photo 41
North side crack in mortar.

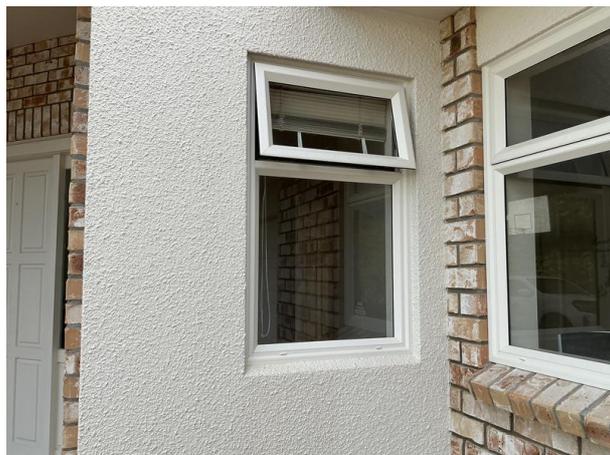
Photo 45

Windows within the plaster system have no visible head flashings.

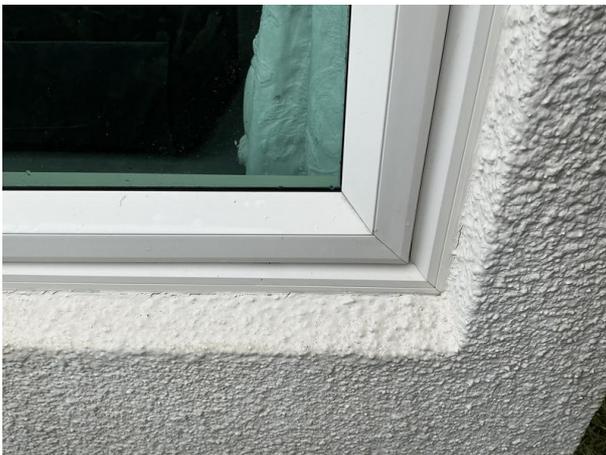
Photo 48
West side crack around window.

Any incomplete or damaged exterior side seals at the cladding to the exterior joinery units need to be repaired to stop water ingress.

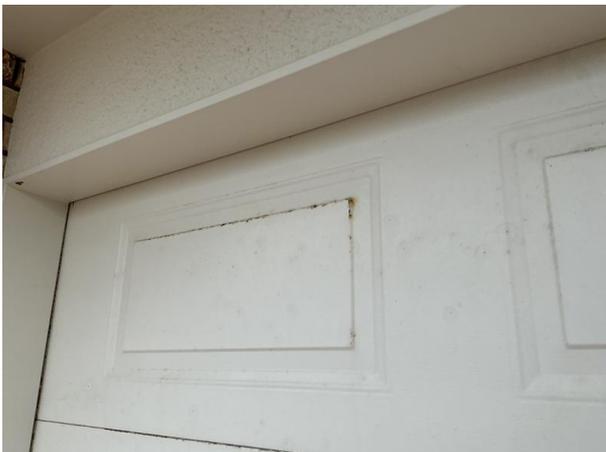
Photo 51
Rust visible to garage doors.

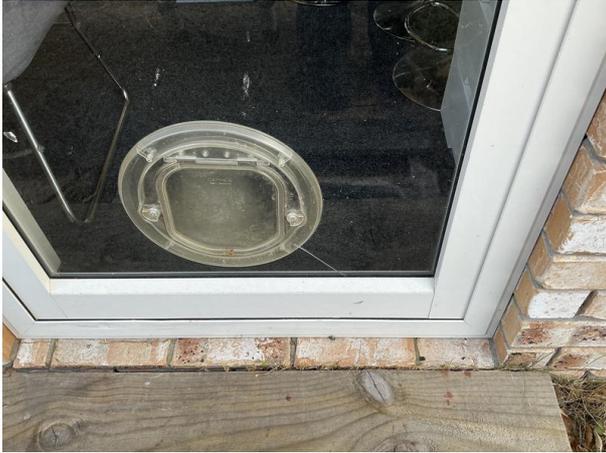
Photo 52
East side crack to garage door glass.

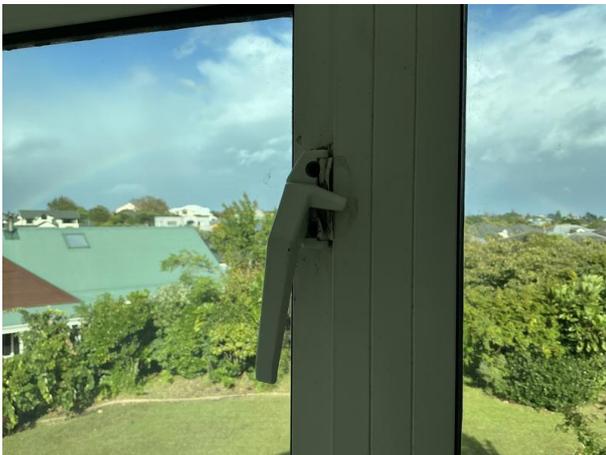
Photo 53
Broken plastic tab, this will make the window drafty. This repeats in numerous locations around the house.

This type of window hardware has a small plastic tag that closes the window tightly, these commonly break off through normal use, repairing or replacing the damaged hardware will assist with preventing minor draughts.

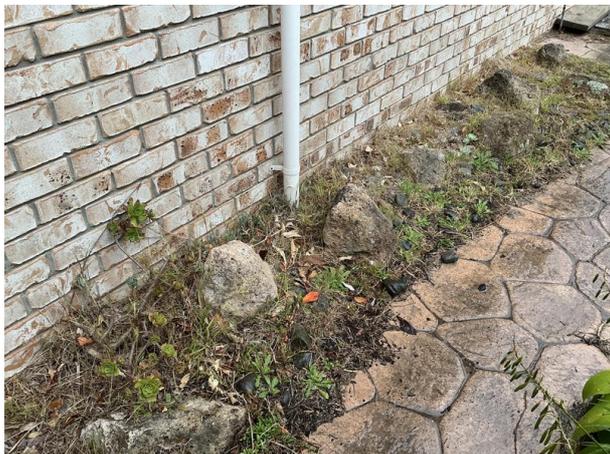
Photo 54
East side garden bed is in contact with the cladding.

It is recommended to keep garden vegetation clear of the exterior cladding. Adequate clearance is essential for the cladding system to function properly and to prevent moisture intrusion through capillary action. Maintaining this separation helps protect the cladding's integrity and reduces the risk of water damage.

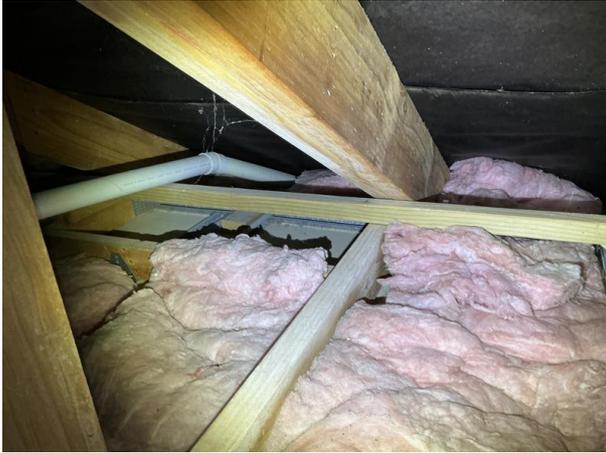
Photo 56
Upper level has missing insulation.

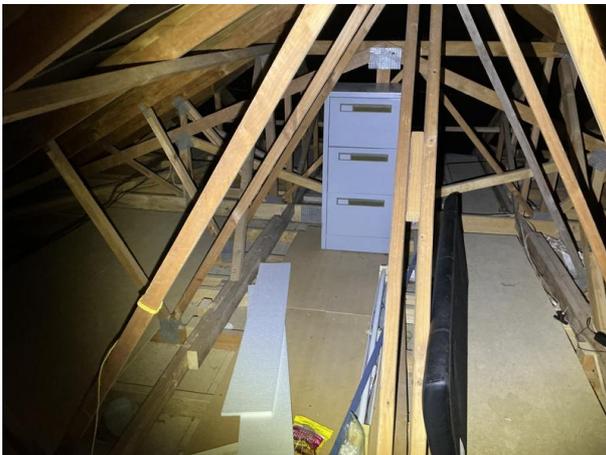
Photo 57
No insulation over the garage. Stored property visible.

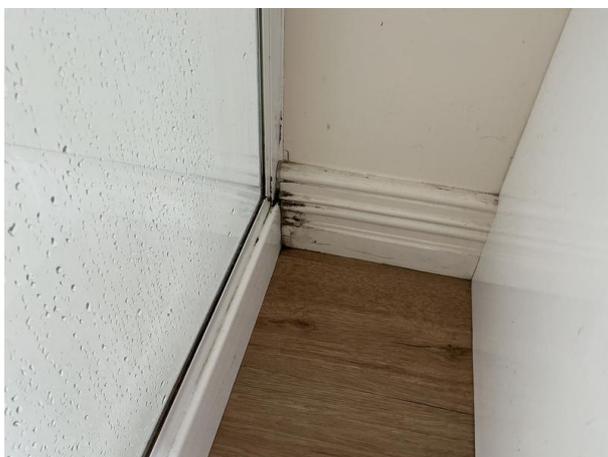
Photo 72
Moisture damage and leaking to the corner of the shower.

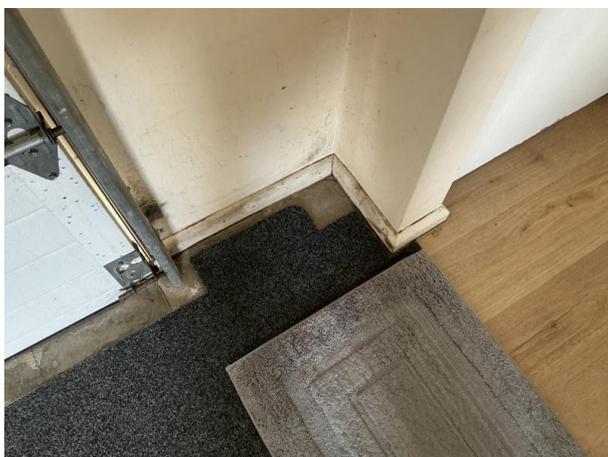
Photo 78
Moisture damaged skirting, moisture tested no indication of moisture.

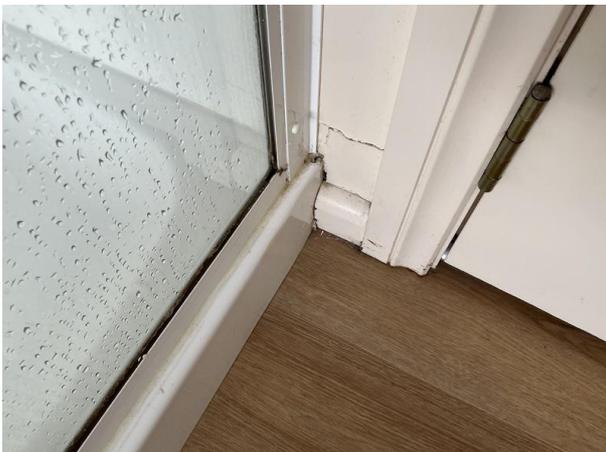
Photo 84
Damage to corner of the shower.

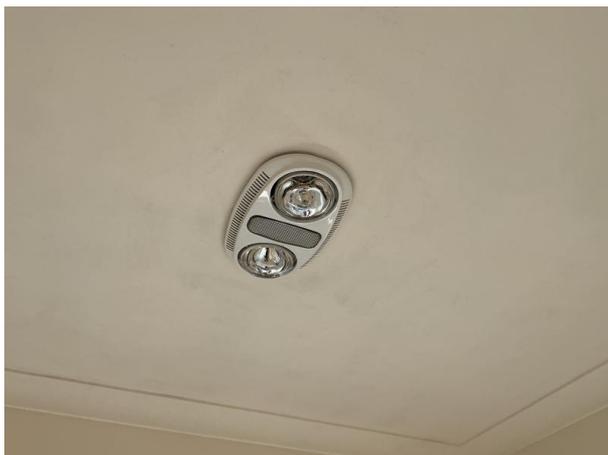
Photo 85
Extract fan is very noisy.

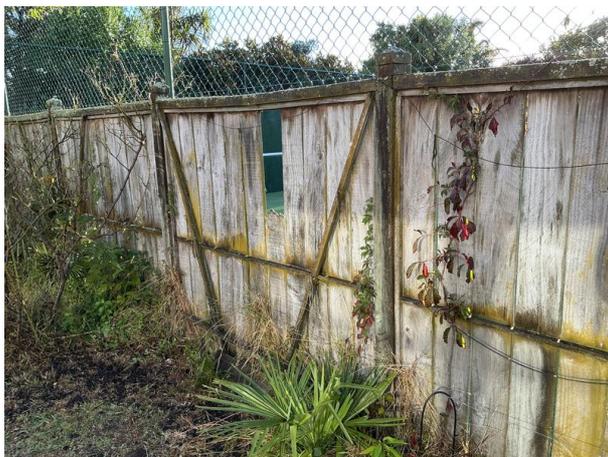
Photo 99

East side has a broken paling.

General upkeep and maintenance, keep vegetation and soils clear of timbers as these timbers are only exterior treated and will rot if vegetation or soils are up against them.

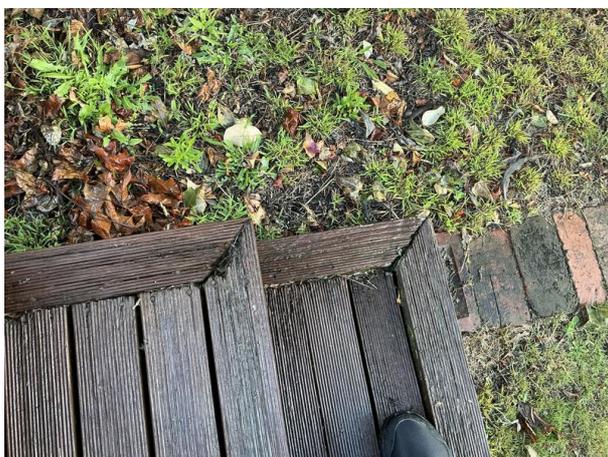
Photo 105
Rot to steps, one board is not supported.

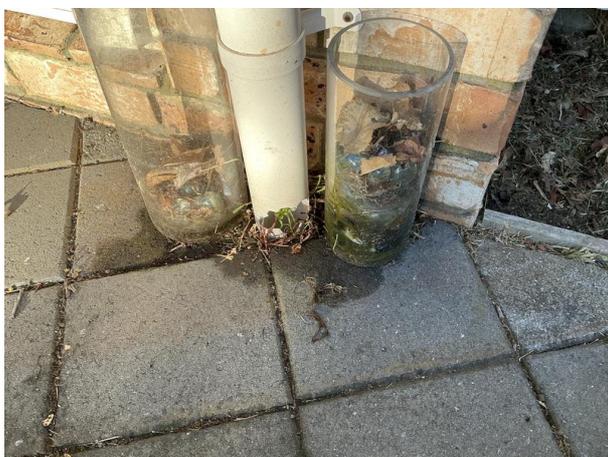
Photo 108

Downpipe located on the east side
connection not visible hole in downpipe.
