## Brian Marsh Property Inspection

17 c Epiha Street  
Paraparaumu  
Kapiti

## Inspection Overview

**Date of Inspection** 31 July 2026

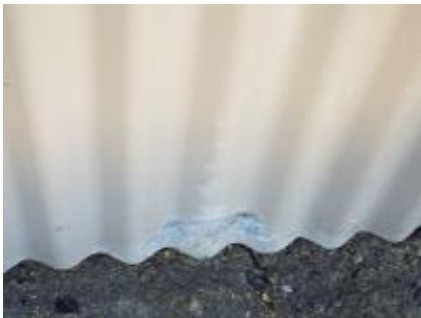
small area of surface rust needs treating at  
the front of the house

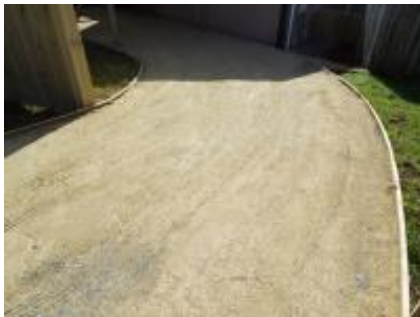
drive in good order

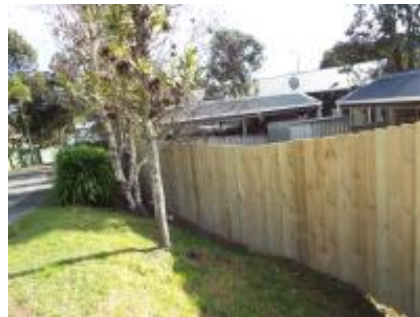
new fence noted

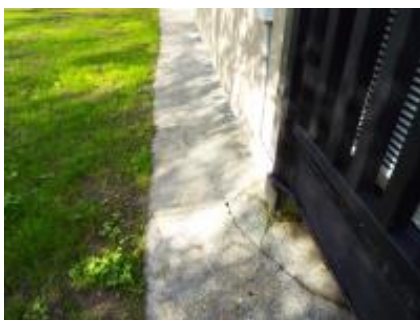
paths fine

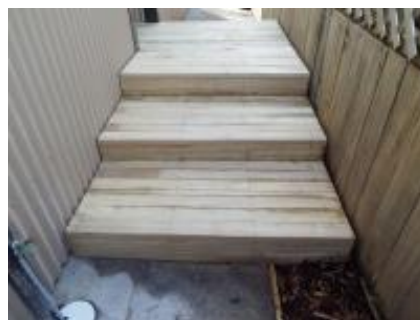
good order

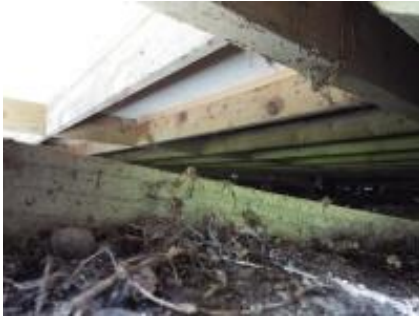
all dry at the time of inspection

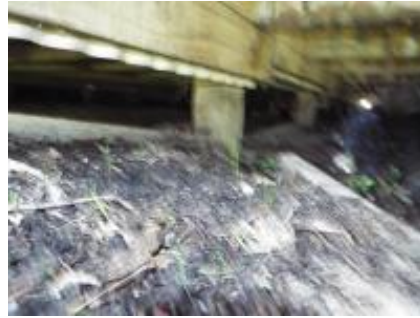
piles appear in good order

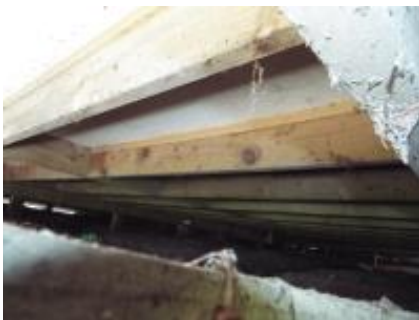
appears well insulated

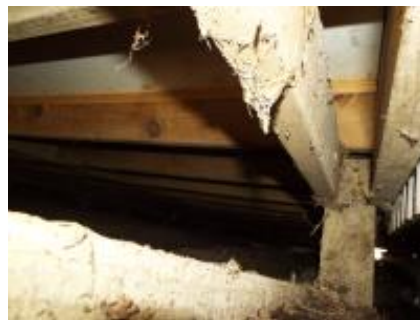
no issues

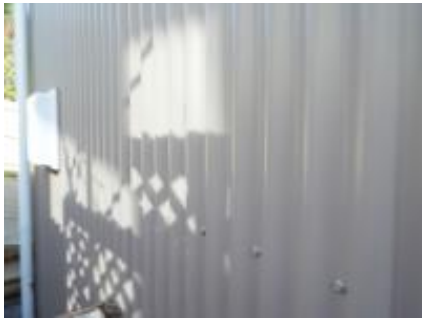
exterior appears well painted

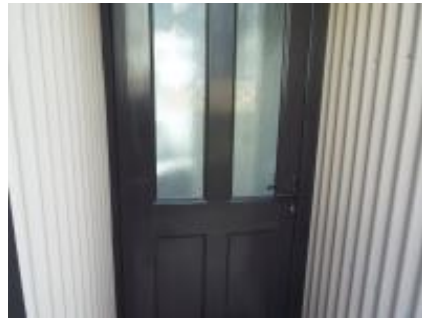
joinery in good working order

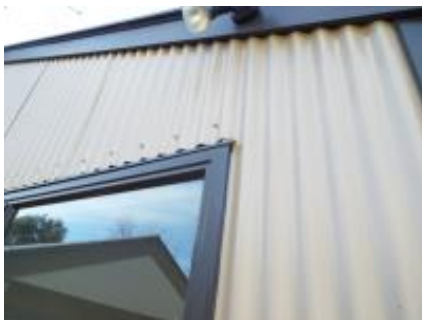
good flashing detail

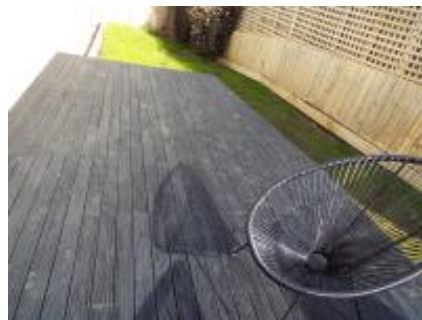
deck appears fine

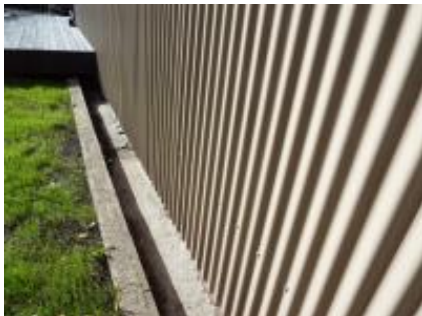
no issues

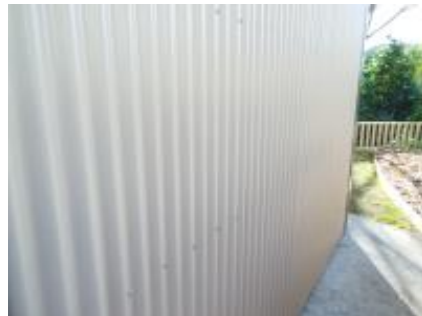
all fine at the time of inspection

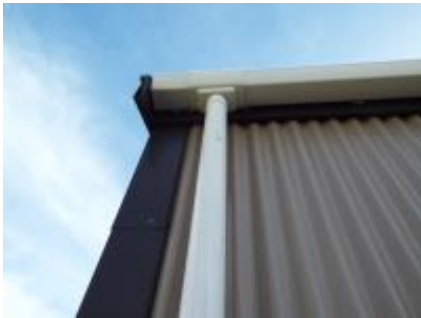
no issues

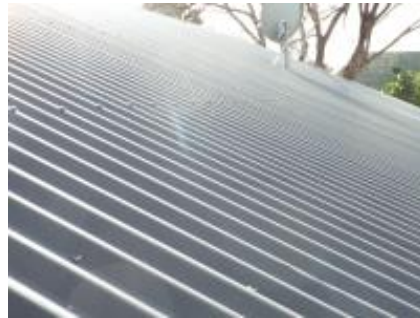
roof appears in good order

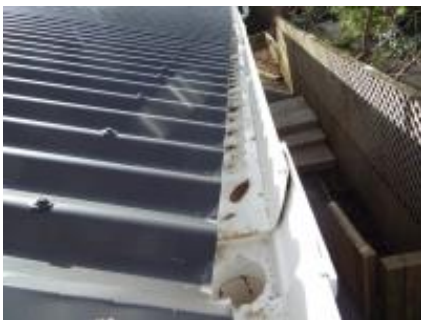
keep gutters clean

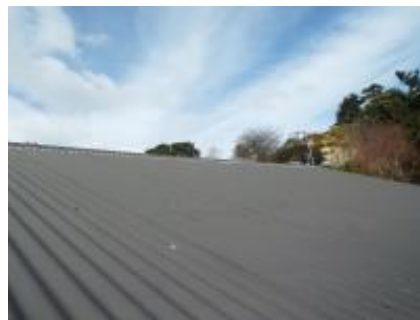
no issues

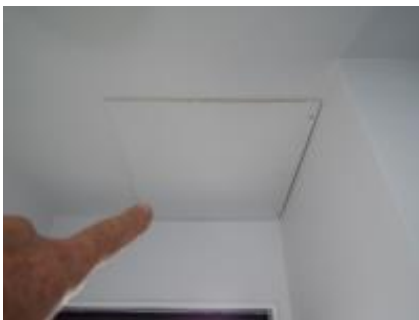
access panel screwed shut

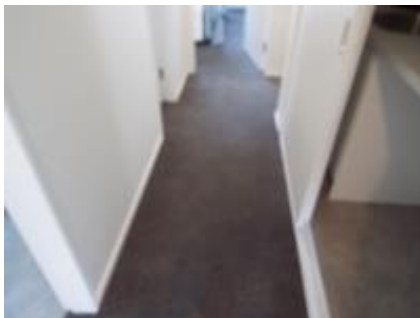
floor coverings in good order

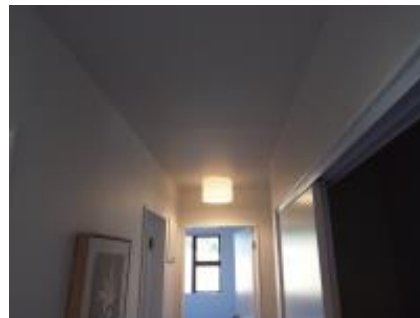
interior well painted

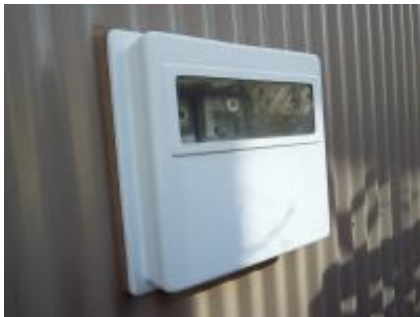
good order

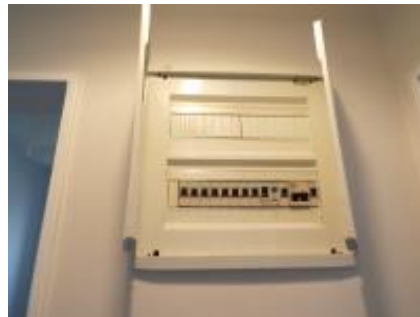
good order

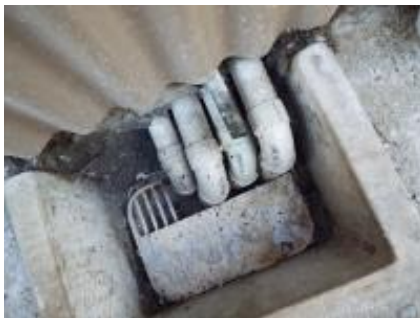
drain clean at the time of inspection

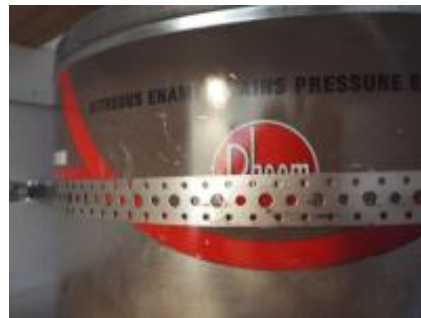
good order

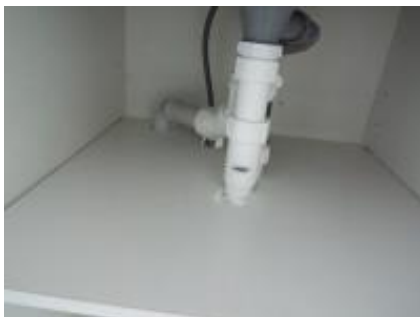
plumbing fine at the time of inspection

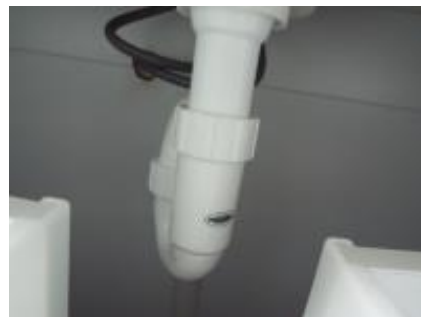
no issues
