**Client name: John Inglis
EQC review & Floor Level survey**

Address: 28 Laing Cres, Heathcote, Christchurch

Description of dwelling

1980's era Type B2 foundation (Timber floor on concrete perimeter foundation supported by piles) with Brick Veneer Cladding, Concrete Tile roof, set on a flat section.

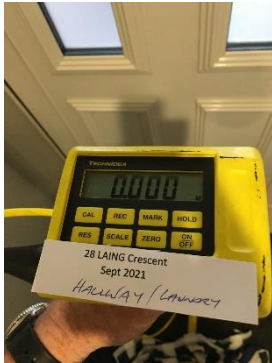
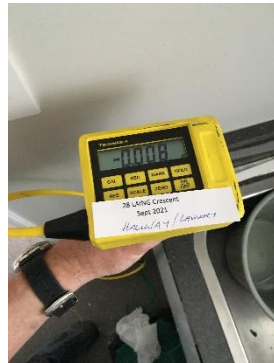
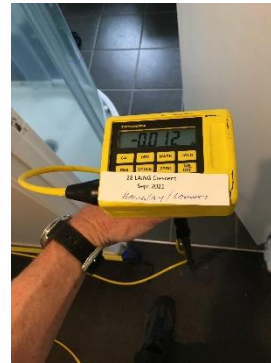
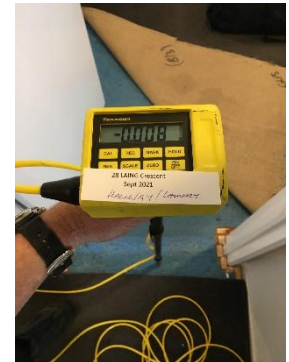
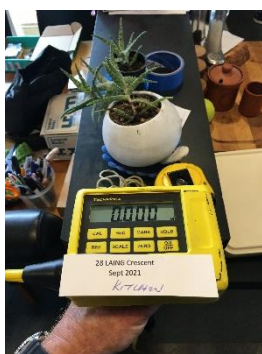
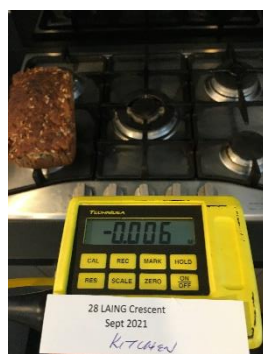
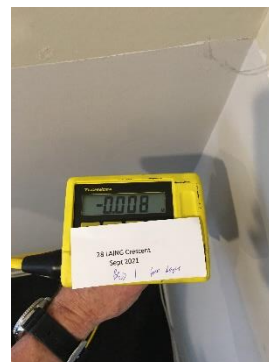
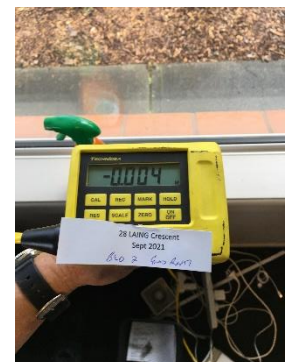
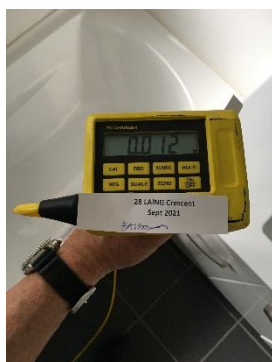
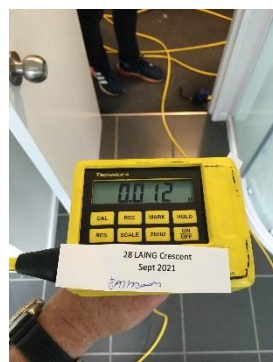
Floor levels Images taken on site (In-situ, not adjusted for hard floor coverings)

From visual observations on site, comparing with the EQC information supplied CLM/2011/172520 (10/10/2011), the property presents well. The floor levels as recorded are 24mm (+/3mm). Refer to Plan.

Levels were recorded using a Zip Level Pro, to New Zealand Institute of Surveyors (NZIS) recommended methodologies.

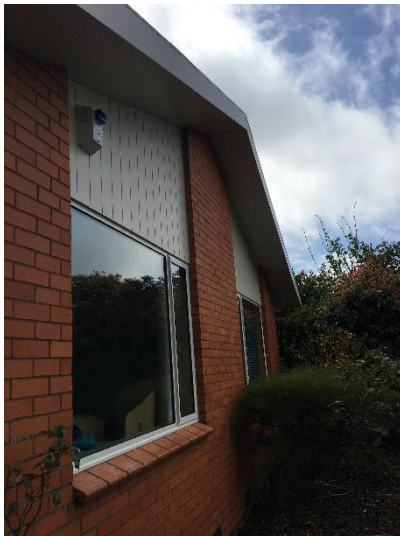
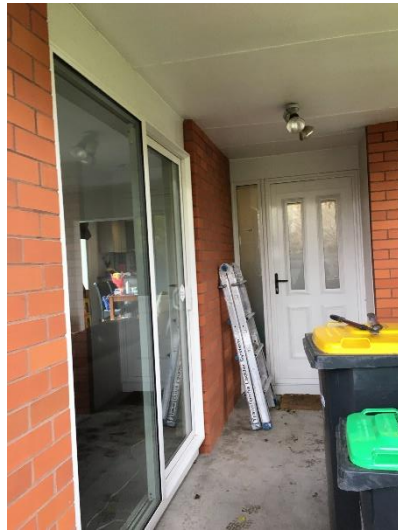
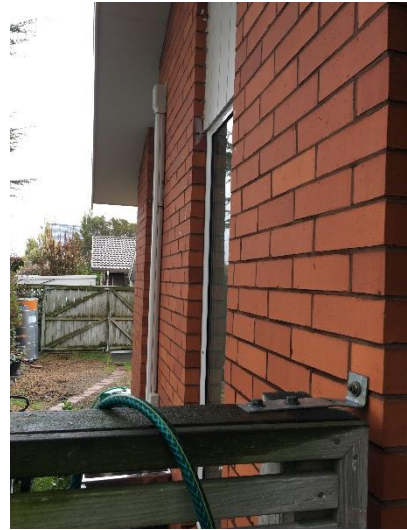
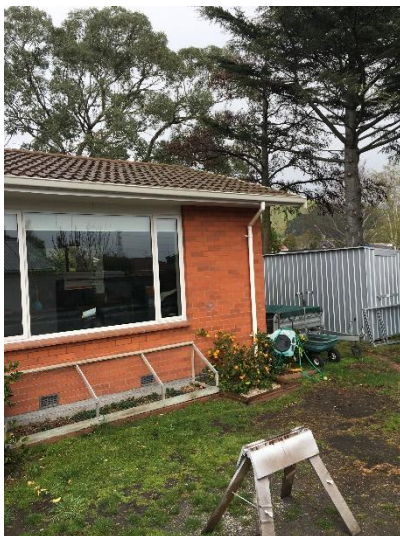
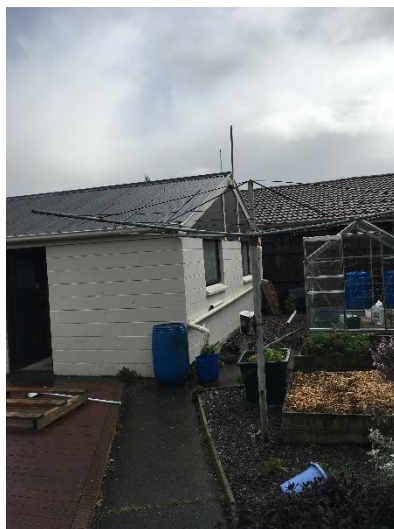
Images Building Elements
