## RED LBP PRE-PURCHASE REPORT

# PRE-PURCHASE BUILDING REPORT

<b>Property Address</b>	36 Burn Street, Levin 5510
<b>Client</b>	Iraia Peni
<b>Date of Inspection</b>	12th December 2025
<b>Time</b>	1:00 pm
<b>Inspector</b>	Tom Kimberley National Certificate in Carpentry, Licensed Building Practitioner.
<b>LBP Number</b>	131336
<b>People Present</b>	Inspector
<b>House Occupied</b>	No

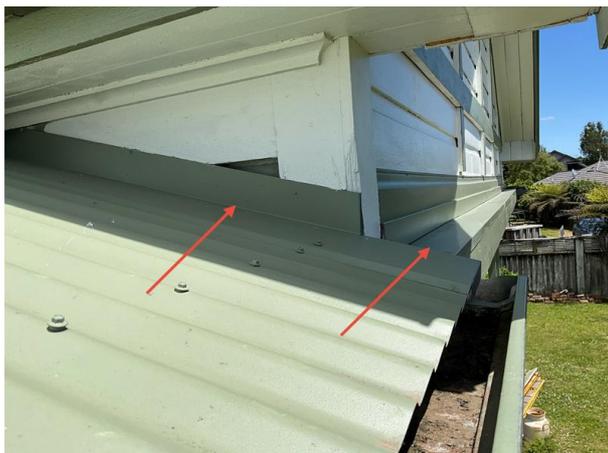
**Photo 5**

Western elevation. Profiled metal apron and cap flashing with a factory paint finish, viewed on the western side of the roof. The apron flashing is not located behind the timber weatherboard cladding

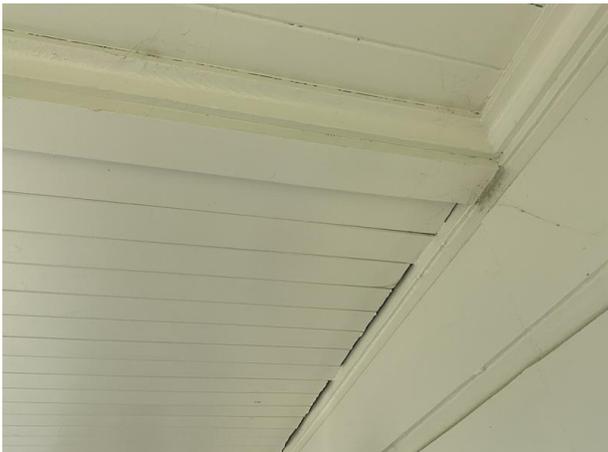
**Photo 8**  
Area of soffit to cladding junction is not covered. Located on the northern side of the house.

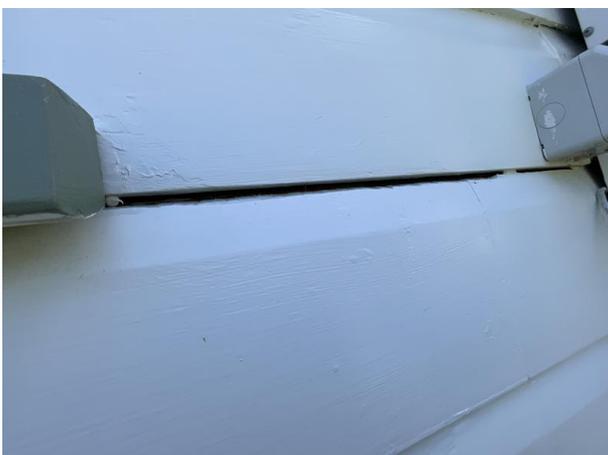
**Photo 13**  
There is a visible gap between the shiplap weatherboard cladding located on the southern side beside the gas infinity.

It is recommended to inspect the exterior cladding and repair or replace any sections that are rotten or damaged. Deteriorated cladding can compromise the building's weathertightness, leading to moisture ingress, structural weakening, and potential mold growth. Ensuring that all damaged cladding is properly replaced or repaired will help maintain the integrity and durability of the building while preventing further deterioration.

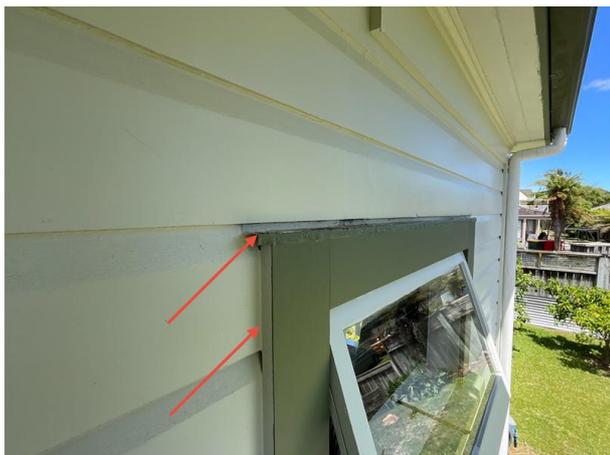
**Photo 17**  
Window head flashing and cladding to  
timber joinery junction detail.

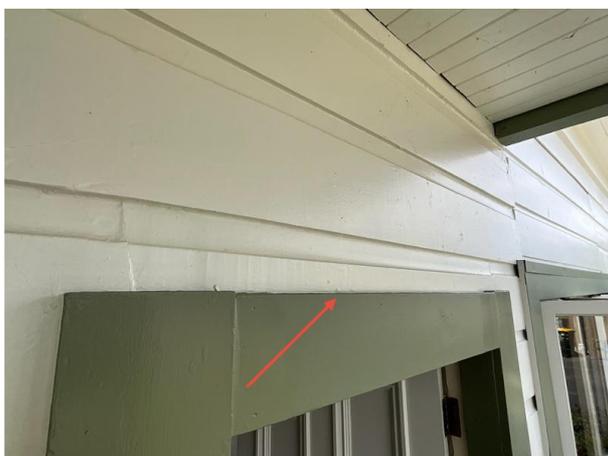
**Photo 22**  
No head flashing located above the external kitchen door.

Head flashings are absent to sections of the exterior joinery, increasing the risk of moisture ingress at the junction between the joinery and cladding. It is recommended that suitable head flashings be installed by a suitably qualified contractor or Licensed Building Practitioner (LBP) to direct water away from the joinery and improve the weathertightness of the exterior envelope.

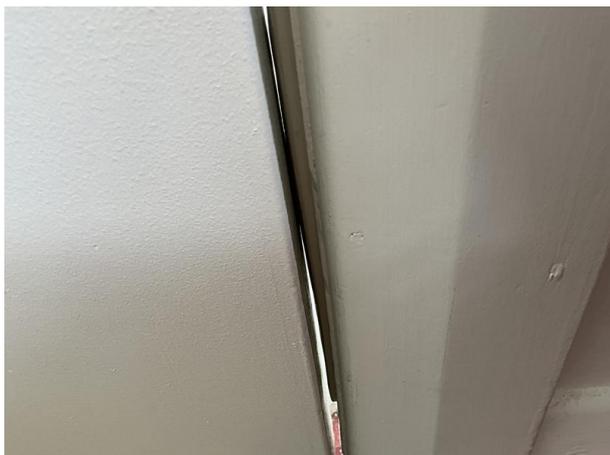
**Photo 23**  
The laundry door is binding on the bottom edge.

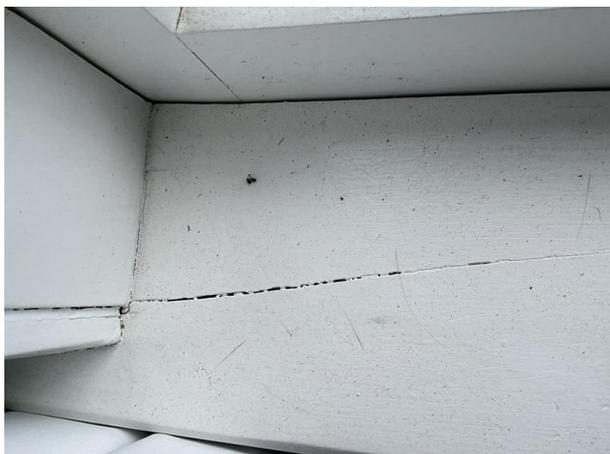
**Photo 25**  
Splitting to the painted timber window reveal of the bedroom three window on the southern side.

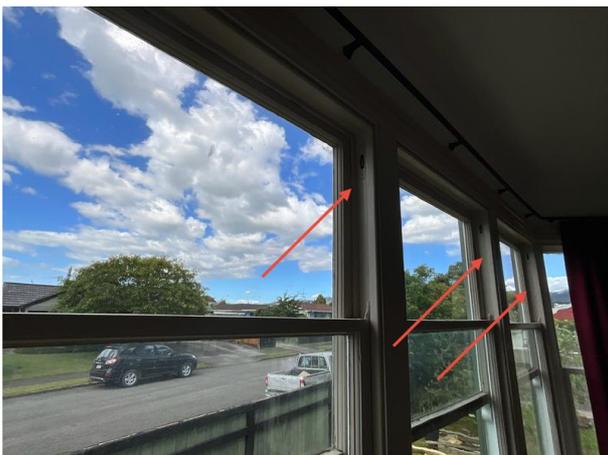
**Photo 29**  
The lounge windows have no counterweight ropes. Unable to test function.

Some repairs required to the opening sashes of the windows in order to restore functionality and to reduce draughts.

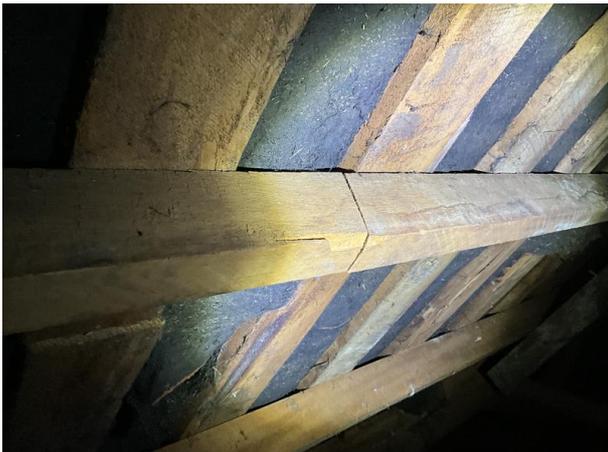
**Photo 43**  
Cut timber rafter located directly above  
the manhole.

It is recommended that any cut timbers are repaired by a suitably qualified tradesman person.

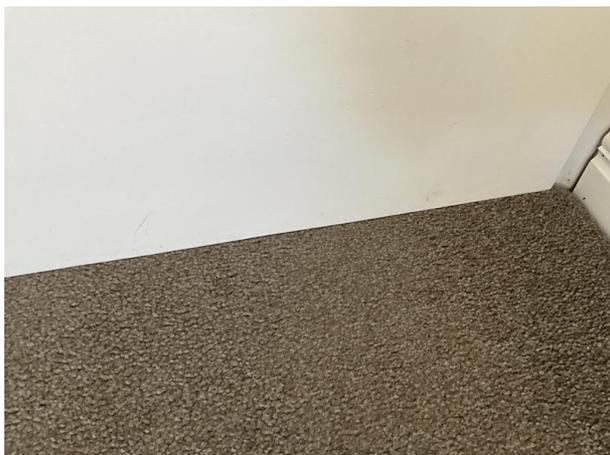
**Photo 54**  
Bedroom 2 door is rubbing on the carpet.

The interior door is binding/rubbing, this can be adjusted or planned to free its operation.

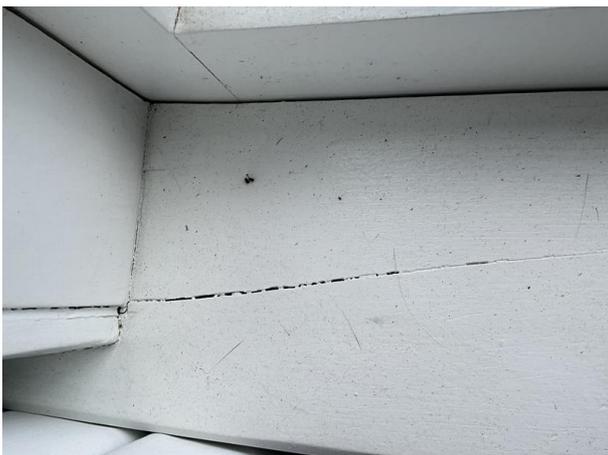
**Photo 56**

Defects - Splitting to the painted timber window reveal. Refer to photo.

Splitting to the painted timber window reveal on the right hand side of the southern window.

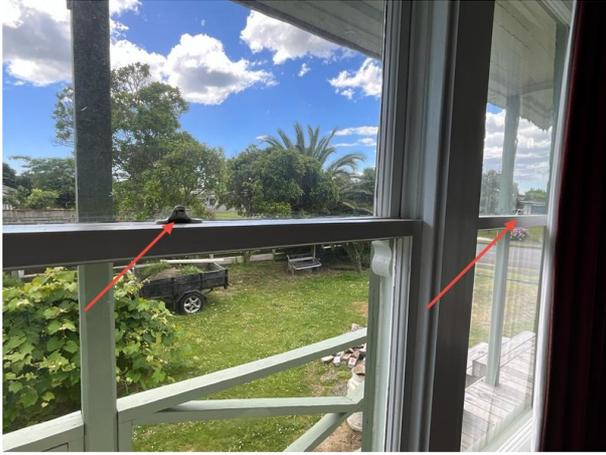
**Photo 57**

Living room.

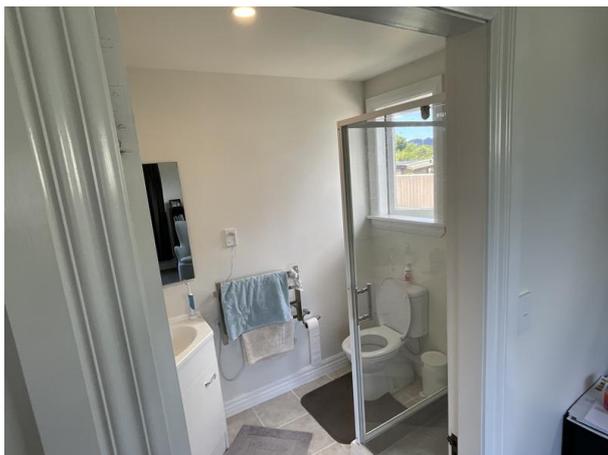
**Photo 59**  
Ensuite.

There is no externally vented mechanical ventilation system installed in the ensuite. It is recommended to install a suitable system for the room's requirements.

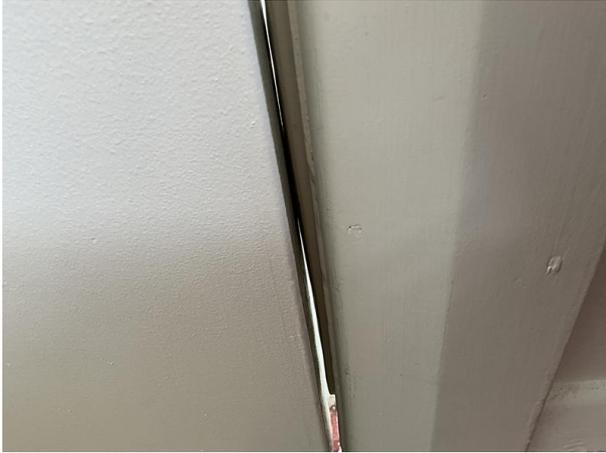
**Photo 68**

Defects - The external laundry door is binding on the bottom edge. Refer to photo.

Laundry door is binding on the bottom edge.

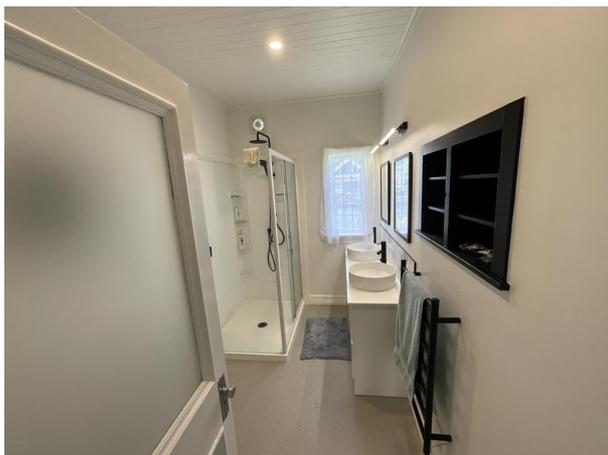
Defects - Missing wall linings and ceiling linings. Refer to photos.

**Photo 69**  
Bathroom.

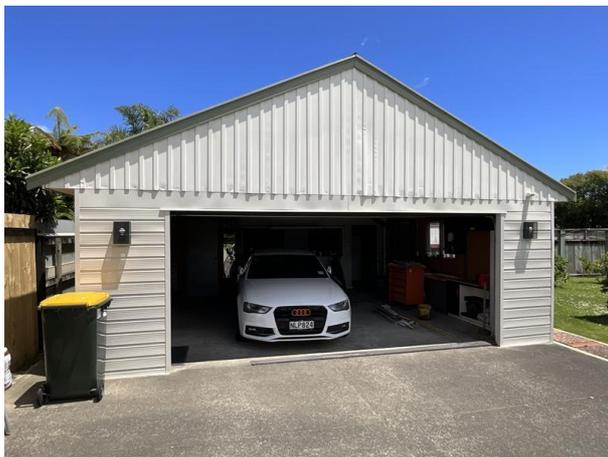
**Photo 72**

Garage. Profiled metal cladding with a factory paint finish.

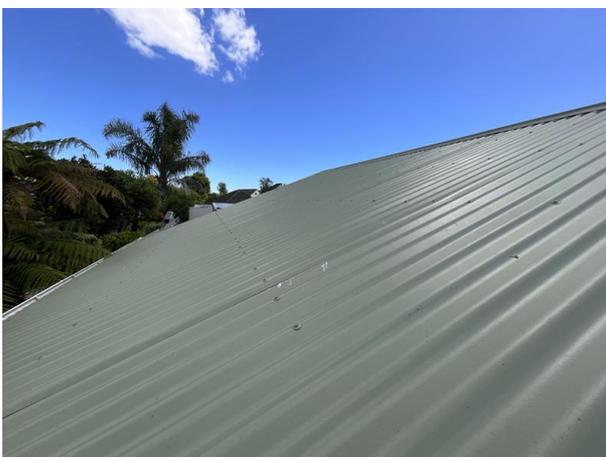
**Photo 78**  
Garage roof. Profile-long run metal sheeting with nail fixings.

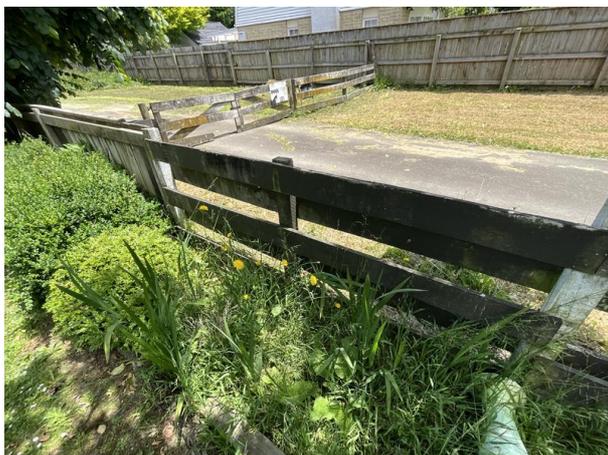
**Photo 81**

Western boundary fence. Painted timber palings and rails with timber posts.

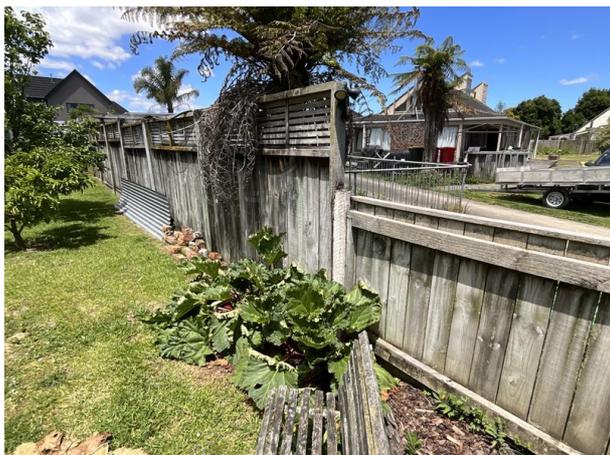
**Photo 82**  
Southern boundary fence. Unpainted timber palings with timber rails and posts.

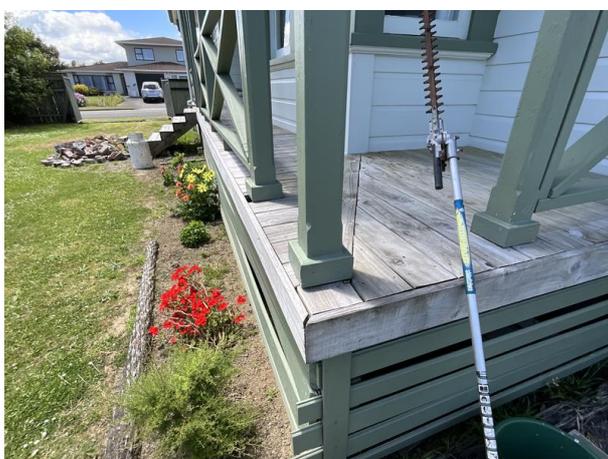
**Photo 87**

Timber deck located on the western side of the house.

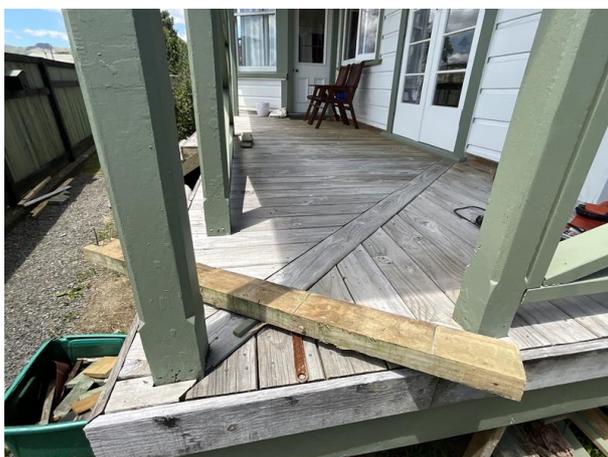
**Photo 88**

Timber deck located on the northern side of the house.

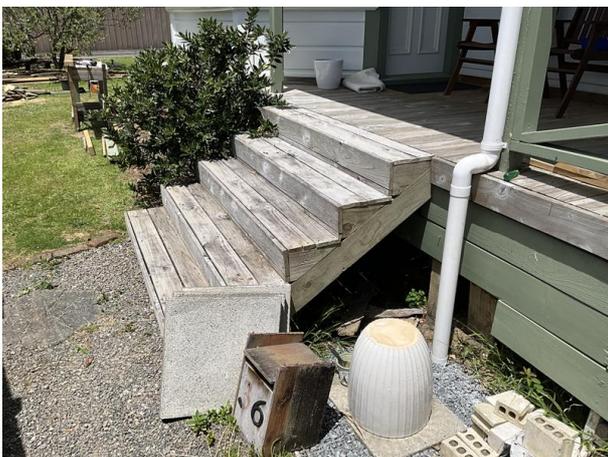
**Photo 91**  
Northern deck stairs. No handrail has been installed.

It is recommended to install a compliant handrail for any access steps with 3 or more risers/tread/steps.

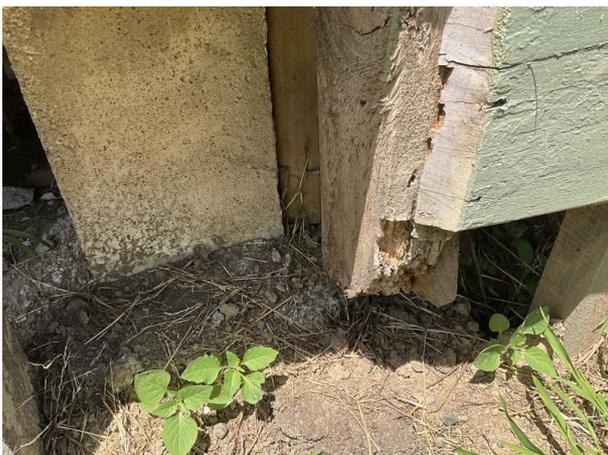
**Photo 92**  
Rotted timber on the western side of the deck.

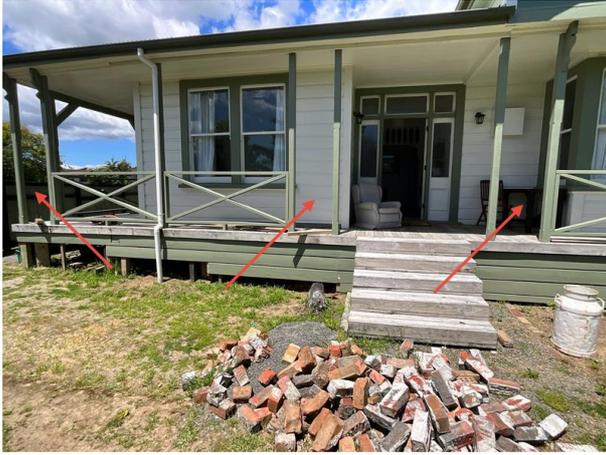
**Photo 95**

Area of missing balustrade straight to the deck on the western side of the house.

It is recommended that the missing areas of balustrade are reinstated.

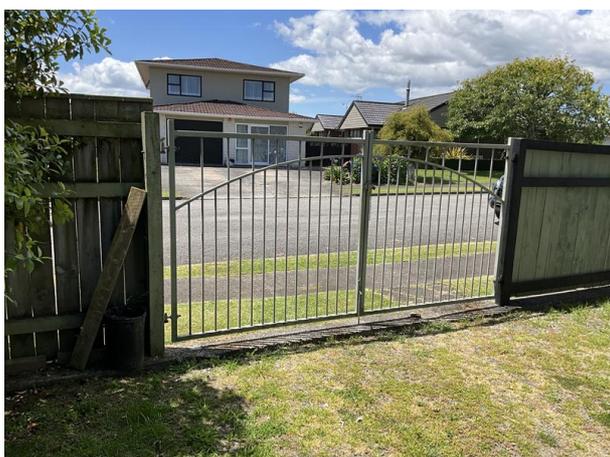
**Photo 97**  
Driveway gate located on the western side of the house. Tested functional.

It is recommended to apply regular lubrication to the hinges and latch to maintain full function.

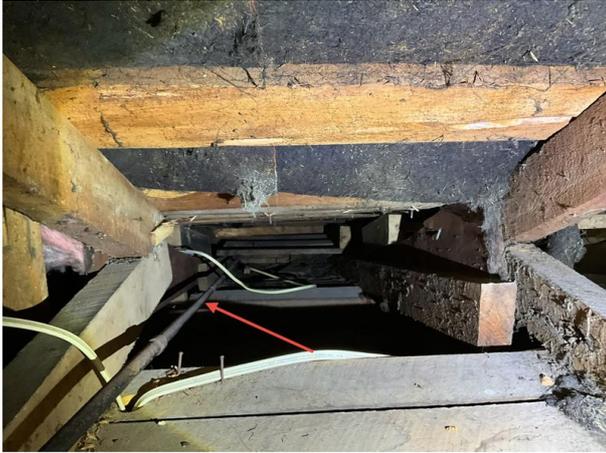
**Photo 100**  
Steel conduit wiring.

Have an electrician remove any redundant wiring and check that none of the conduit is carrying any live wiring.

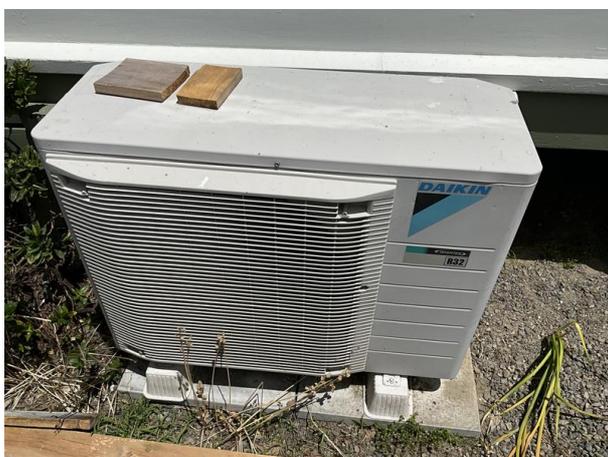
**Photo 103**  
External heat pump unit is located on the northern side of the house.

Follow the manufacturer's recommended servicing schedule to ensure the equipment operates efficiently and maintains optimal performance. Adhering to these guidelines helps identify and address potential issues early, reducing the risk of costly repairs and ensuring compliance with warranty requirements.
