Independent Builders Report

Total Home Inspection Services Porirua City Ltd

Thu 26 Feb 2026

64 Airlie Rd, Plimmerton, Porirua, 5026, New Zealand

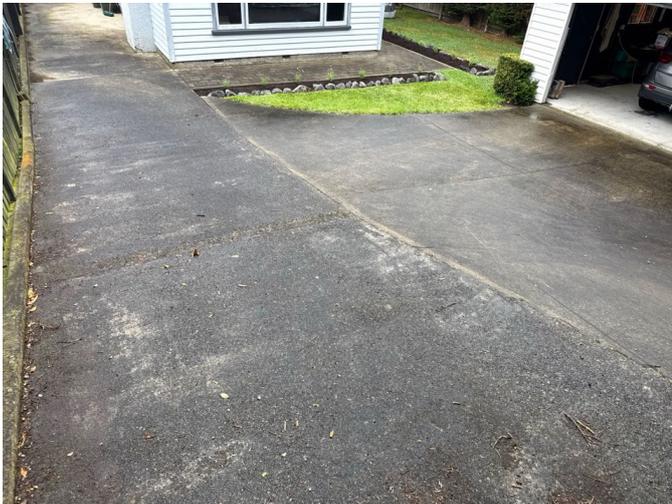
The driveway slopes down from the street and slightly to the north. The surface condition is generally good.

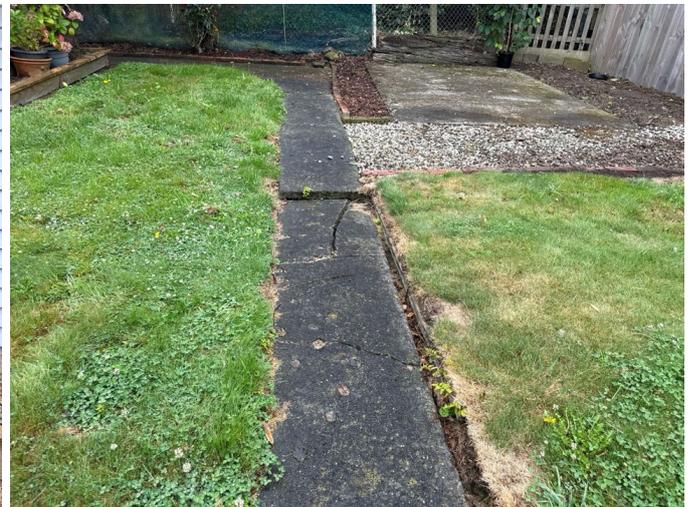
Settlement cracking to the east path. Consider improvements where trip hazards are present.

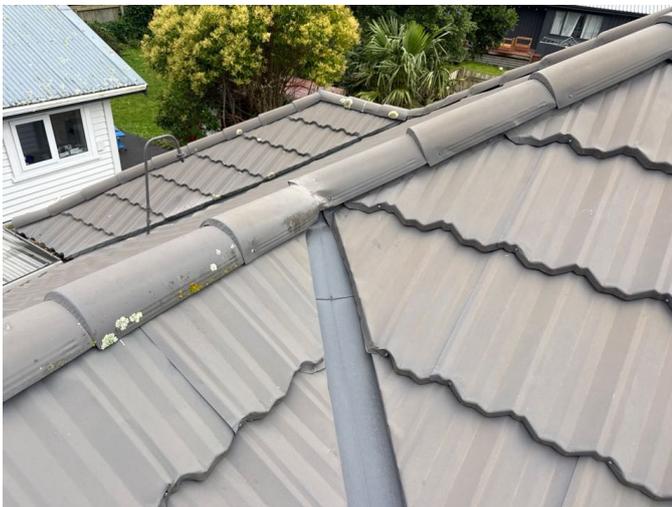
The roof flashings appear to be secure, intact and are effective. No sign of failure could be found beneath where accessible to view.

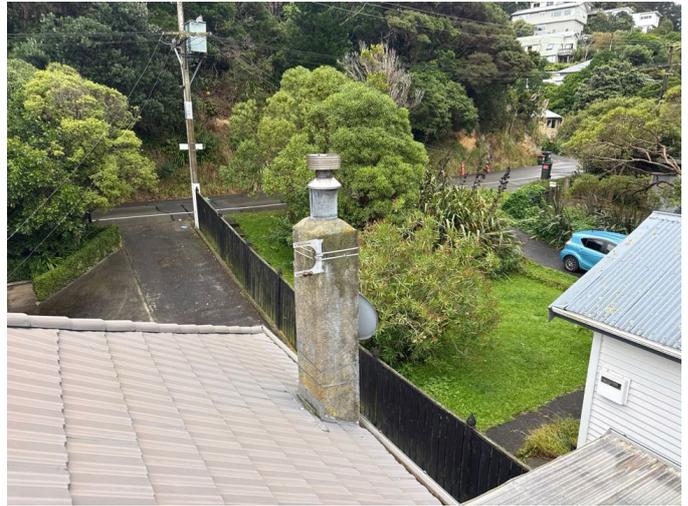
The concrete chimney is intact and solid at the time of inspection. There was no evidence of cracking or structural concerns. The condition of the chimney should be checked after earthquakes.

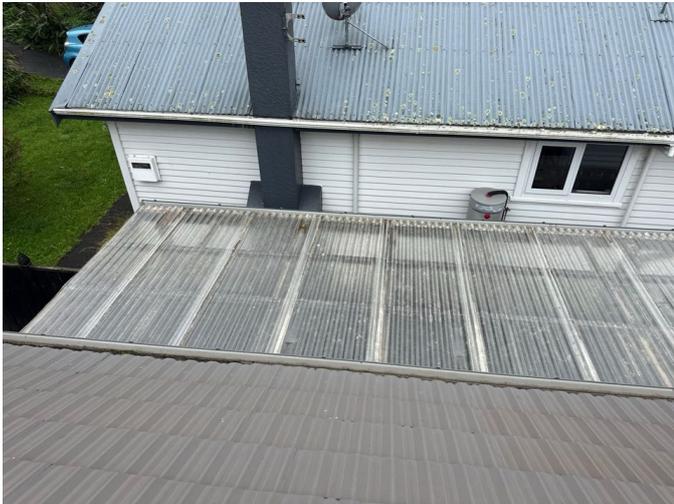
The plastic carport roof is intact and secure

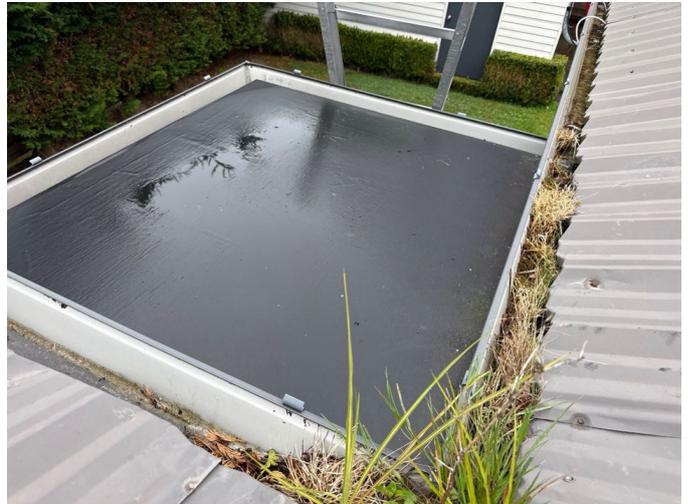
The small Butynol section above the entrance is intact and is effectively glued.

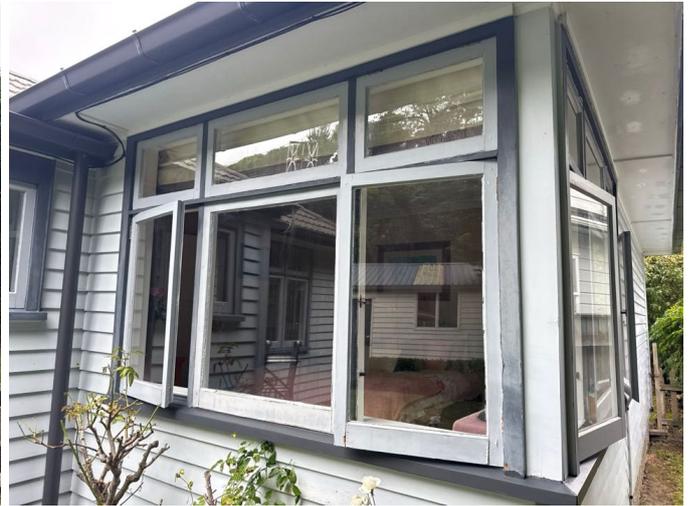
The typical single glazed timber window detail is positioned high up to the soffit with facings, scribes and sill detail. No head flashings but well protected under the soffits.

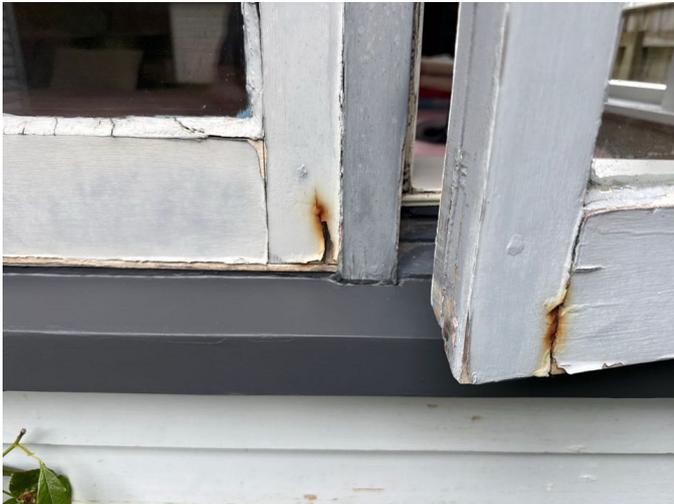
Paint deterioration to the timber windows. During the next upgrade process, every window will need to be assessed and remediated on a case by case basis. The extent of wear is not often realised until the paint upgrade process.

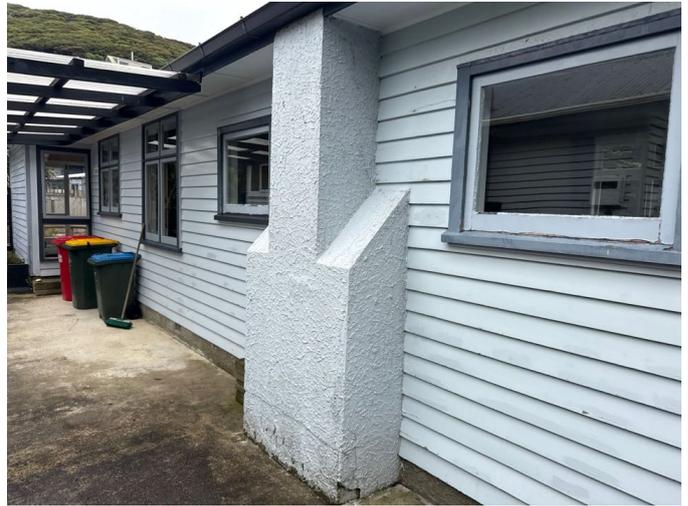
The concrete chimney is showing no evidence of structural deterioration and is effectively sealed at the cladding junctions.

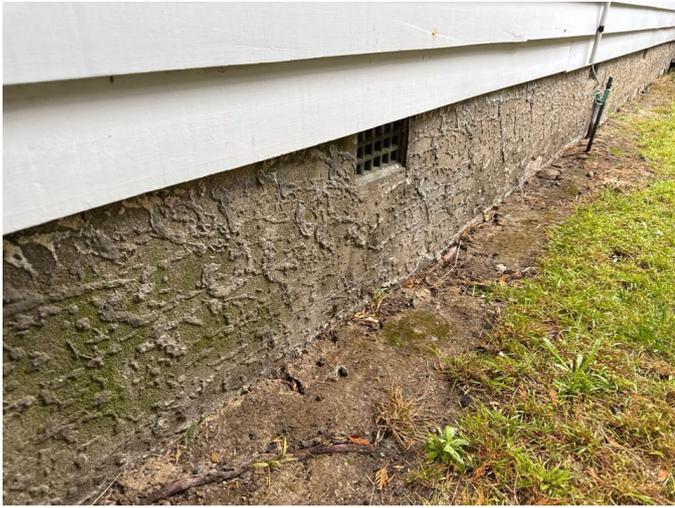
Good ground clearance around the perimeter. The current building code requires a 150mm clearance between the internal floor height and the sealed ground and 225mm to unsealed ground.

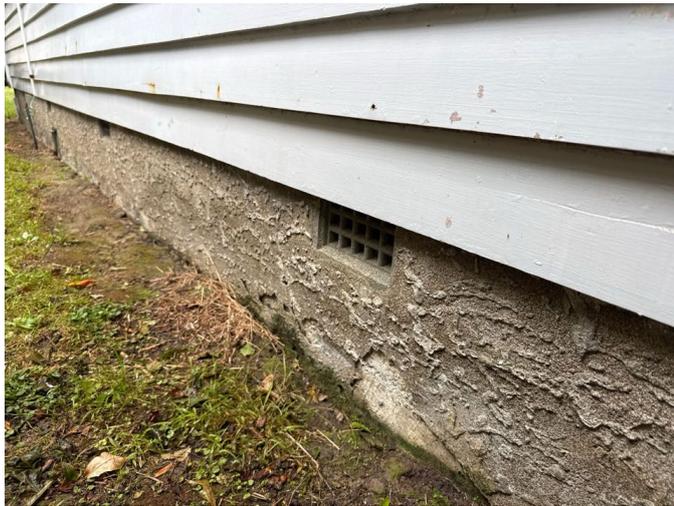
The concrete ring foundation is in a typical condition for the age. No sign of cracking or significant stress.

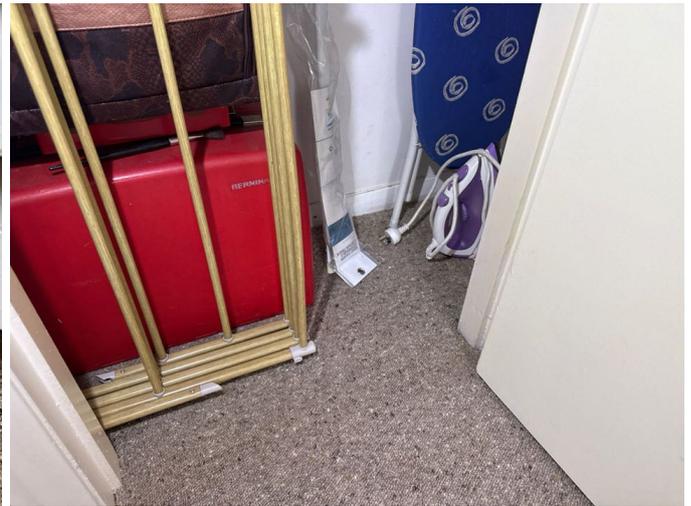
The owner disclosed that a plumber accessed the sub floor through the bedroom 3 wardrobe floor during historic improvements to the bathroom. Carpet has since been installed over the area. It is not known if there is a removable hatch beneath.

Type	Condition
The pile type could not be determined	<p>There is no access currently to the sub floor as the access point has been carpeted over in the bedroom 3 wardrobe.</p> <p>Access should be created and further investigation undertaken to rule out or confirm the presence of the following potential risks. The risks include but are not limited to:</p> <ul style="list-style-type: none"> - Deterioration to the framing and piles - Pile/bearer connections - if present, condition and if upgrade is required - Undesirable plumbing types (Dux Qest), leaks and water runoff issues - Determine if insulation can be installed - Borer activity/damage - Mould/fungal growth - Ventilation quality - Subsidence. <p>NOTE: Due to the low height of the floor, there may not be enough room to physically access all areas of the sub floor.</p>

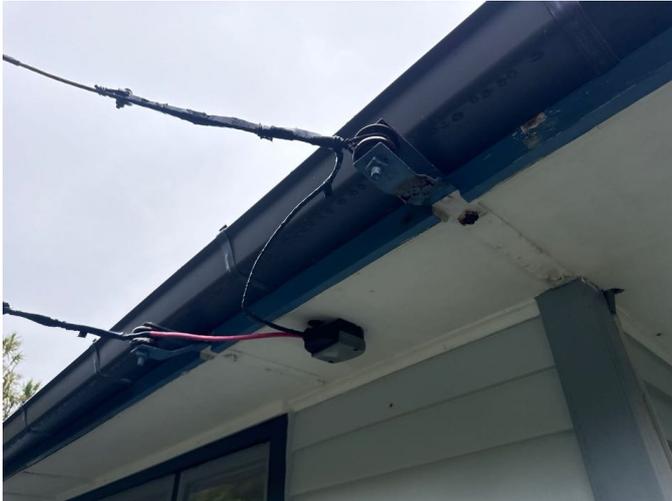
The rusting main connection bracket will need to be monitored closely. Secure at the time of the inspection. If any structural weakening is noticed a registered electrician or Linesman should be engaged to replace the bracket.

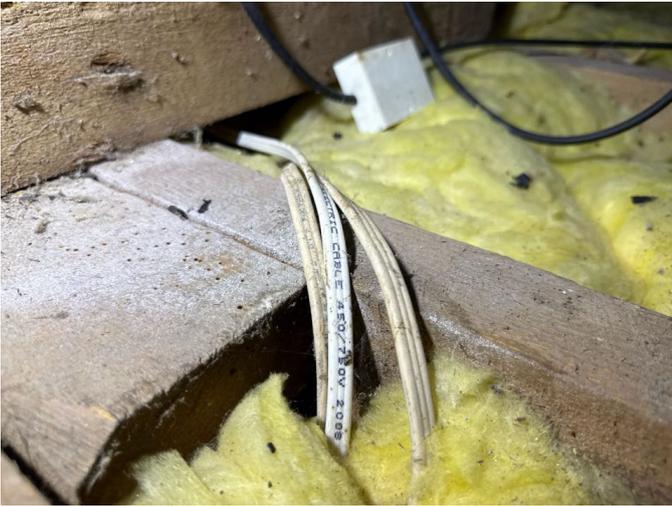
Only modern TPS wiring sighted during the inspection.

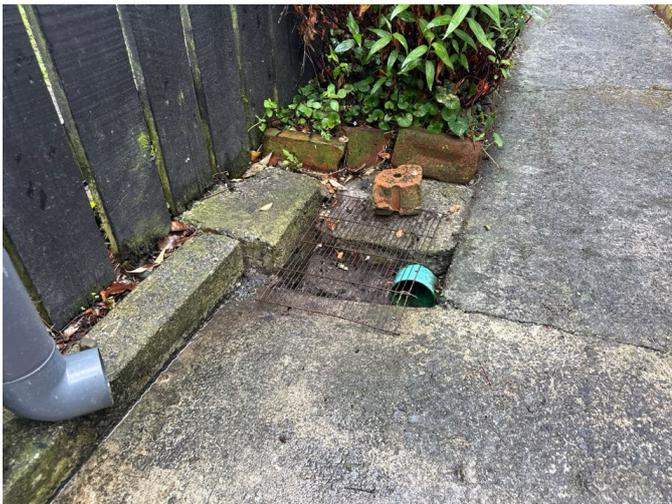
Drain to the side of the driveway. There was no sign of current blockages or recent overflows. The effectiveness of the drains (in general) will need to be monitored over time.

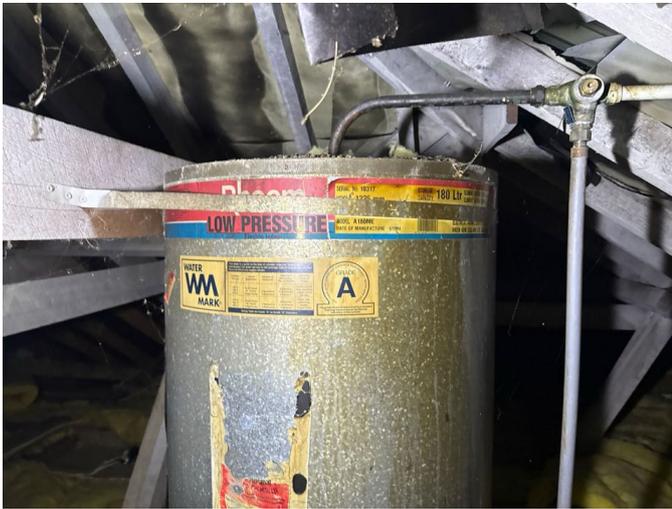
Ceiling cavity.
Rheem 180L Low Pressure Electric Hot Water Cylinder. Seismic restraint installed.

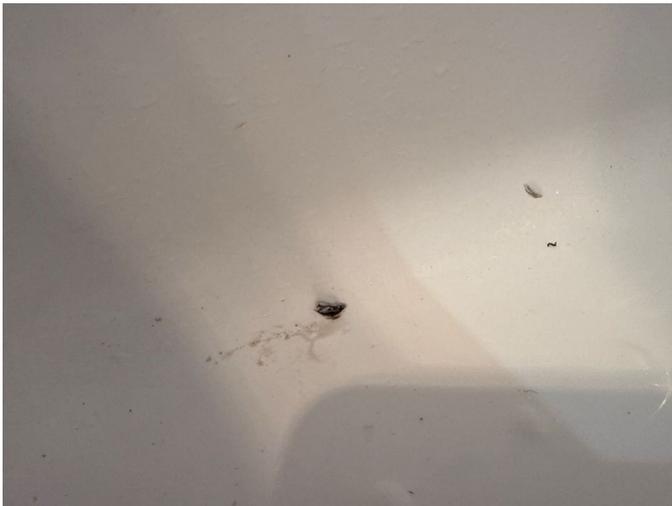
The dent in the base of the bath does not appear to have gone right through. The dent should be filled to prevent the risk of water escaping.

The bathroom is generally tidy and functional. The small dent in the base of the bath should be sealed to prevent the risk of water eventually escaping.

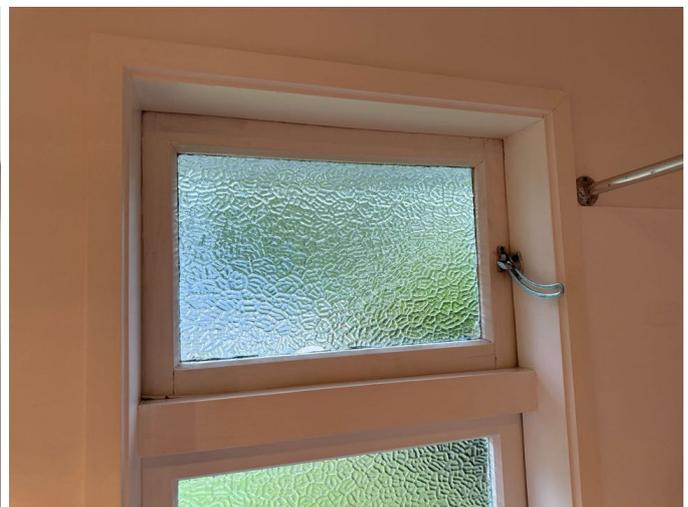
The owner disclosed that the top window is to have a hinge replaced.

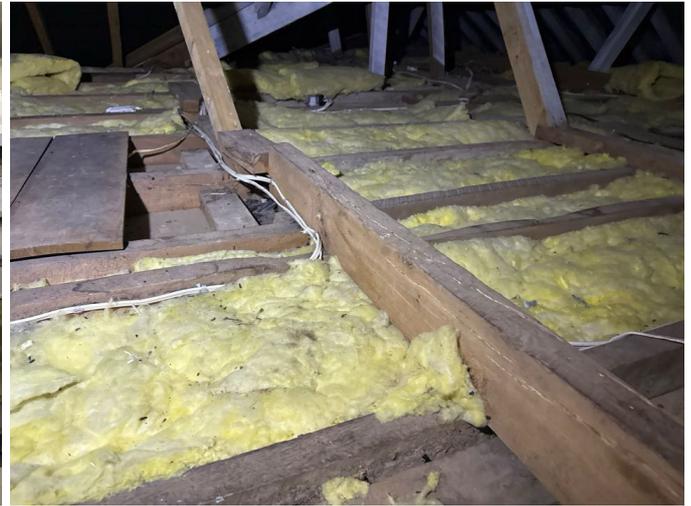
Average level of insulation installed. There was no labelling present to indicate the R-Value of the material. The thermal resistance rating or R-Value is the measure used most commonly in the building and construction industry to determine a material's ability to resist the transfer of heat. The higher the R-Value the better thermal resistance the product will provide.

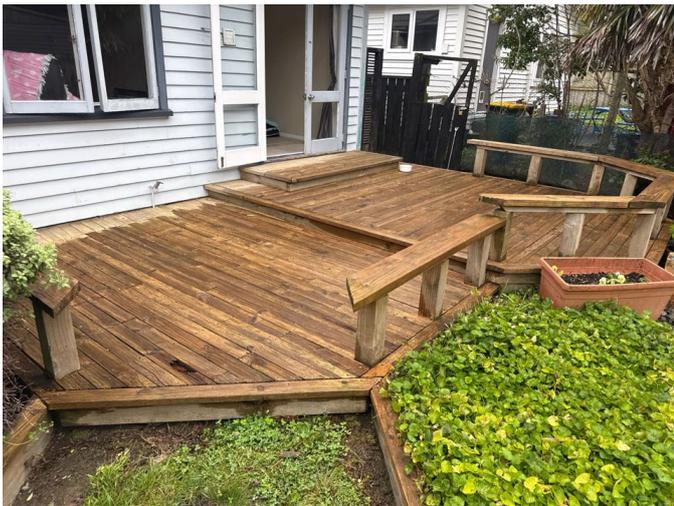
The main structure could not be inspected as the edge is closed off

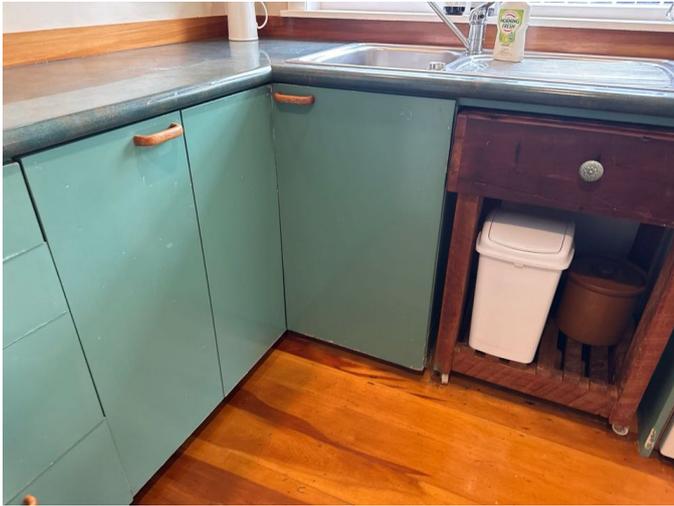
Age related wear to the cabinetry in areas but still in a functioning condition. Cosmetic defects only.

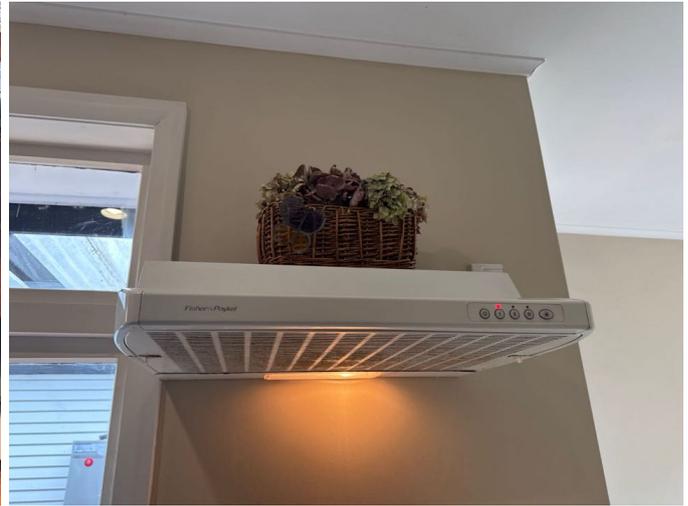
The range hood extraction unit is functioning

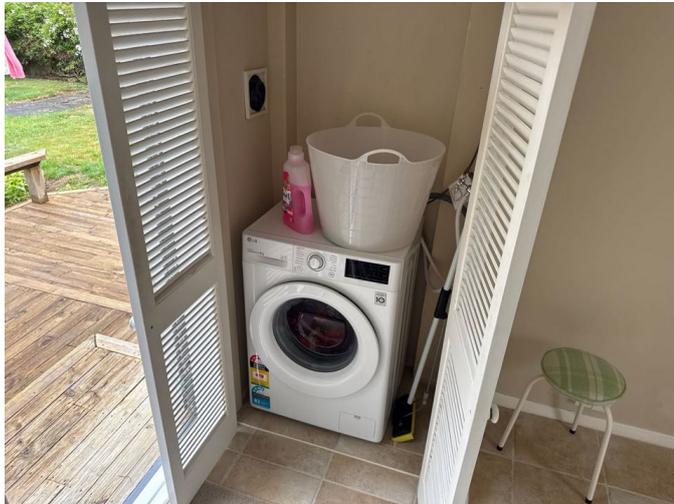
Compact laundry space noted

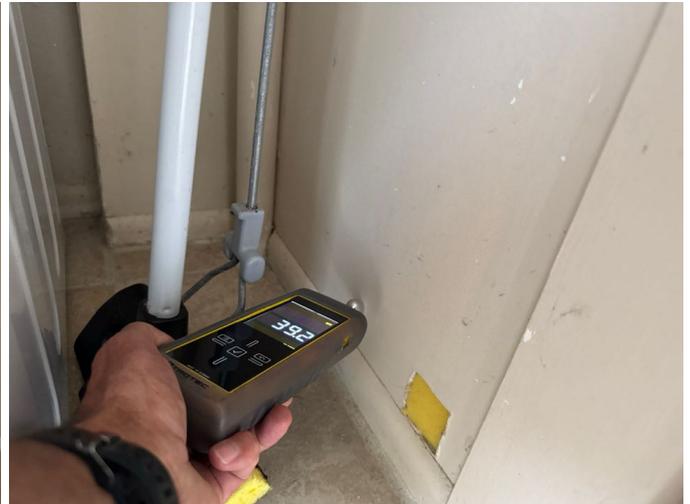
Moisture levels in the laundry were within the normal range at the time of inspection.

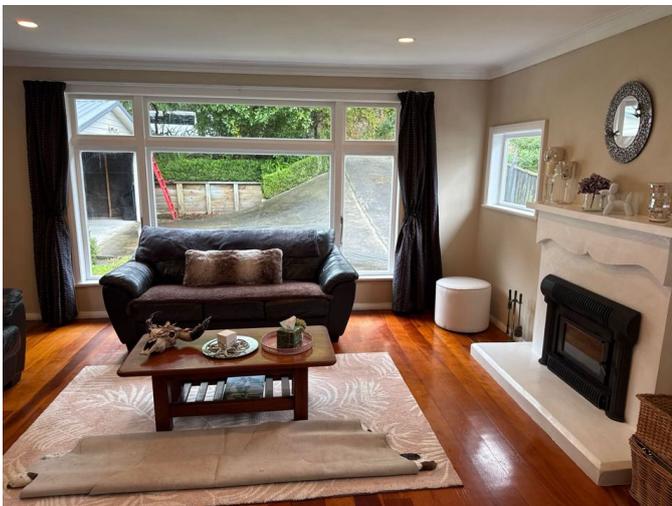
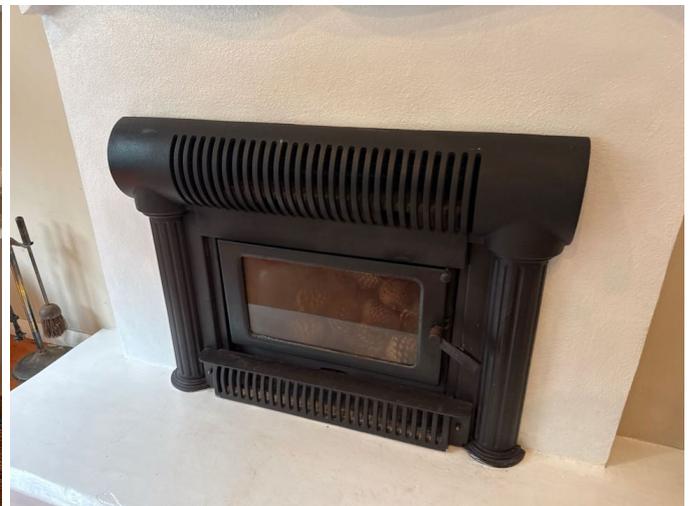
The fireplace and chimney were not checked as part of the inspection process. All fireplace manufacturers stipulate an annual service and insurance companies require evidence of due care and maintenance in the event of a claim. Purchasers should check when the fireplace was last serviced prior to the first use and have a service completed if necessary. The chimney was not checked as part of this inspection process.

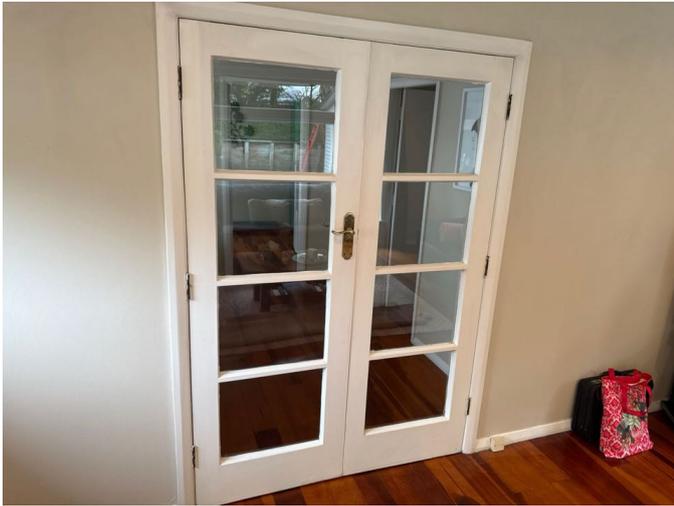
The internal doors are functional

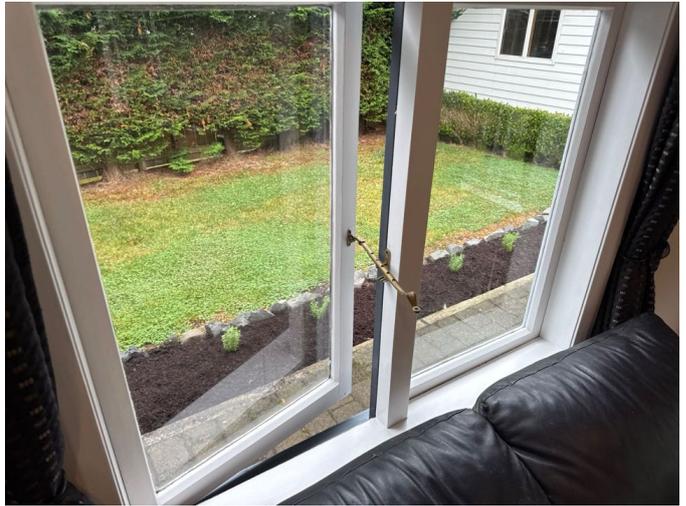
The windows are functional.
Draught stopping foam has been installed where the windows have warped.

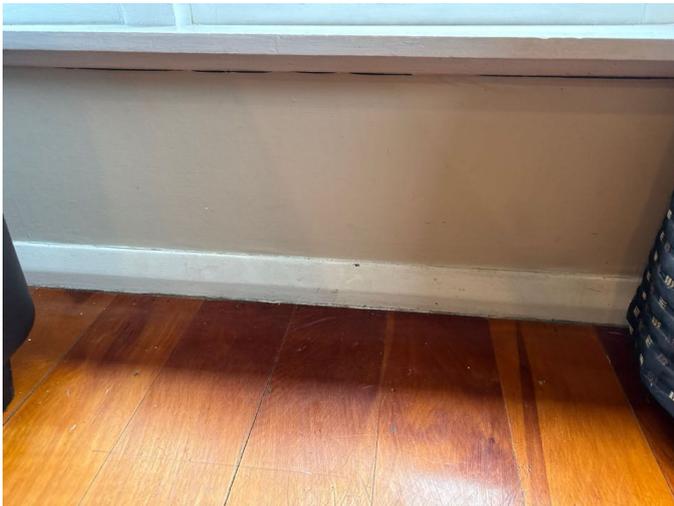
The wall and ceiling linings and timber flooring are in good condition

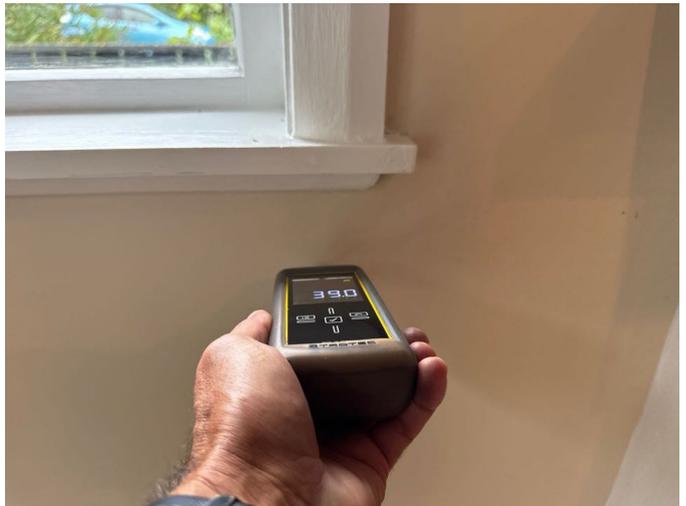
Moisture levels to the external walls were within the normal range at the time of inspection

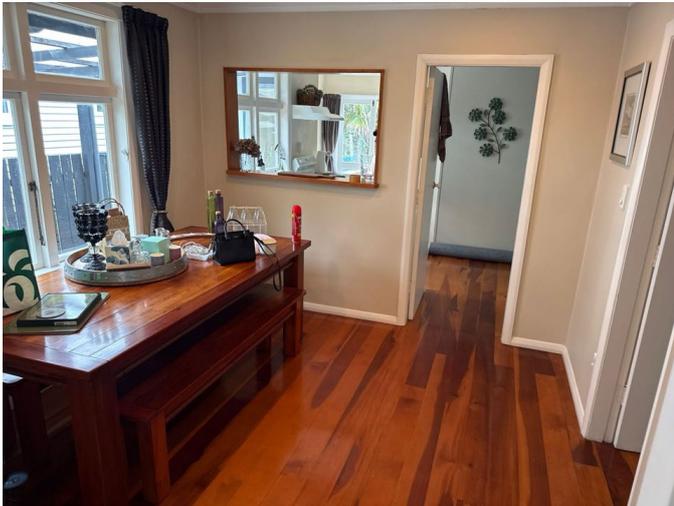
The dining area is tidy

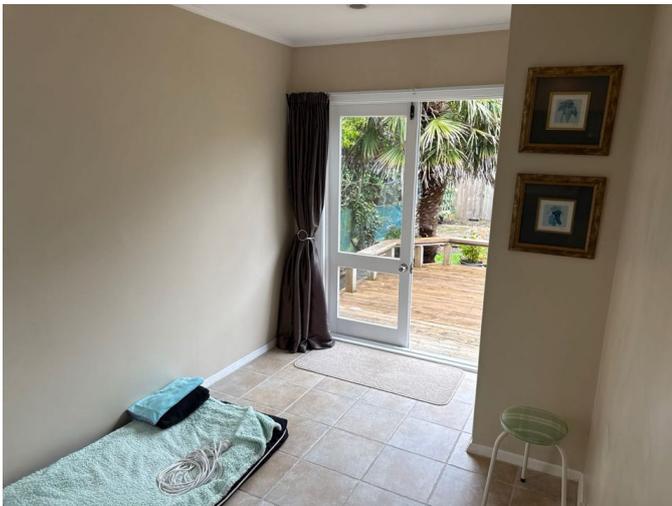
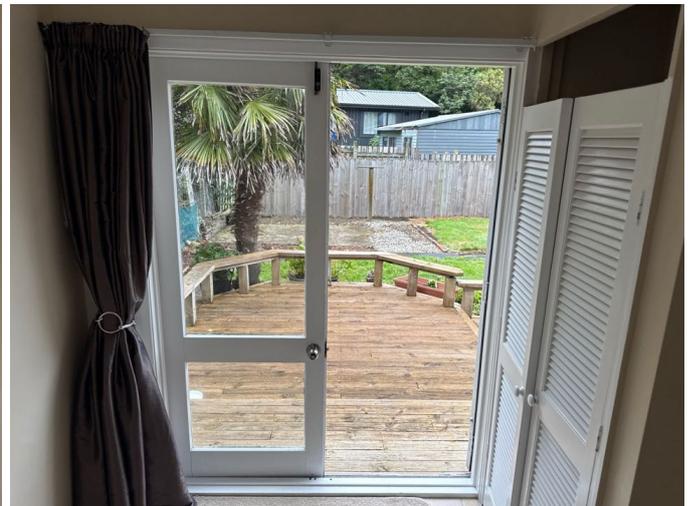
The external doors are functional

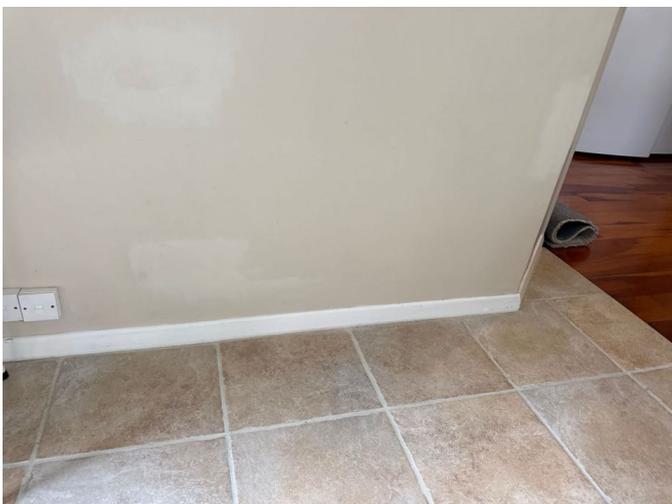
The wall linings and tiles are generally tidy

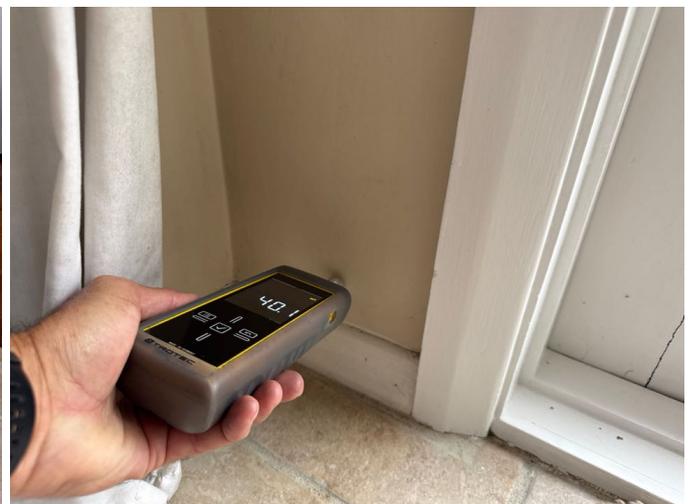
Moisture levels to the external walls were within the normal range at the time of inspection

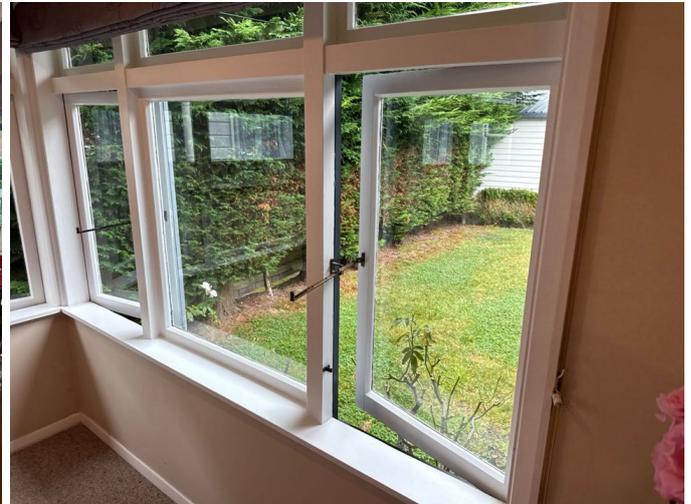
The windows are functional

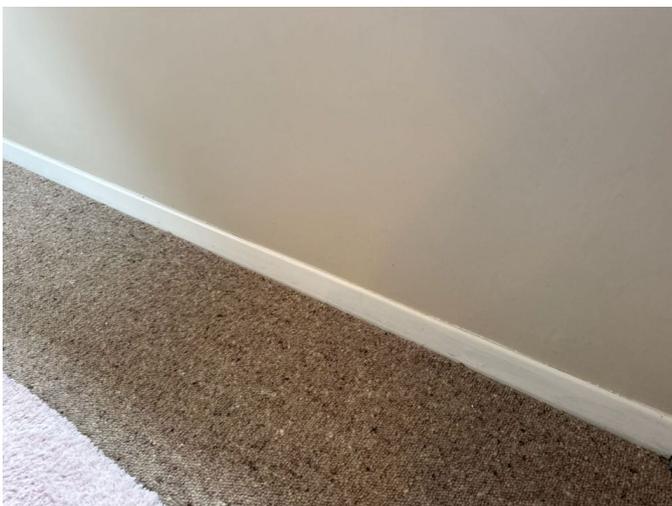
The wall and ceiling linings and carpet are in good condition

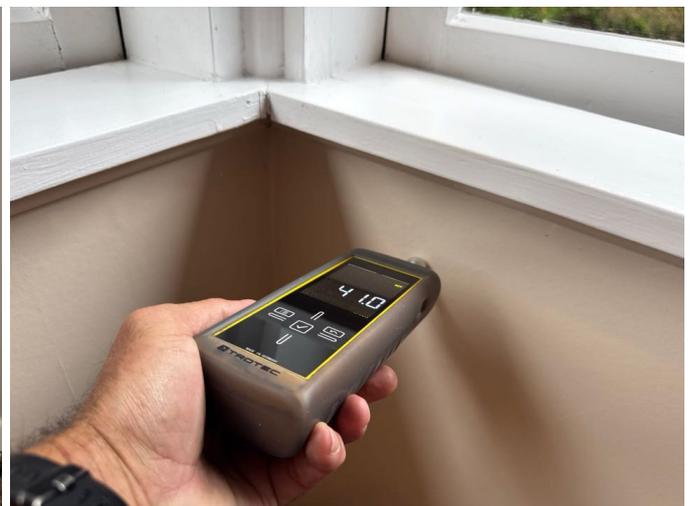
Moisture levels to the external walls were within the normal range at the time of inspection

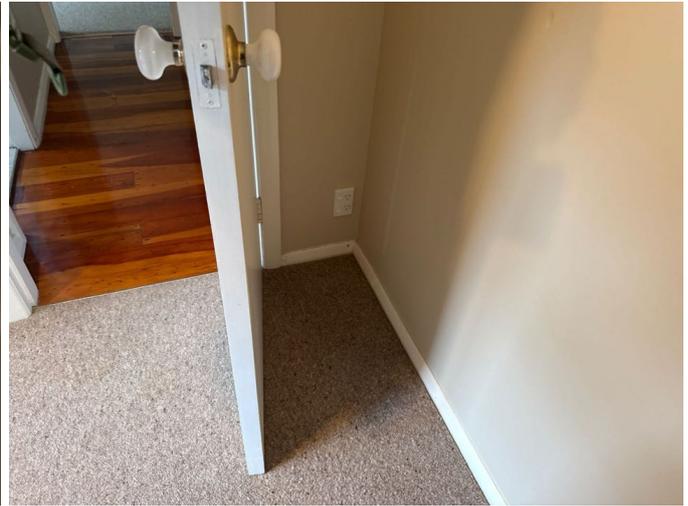
The internal doors are functioning well. Door stops should be installed where missing to prevent the risk of damage to the wall linings.

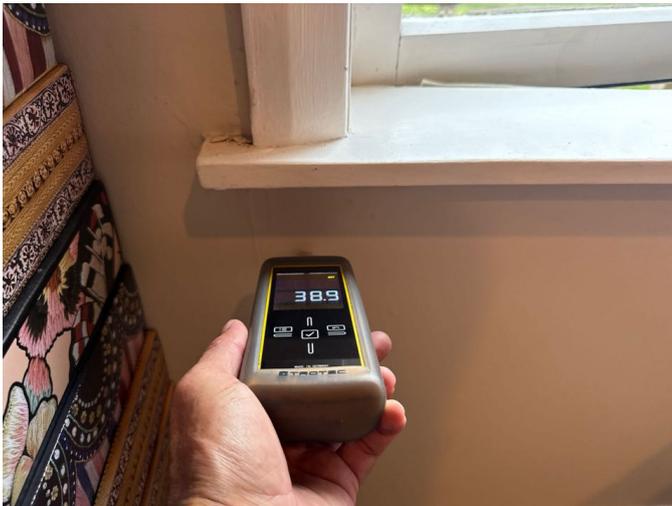
Moisture levels to the external walls were within the normal range at the time of inspection

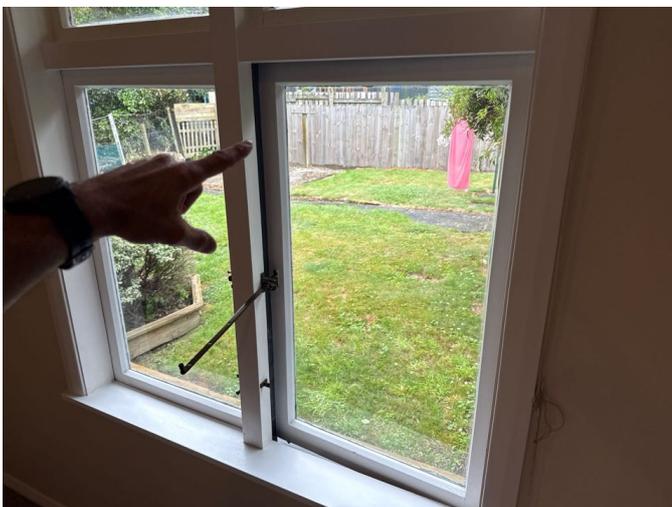
The windows require easing where they are catching to help them work more effectively.

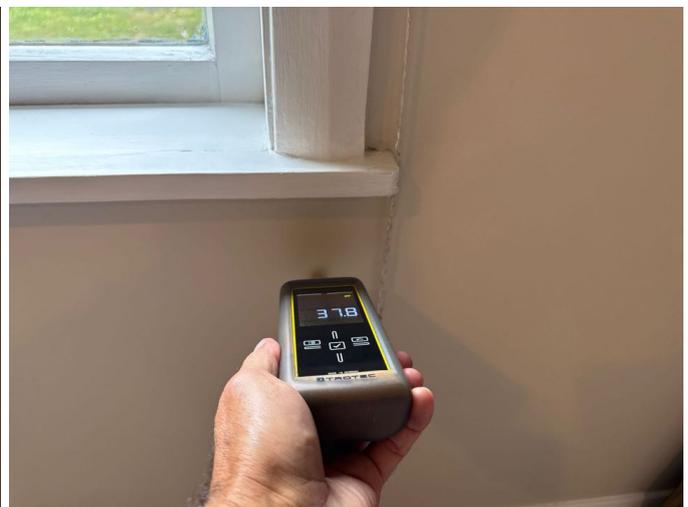
Moisture levels to the external walls were within the normal range at the time of inspection

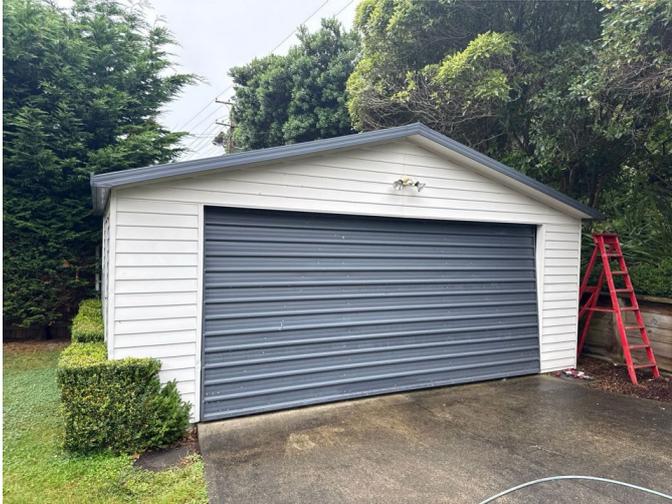
The surface condition of the garage door is average

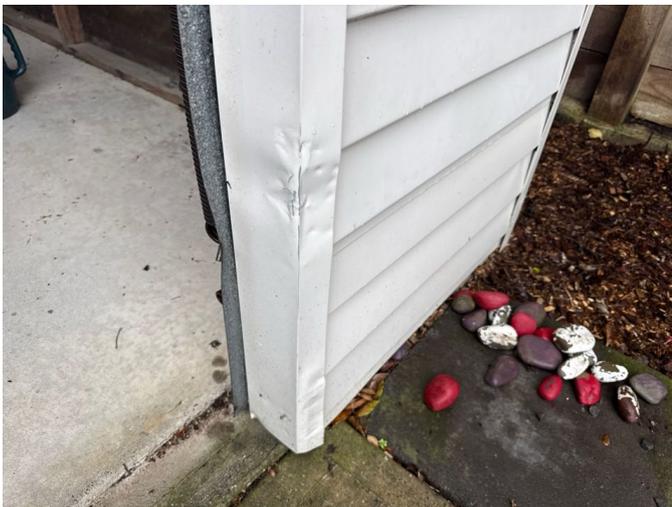
Cosmetic wear and tear to the garage noted

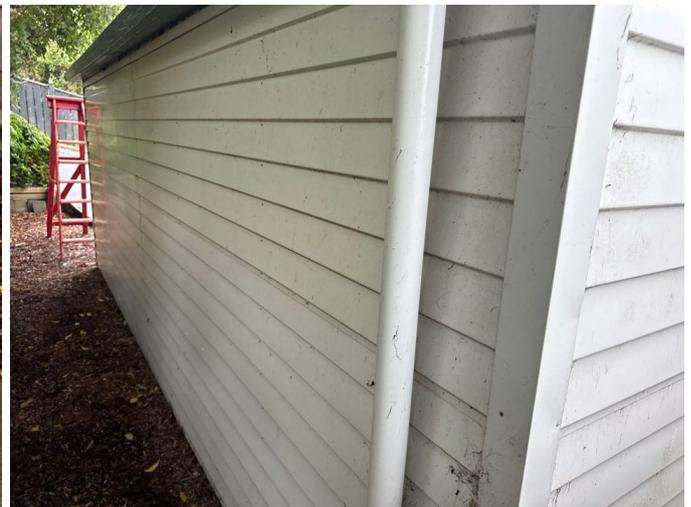
Regular soft washing of the exterior may help promote longevity

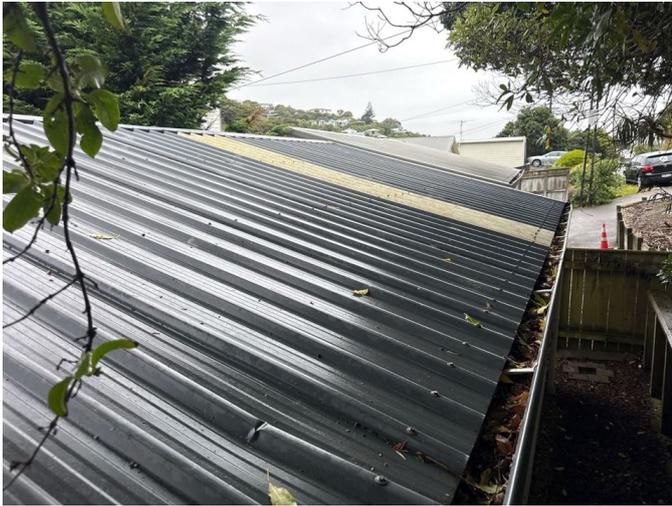
The lightweight steel and plastic roof is generally in good condition. The spouting requires a clean out. Trees over hanging the roof should be trimmed back.

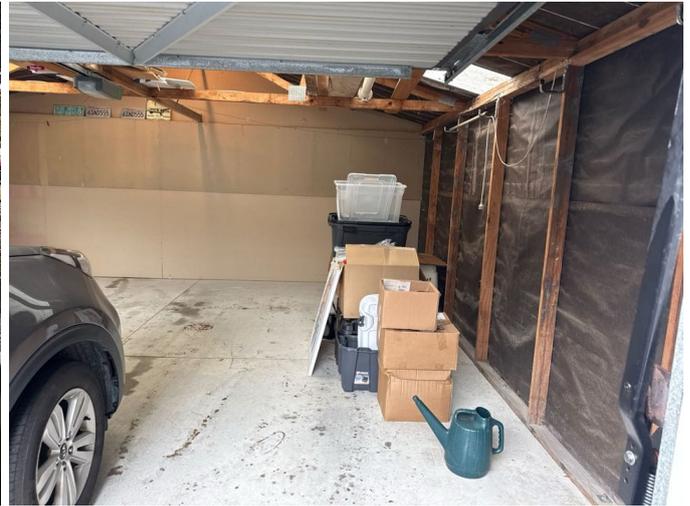
The inside of the garage is tidy

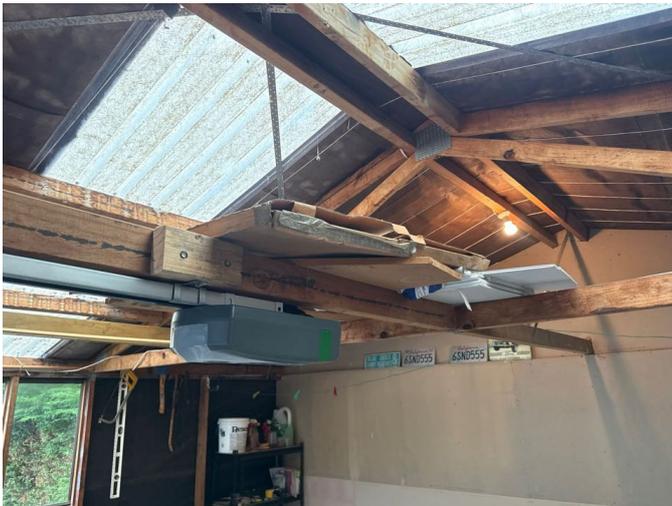
New garage door opener installed

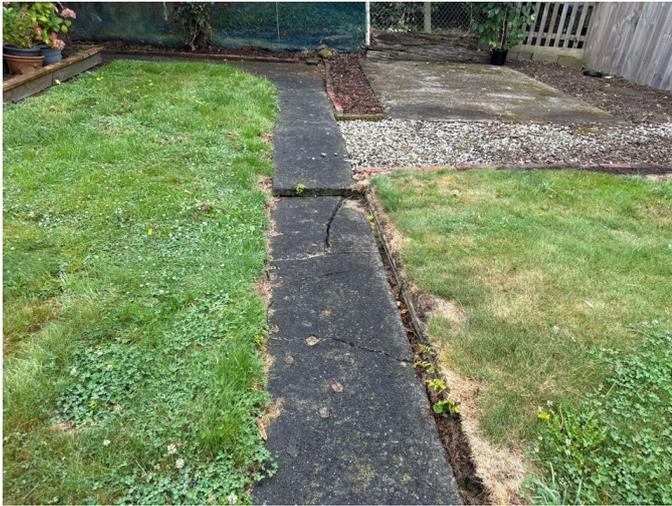
Settlement cracking to the east path. Consider improvements where trip hazards are present.
