RED LBP PRE-PURCHASE REPORT

PRE-PURCHASE

PRE-PURCHASE BUILDING REPORT

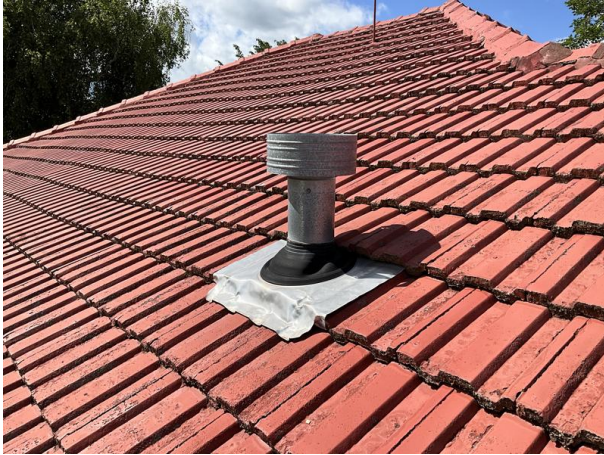
Photo 6

Flue penetration viewed on the northern side of the roof.

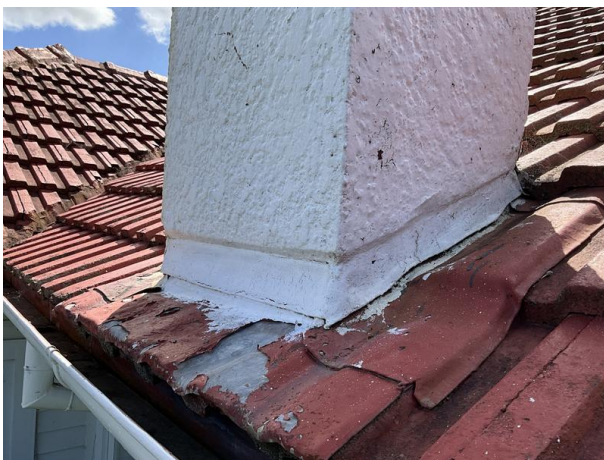
Photo 10

Chimney penetration located on the western side of the roof.

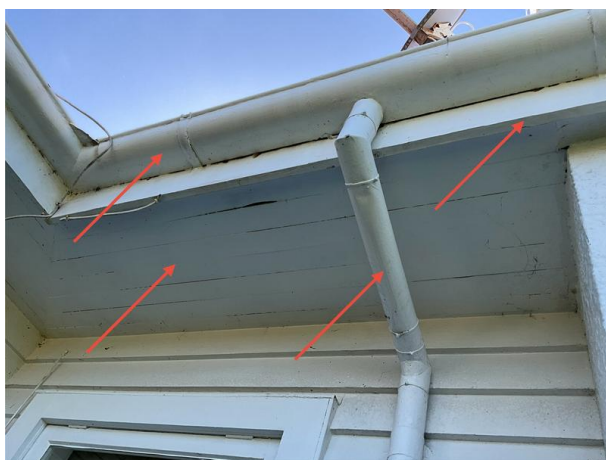
Photo 11

Profiled metal gutter and downpipes with a paint finish, timber fascia and soffits with a painted finish.

There are areas of the timber fascia that require sanding back any loose flakey paint, apply a sealer coat then redecoration to prevent further deterioration.

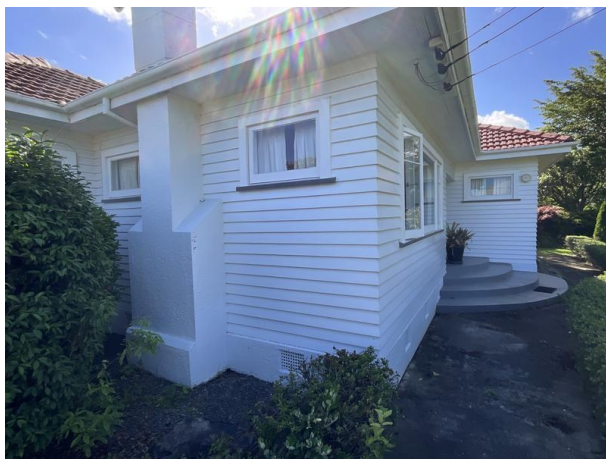
Photo 13

Timber weatherboard cladding with a painted finish is located on all cladding elevations.

Some areas require maintenance as they are weathering due to either being more exposed to the elements or from generally being on the south side of the home.

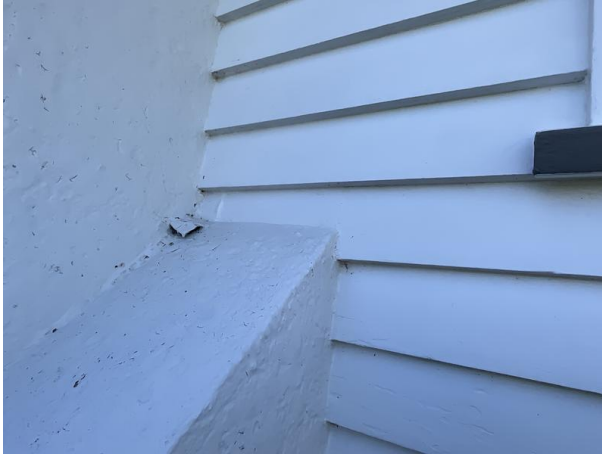
Photo 15

Weatherboard cladding to the brick chimney junction is sealed.

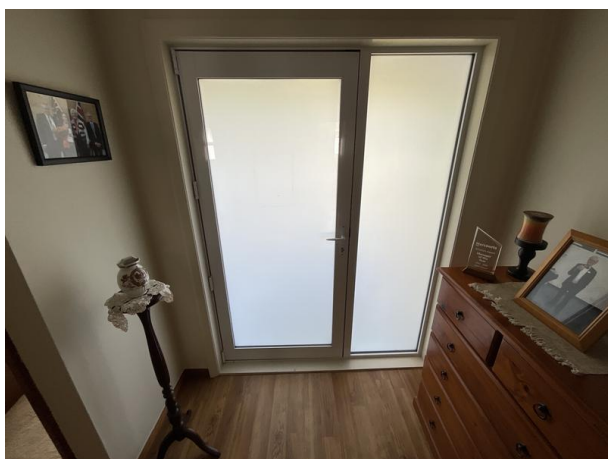
Photo 19
Double glazed aluminium joinery with painted timber reveals located at the front entrance.

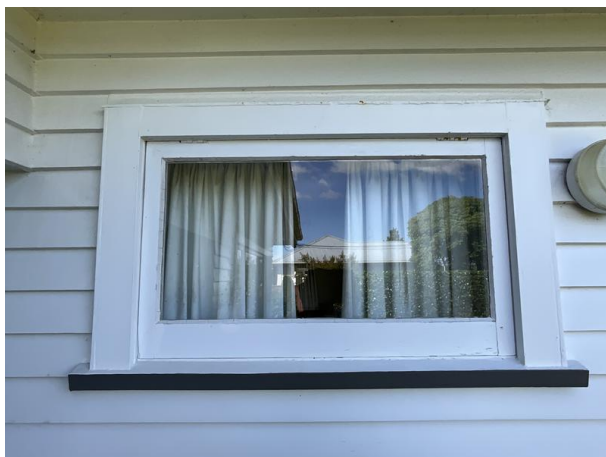
Photo 20

Single glazed timber window joinery with painted timber window reveals.

Some repairs required to the opening sashes of the windows in order to restore functionality and to reduce draughts.

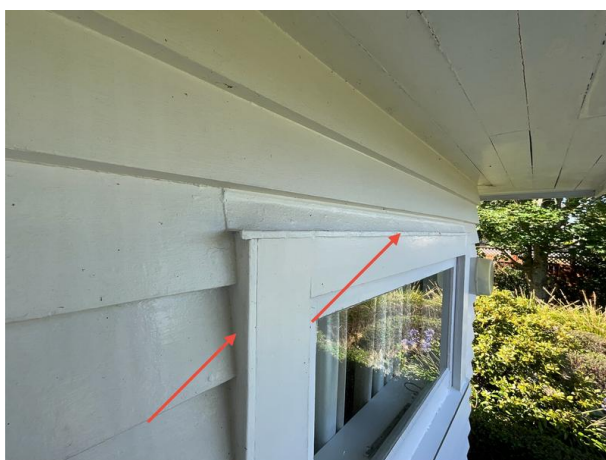
Photo 21

Window head flashing and timber scribe detail.

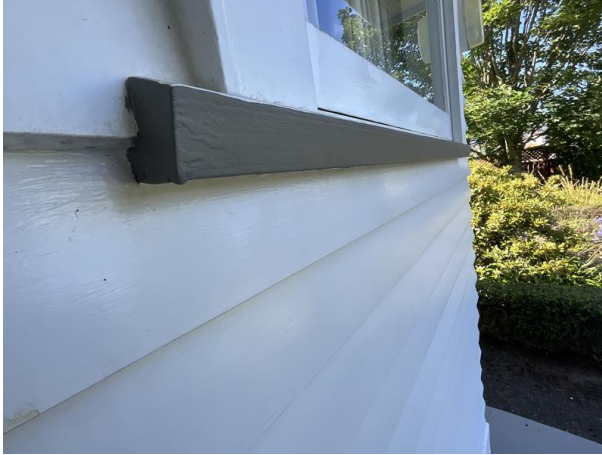
Photo 22
Windowsill detail.

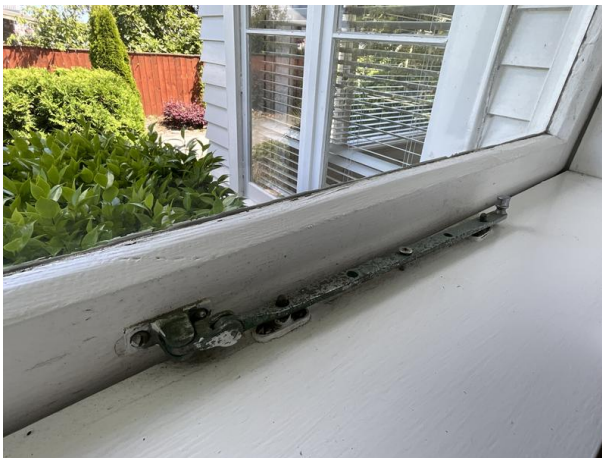
Photo 26

Western living room window hardware is screwed shut.

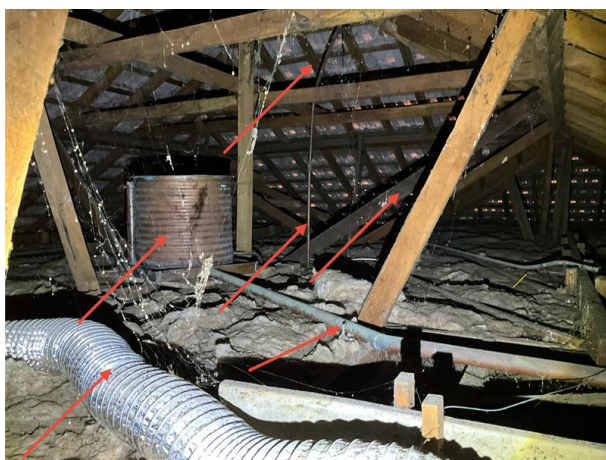
Photo 34

Roof space. Pitched timber framing with timber battens, glass wool insulation, copper head tank, extraction fan ducting and copper plumbing.

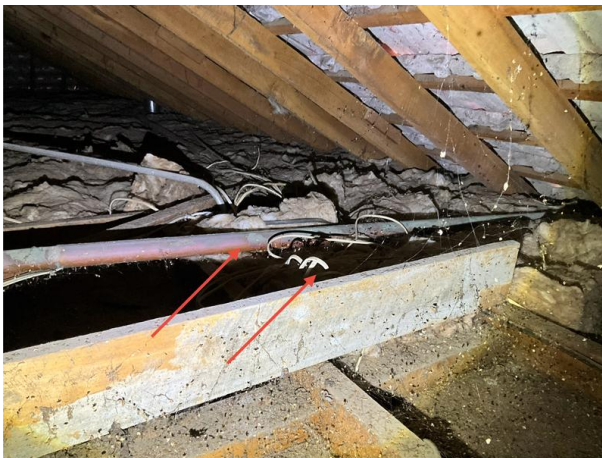
Photo 36

Modern TPS wiring, and copper piping.

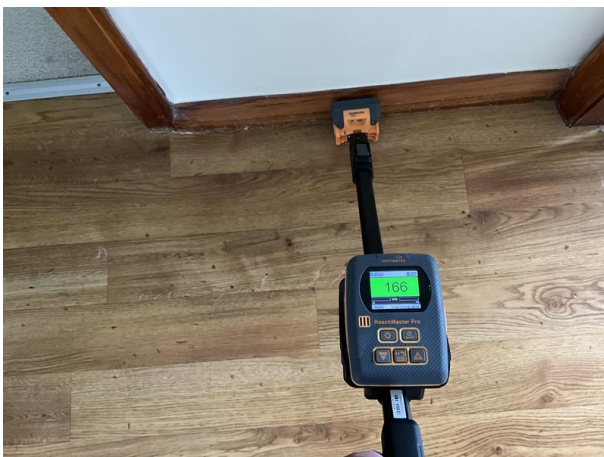
Photo 38

A base moisture reading level of 166 was recorded to the hallway.

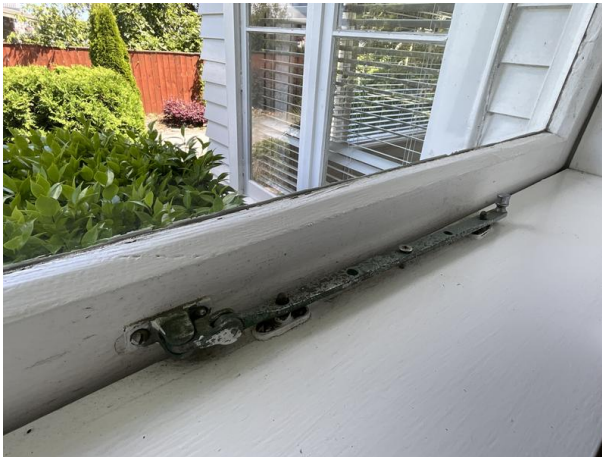
Defects - Window hardware is screwed shut. Refer to photos.

Photo 52
Western window hardware is screwed shut.

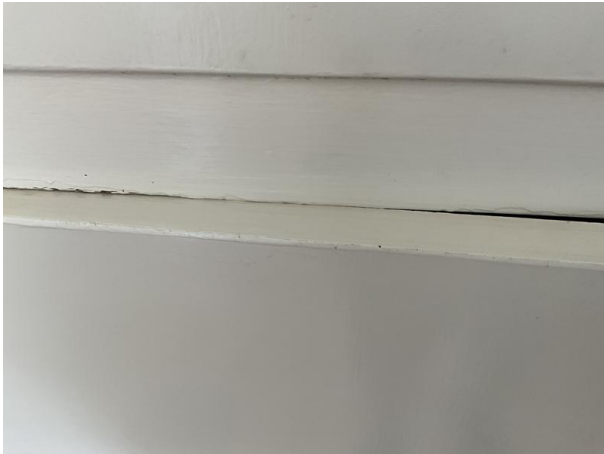
Photo 54

The door to the hot water cylinder cupboard is binding.

The interior door is binding/rubbing, this can be adjusted or planned to free its operation.

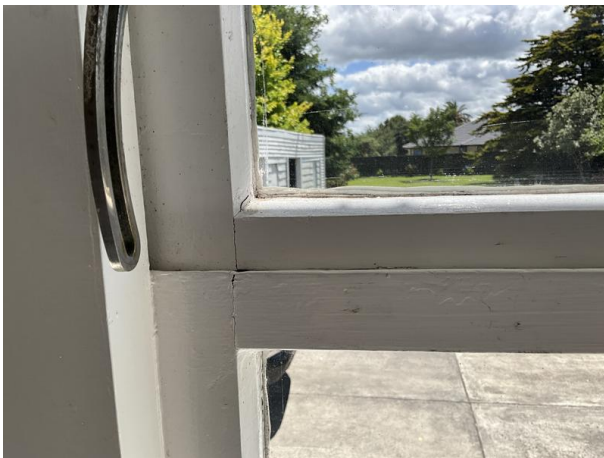
Photo 55

The fan light window sash is binding.

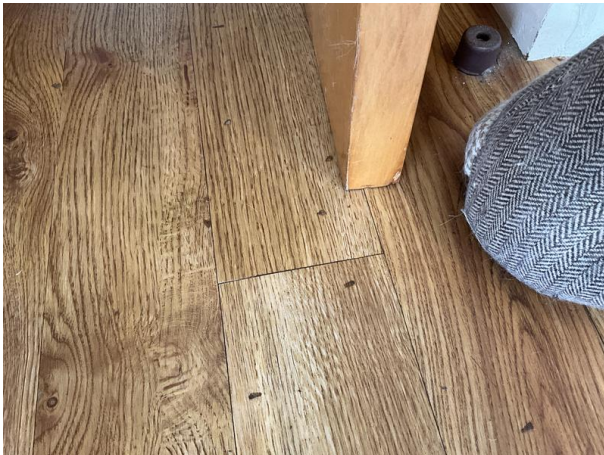
Photo 56

Swelling to the vinyl planking flooring beside the hot water cylinder cupboard.

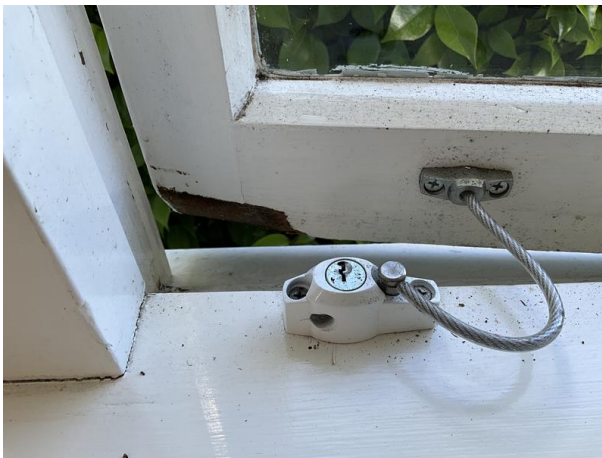
Photo 59
Timber window joinery requiring redecoration to the window sash on the eastern side of the lounge.

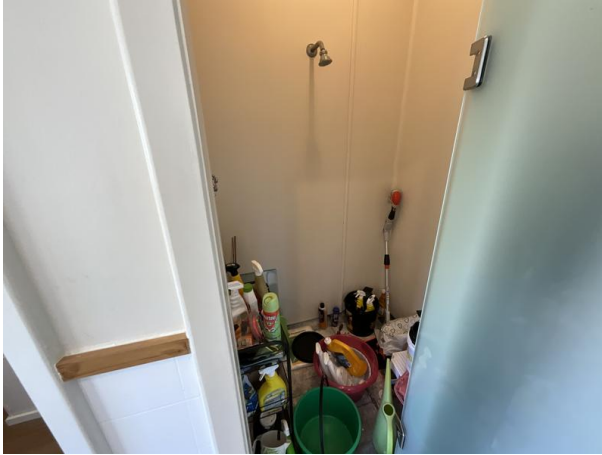
Photo 62

Shower located in the laundry. Unable to test function due to stored personal items.

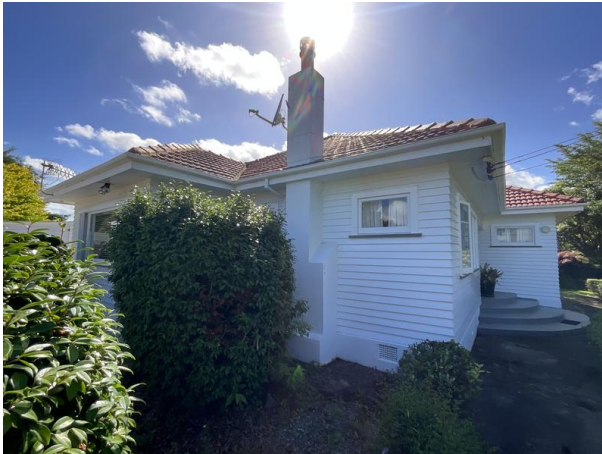
Photo 68
Chimney with a plastered finish located
on the western side of the house.

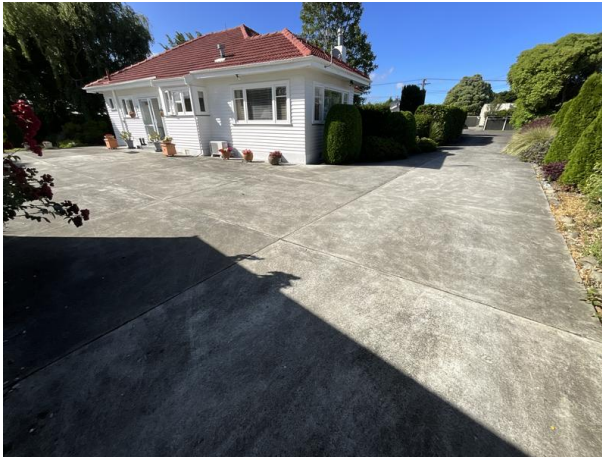
Photo 69
Concrete driveway.

General upkeep and maintenance of the driveway is recommended, including cleaning it and keeping it free of debris.

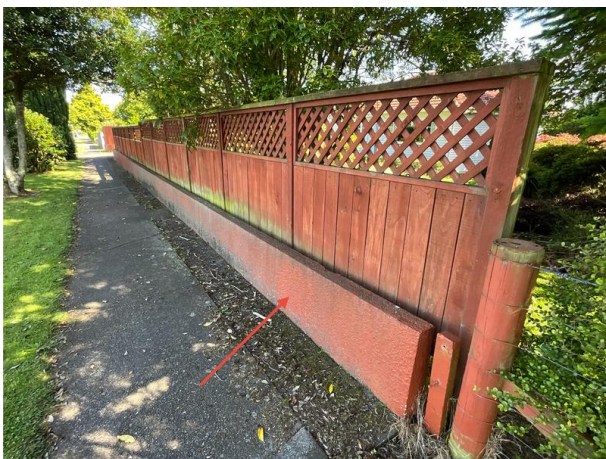
Photo 71

Southern boundary fence. Painted timber palings and trellis with timber rails and post. Concrete nib wall.

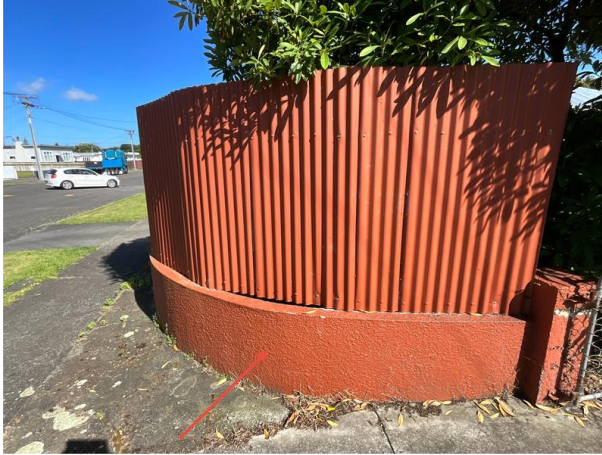
Photo 72

Southern boundary. Profiled metal sheeting with a factory paint finish with timber railings and posts. Concrete nib wall.

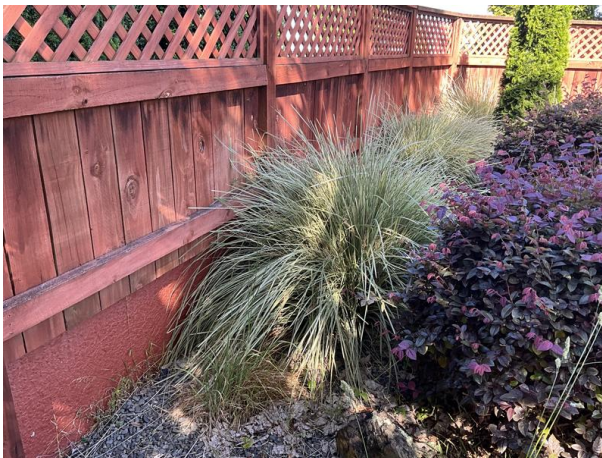
Photo 73

Areas of vegetation growth against the southern boundary fence.

Ensure regular upkeep and maintenance by keeping vegetation and soil away from exterior timbers. These timbers are treated for external exposure but are not designed for prolonged contact with vegetation or soil, which can trap moisture and accelerate rot. Periodically inspect the area and clear any overgrowth or soil buildup.

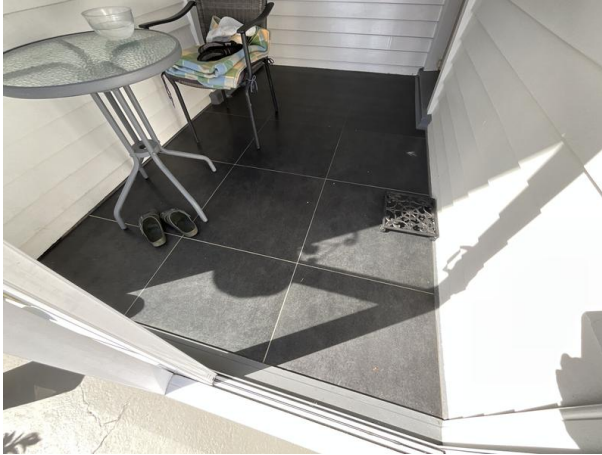
Photo 77

Concrete patio with a tile covering is located on the northern side.

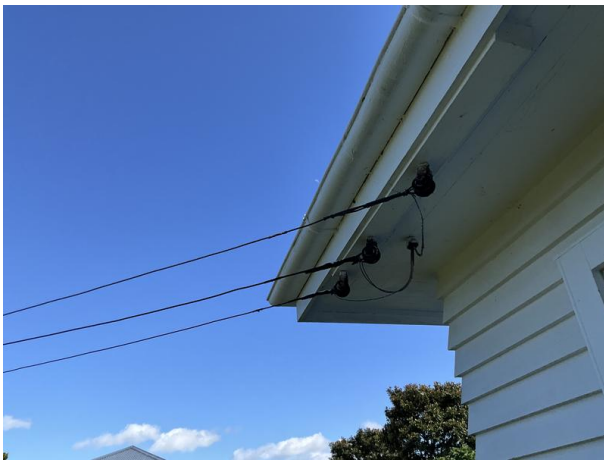
Photo 79

Electrical overhead wire connection located on the southwestern corner of the house.

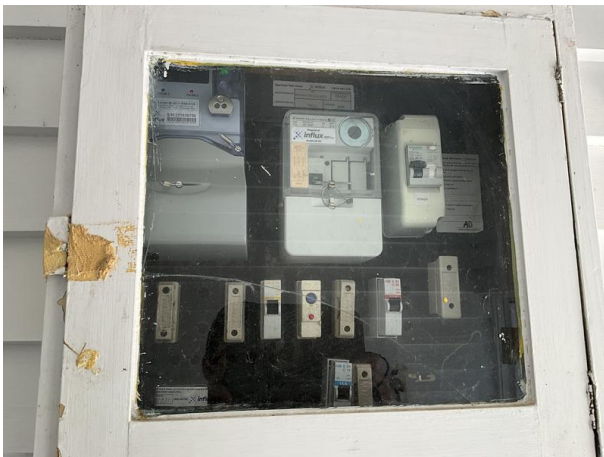
Photo 80

Metre box - Location - The power metre is located on the distribution board. Possible asbestos-containing material.

The electrical meter and distribution board is located at the back entrance.

Have this tested for asbestos before undertaking any invasive works, such as drilling, cutting or sanding.

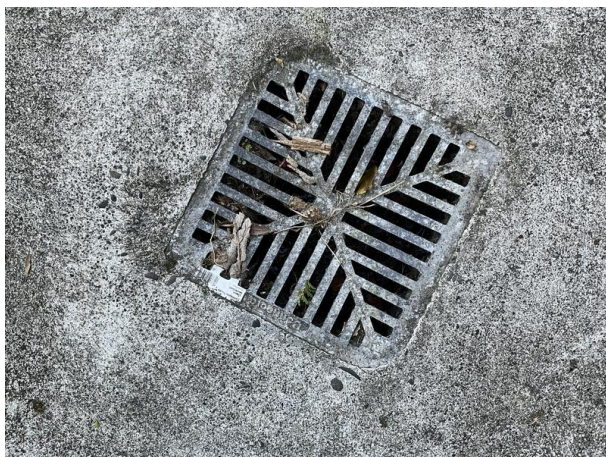
Photo 81

Drainage sump is located on the western side of the driveway.

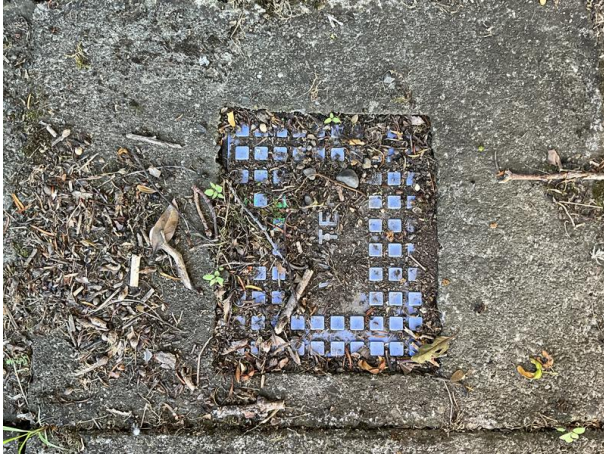
Photo 82

Water toby is located along the southern boundary.

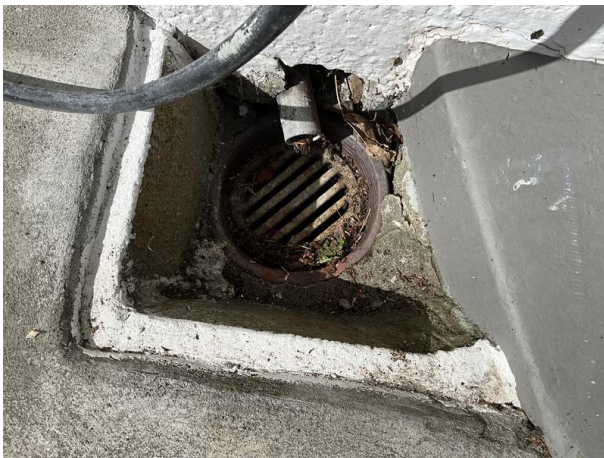
Photo 83

Gully trap is located on the northern side of the house.

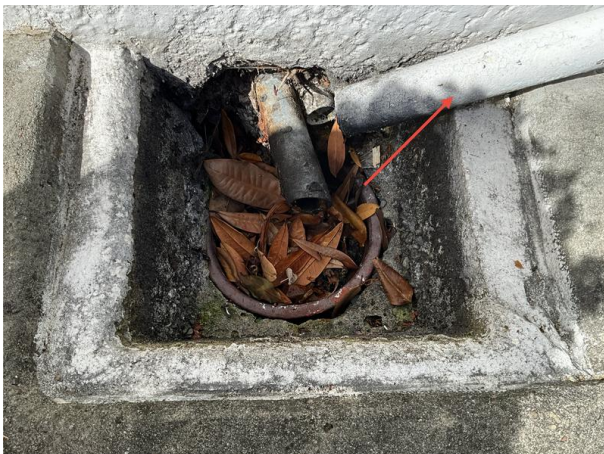
Photo 84

Gully trap is located on the northern side of the house. Note there are debris and a stormwater pipe running into the gully.

It is recommended that any vegetation is removed from the downpipe to stormwater connections.

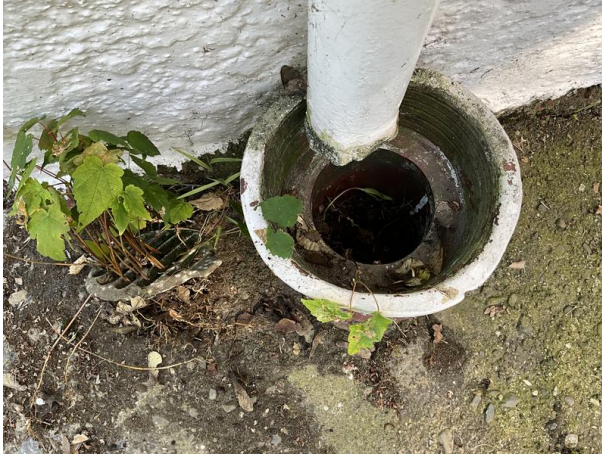
Photo 85

The downpipe to stormwater connection on the south eastern side is blocked with vegetation.

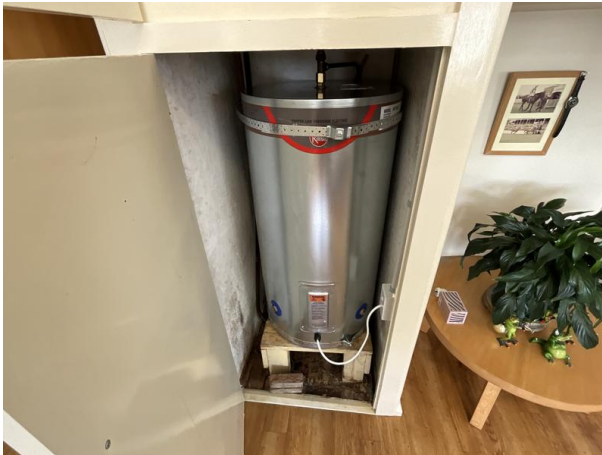
Photo 86

Hot water cylinder is located in the kitchen cupboard.

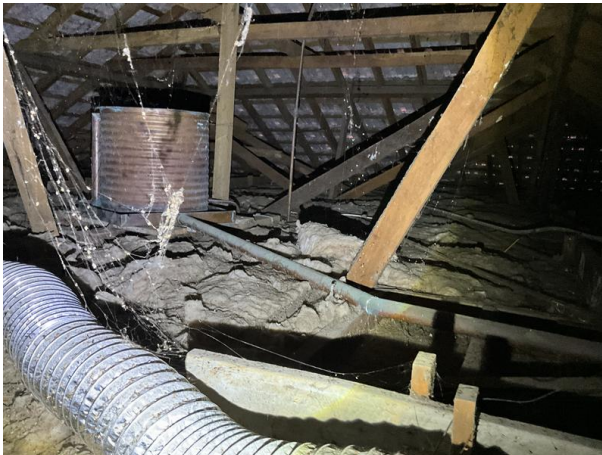
Photo 87

Water heater tank located in the roof space.

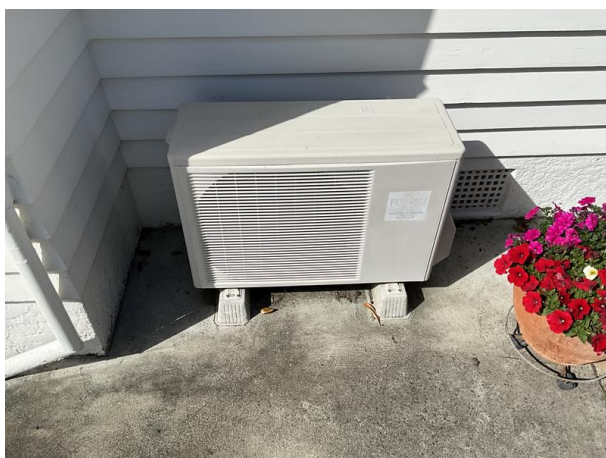
Photo 88

External heat pump located on the northern side of the house.

Regularly clean the filters of your heat pump to maintain optimal performance. The frequency of cleaning depends on the unit's location and usage, typically ranging from every 4 to 12 weeks. Units placed in areas with higher dust or debris accumulation may require more frequent cleaning, while those in cleaner environments may need less frequent maintenance. This ensures efficient operation.

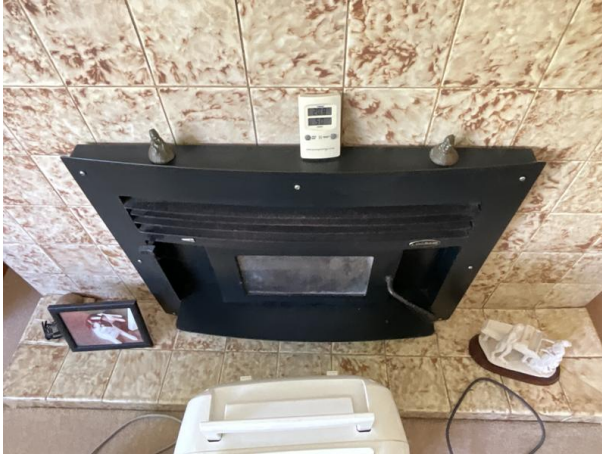
Photo 89

Solid fuel burner is located in the living room.

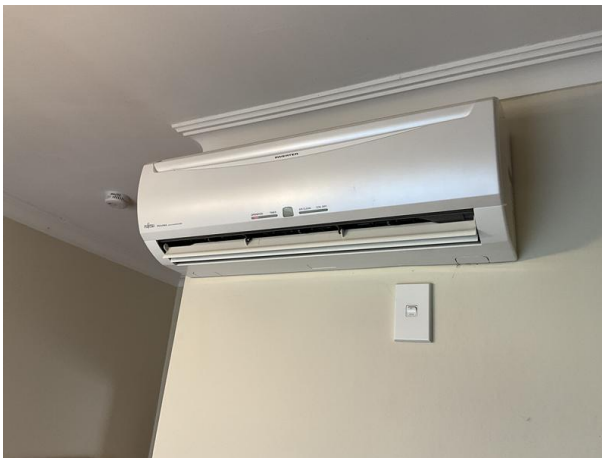
Photo 90

Internal heat pump unit is located in the front entrance. Tested functional.

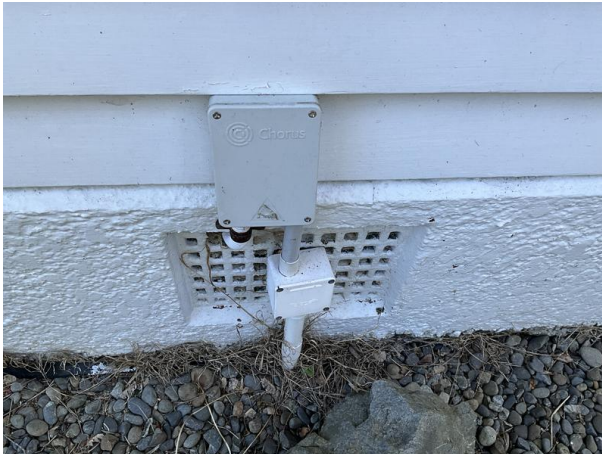
Photo 91
Data is located on the southern side of the house.

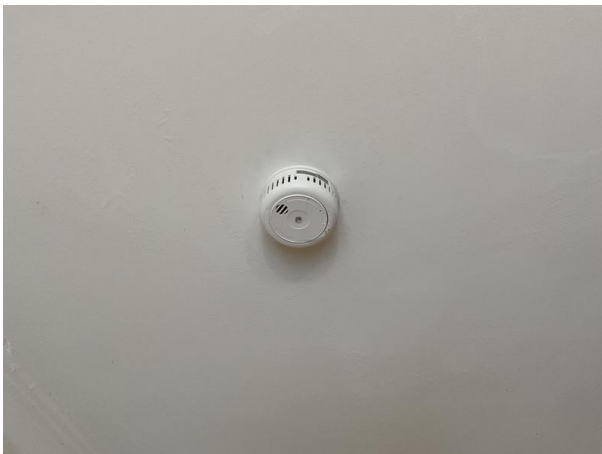
Photo 93
Smokes alarms . Tested functional.

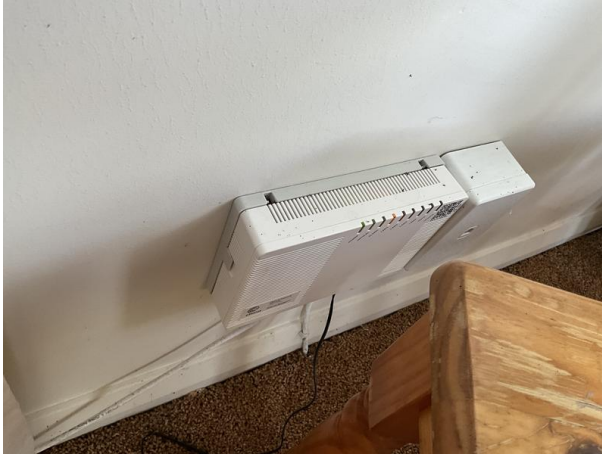
Photo 94

Internet services are located in the lounge.
