RED LBP WEATHERTIGHT REPORT

WEATHERTIGHT REPORT

Property Address	15 Compass Court Paraparaumu
Client	Sitha Than
Date of Inspection	3rd March 2026
Time	8:00 am
Inspector	Trevor Garrett MSc, LBP, Advanced Trade Cert Carpentry, Nat Diploma Construction Management. Member of NZIOB.
LBP Number	131790
People Present	Inspector
House Occupied	No

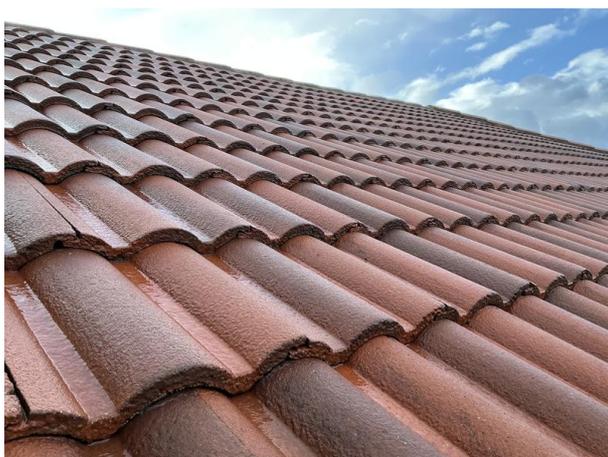
Photo 3

Roof is in serviceable condition.

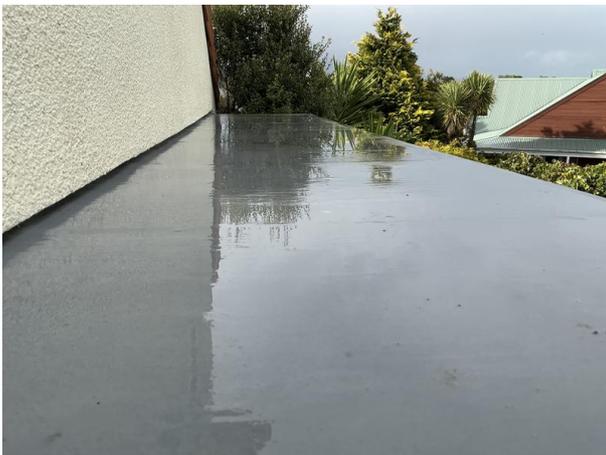
Photo 6
West side membrane roof.

Recommend a roofer specialising in membranes, review the condition of the west side roof and the balcony roof for deterioration repair as required.

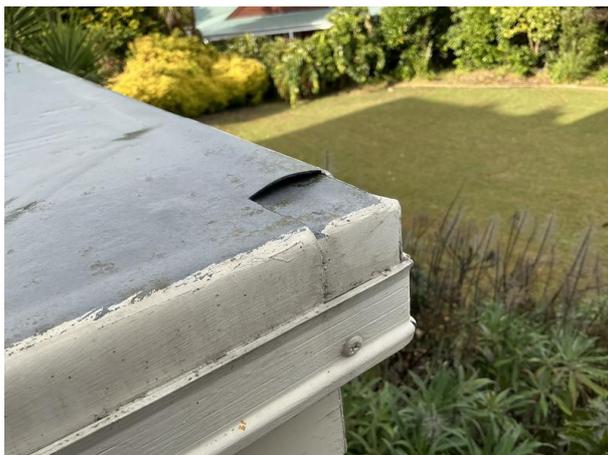
Photo 7

West side lapped joint is delaminating.

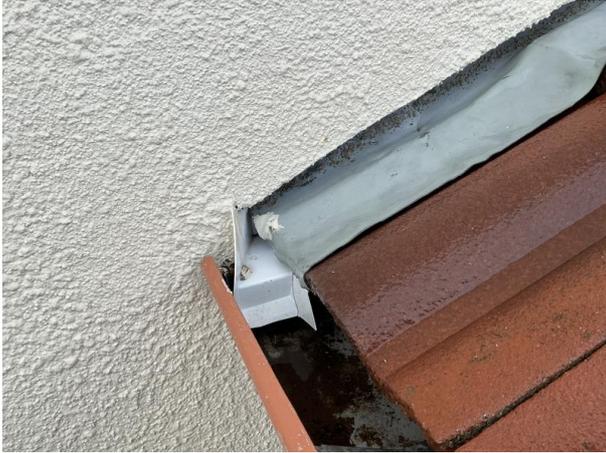
Photo 8
Roof and wall junctions have kick out diverter flashings.

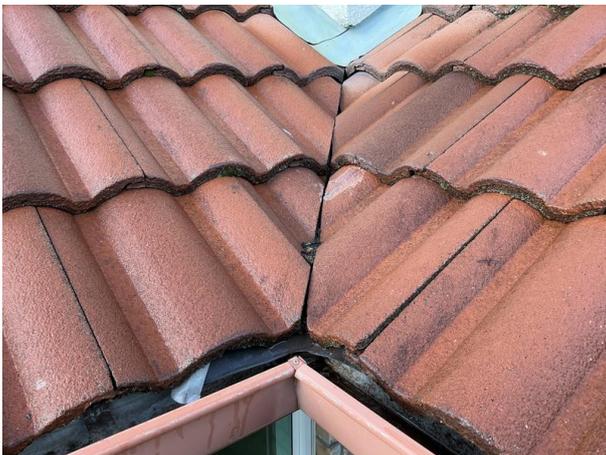
Photo 13
East side valley tiles are in contact, valley flashing is not visible. Debris between the tiles is visible.

The roof tiles over the valleys conceal the valley gutter. This will allow debris to build up between the tiles and have the potential to cause the valley gutter to overflow. It is recommended to cut the tiles back to have a 50-75mm gap between them to allow free discharge of rainwater.

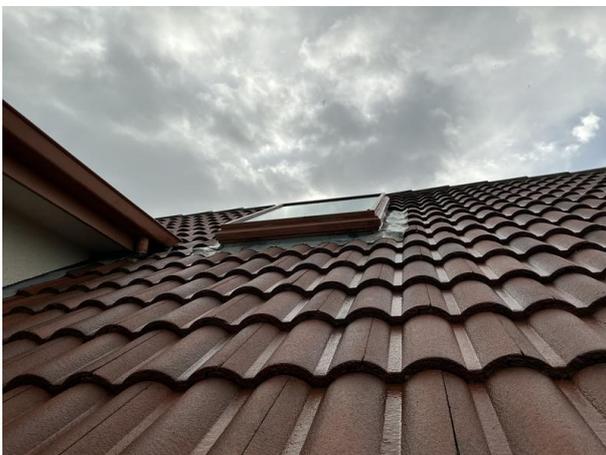
Photo 15
West side skylight.

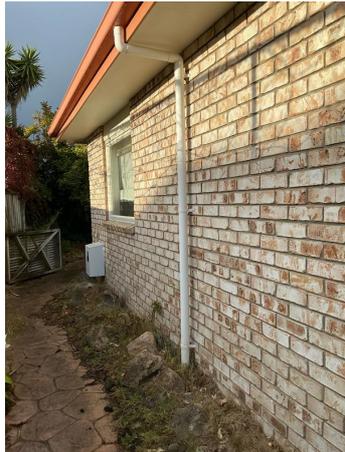
Photo 16

No issues with the lower level downpipes.

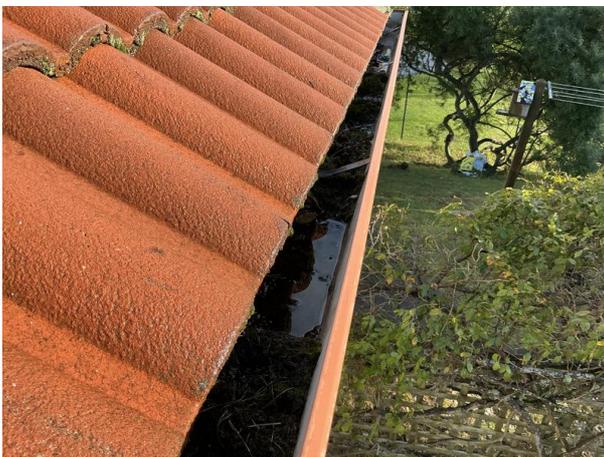
Photo 17

East side debris in the gutters.

It is recommended to clear the gutters regularly to ensure proper drainage and prevent potential issues. When gutters become clogged with debris such as leaves and twigs, water can overflow and accumulate on the roof or other parts of the building. This can lead to water damage and leaks. Keeping the gutters clean ensures efficient water flow away from the roof, protecting the property from moisture-related damage. Recommend further investigation to the east side soffit with the hardboard soffit to establish the causation and damage to the timber framing.

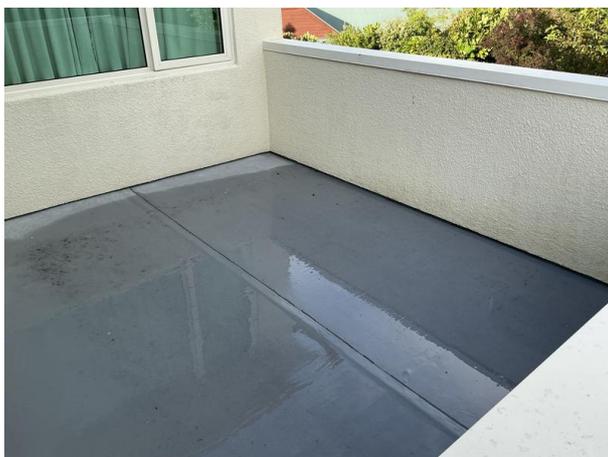
Photo 24
Northwest balcony.

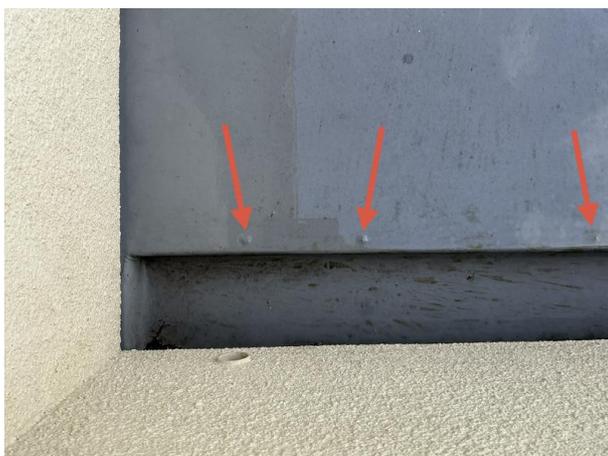
Photo 25
Substrate fixing are protruding through the membrane.

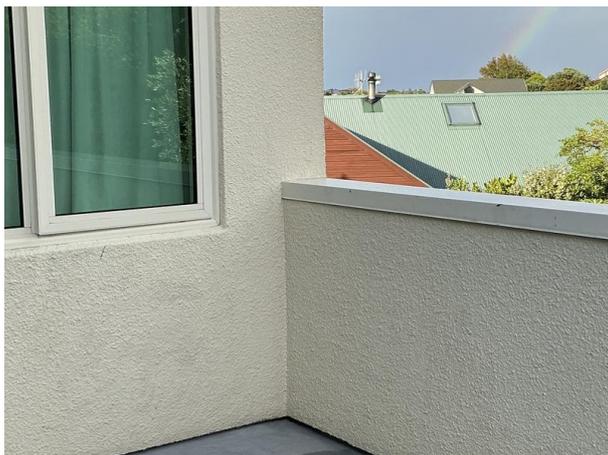
Photo 26
Barrier wall has a cap flashing with no cross fall. The junction to the house has no visible saddle flashing.

- No cross fall to barrier walls.

- No visible saddle flashing to wall and barrier junction
- Poorly positioned overflow.

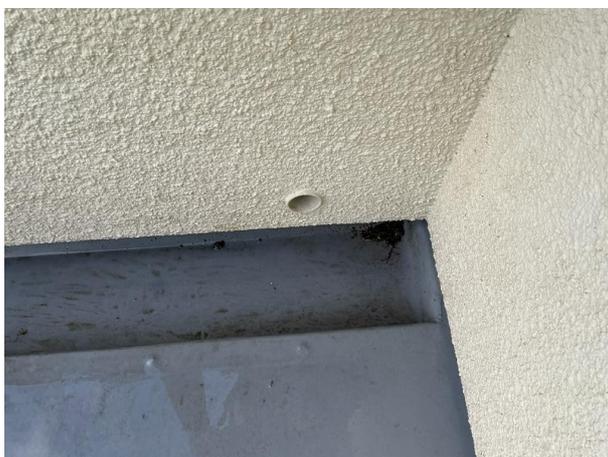
Photo 27
The overflow is too high. The balcony would have to flood before the overflow is activated.

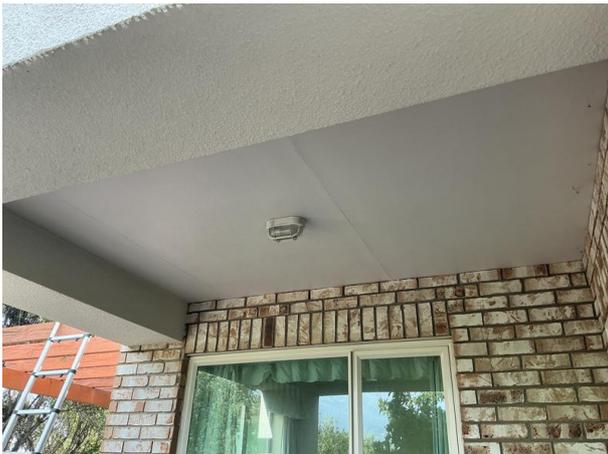
Photo 29
Soffit below the balcony has no visible staining.

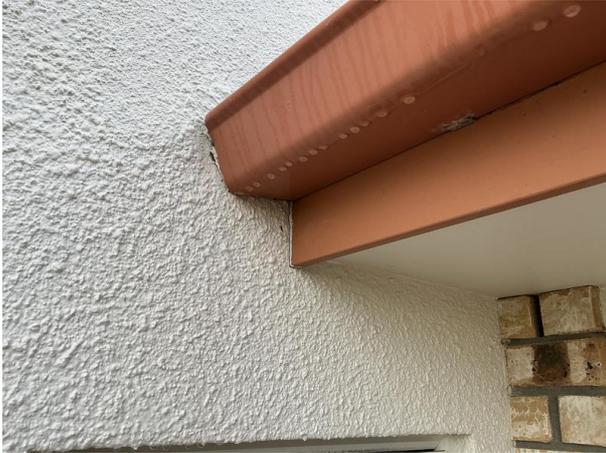
Photo 30
Fascia penetrates the plaster/paint.

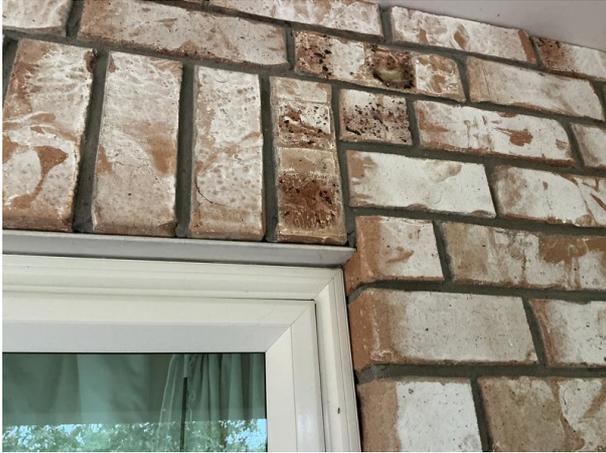
Photo 40
Some windows are installed with steel lintels.

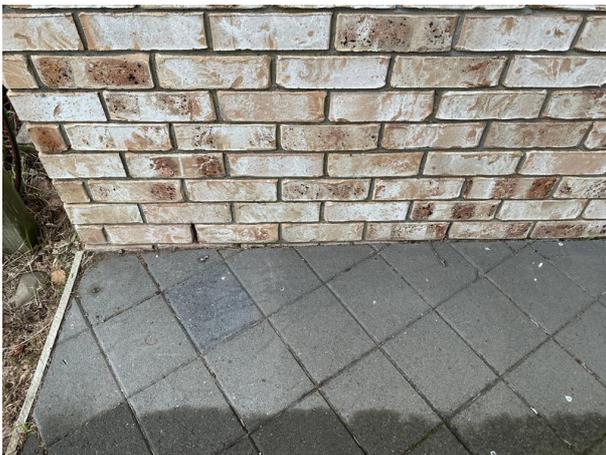
Photo 42
Weep holes are present throughout the brick work.

Weep or drain holes at the bottom of brick veneers are designed to allow water to drain from behind the bricks and facilitate in the movement of drying air. Some weep holes were partially blocked. Have these cleaned out so they operate correctly to ensure the correct performance of the brick cladding system.

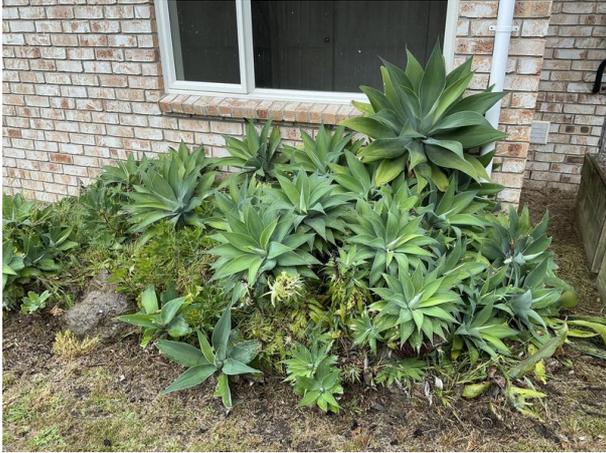
Photo 43
East side vegetation in contact with the brick.

Some areas around the dwelling, the minimum ground clearance have been compromised due to hard landscaping or gardens. This reduced clearance can lead to accelerated weathering of the cladding and increase the risk of moisture-related damage. To mitigate this, it is recommended to lower the ground levels where feasible or install strip or channel drains. These measures will help protect the cladding by minimising exposure to moisture.

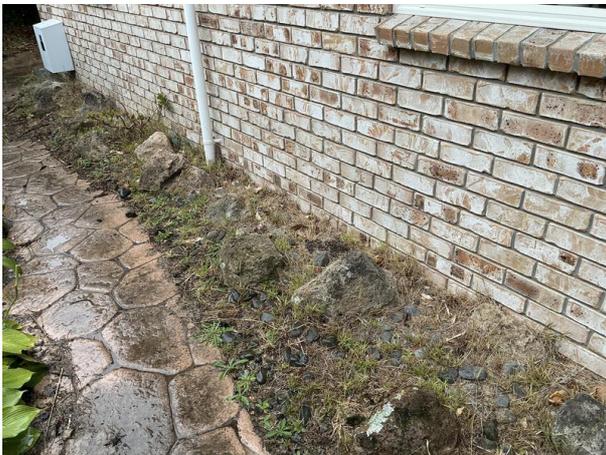
Photo 44
East side vegetation in contact with the brick due to reduced ground clearance.

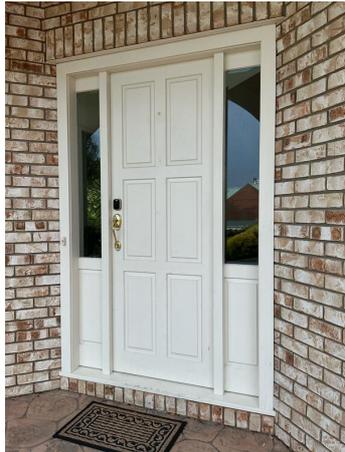
Photo 46
Timber framed entrance doors.

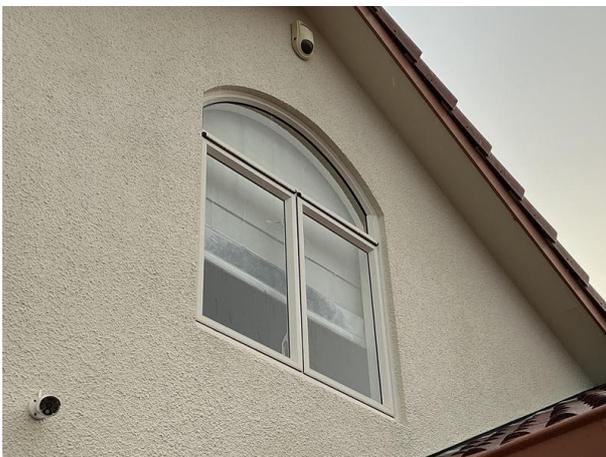
Photo 47
South facing arched window.

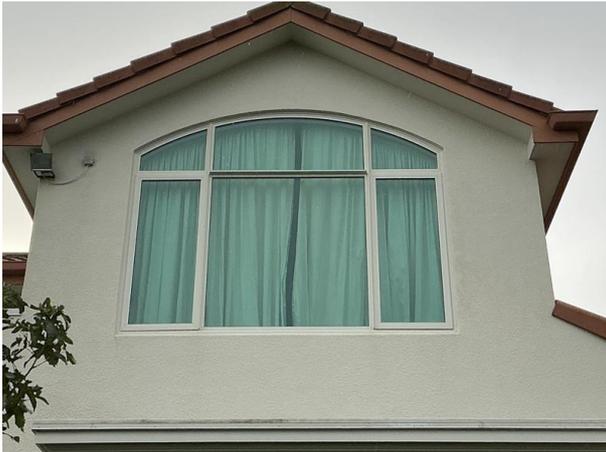
Photo 49
West side arched window.

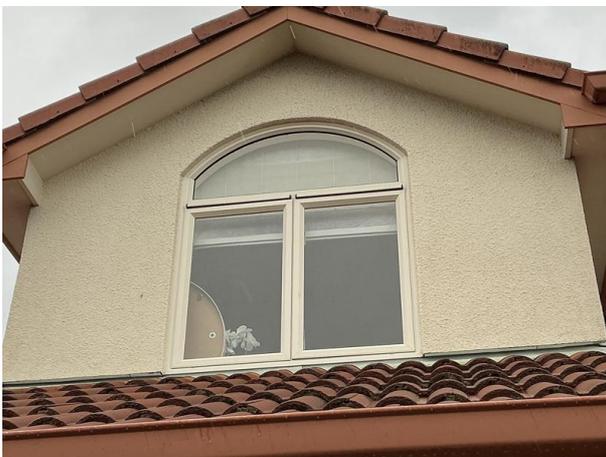
Photo 50
East side arched window.

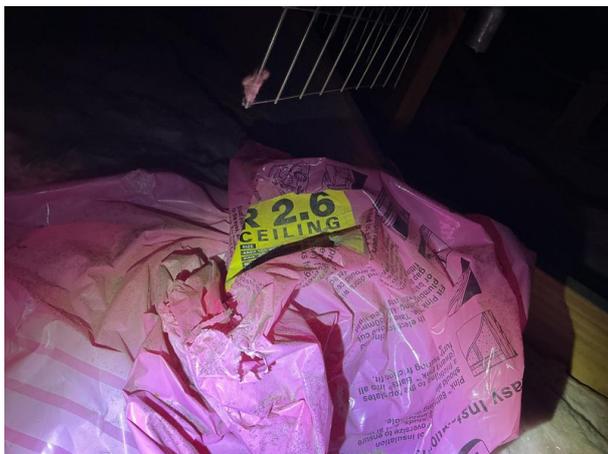
Photo 55

Insulation installation record, R value 2.6.

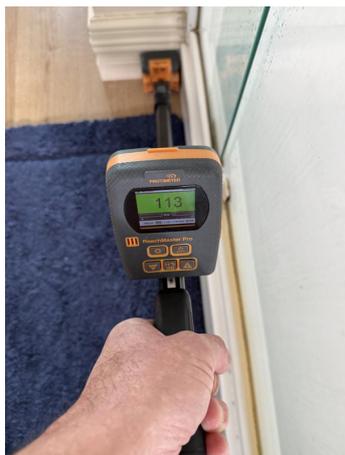
Photo 58
Corner of the ensuite shower has indications of normal moisture.

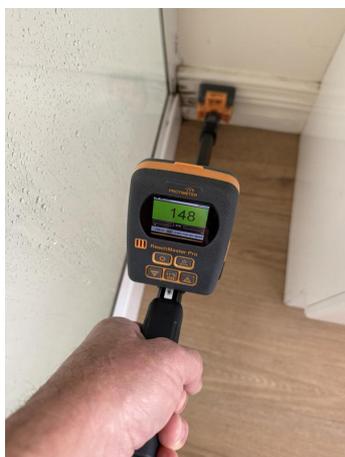
Photo 59
Corner of the ensuite shower has indications of normal moisture.

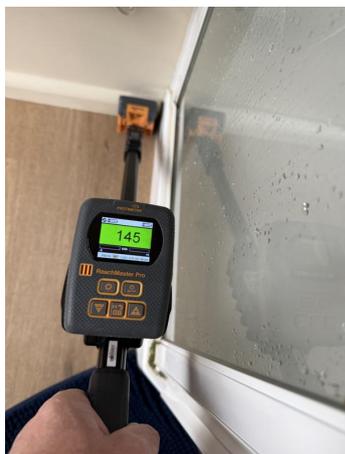
Photo 60
Corner of the bathroom shower has indications of normal moisture readings.

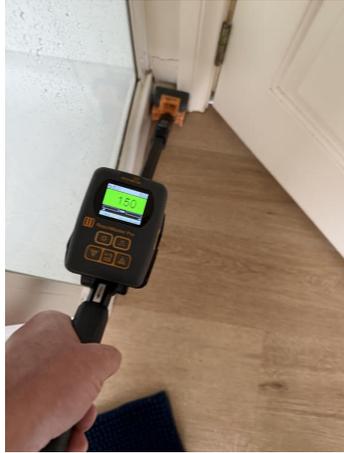
Photo 61
Corner of the bathroom shower has indications of normal moisture readings.

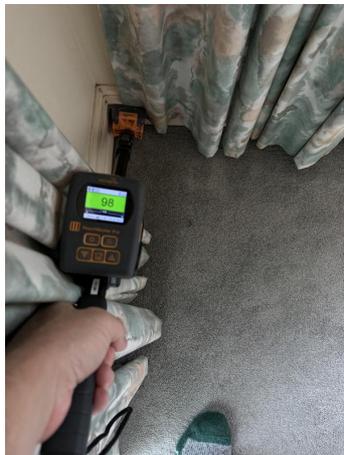
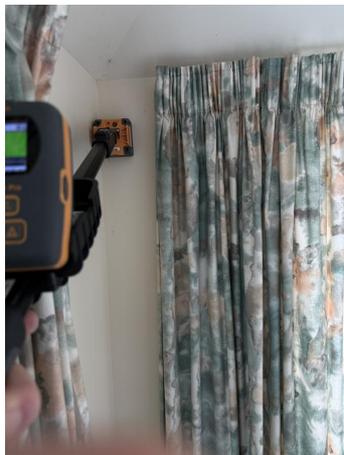
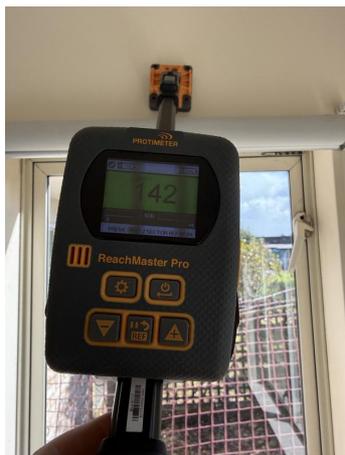
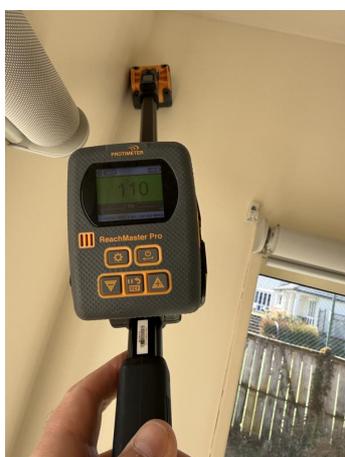
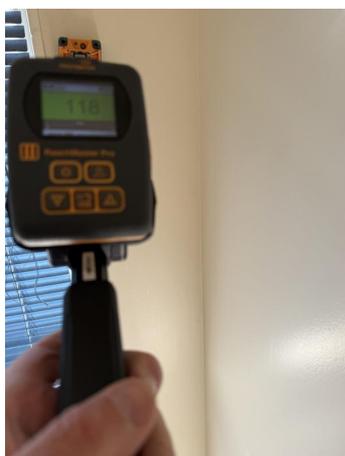
Photo 62
Supplementary moisture testing photos, indications of normal moisture readings.

Photo 63
Supplementary moisture testing photos, indications of normal moisture readings.

Photo 64
Supplementary moisture testing photos,
indications of normal moisture readings.

Photo 65
Supplementary moisture testing photos,
indications of normal moisture readings.

Photo 66
Supplementary moisture testing photos,
indications of normal moisture readings.

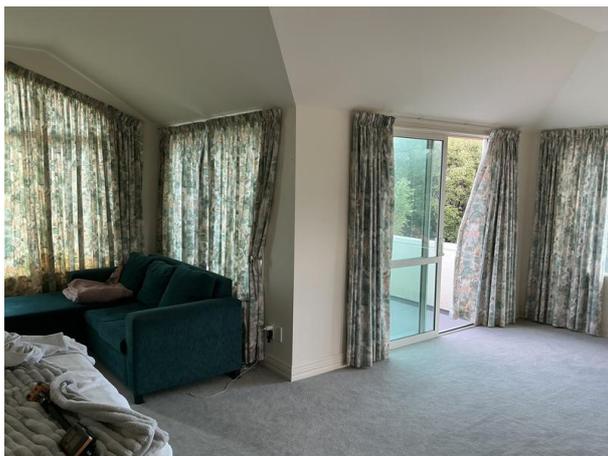
Photo 67
Bedroom 1.

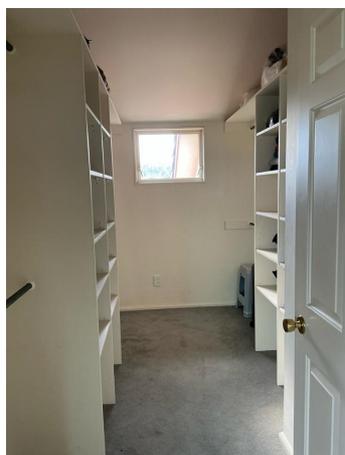
Photo 68
Walk in wardrobe.

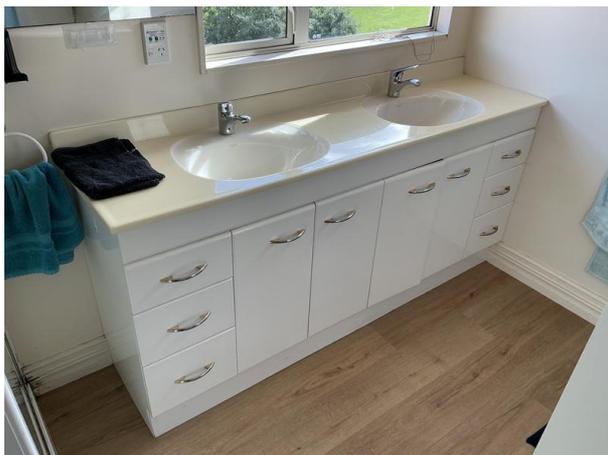
Photo 69
Vanity.

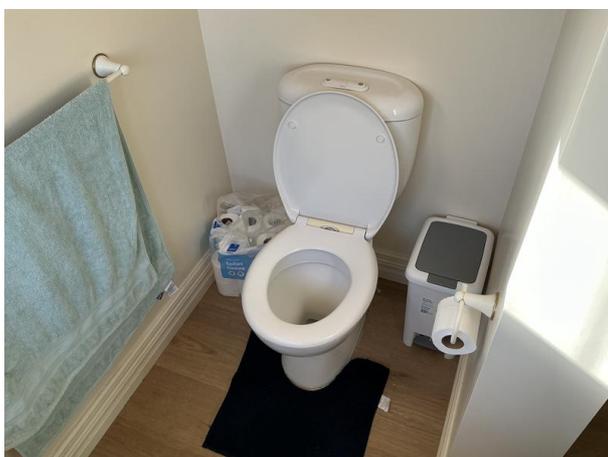
Photo 70
Toilet.

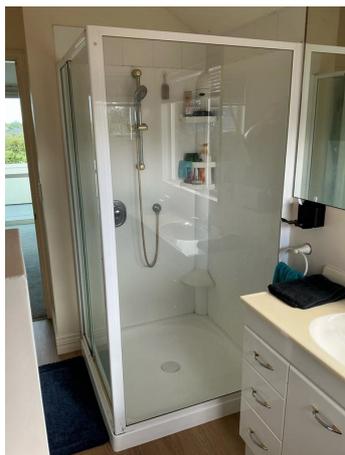
Bath - Bath-wall junction - Shower - Acrylic tray and walls. Water leaking between the wall liner and the shower track junction.

Photo 71
Shower.

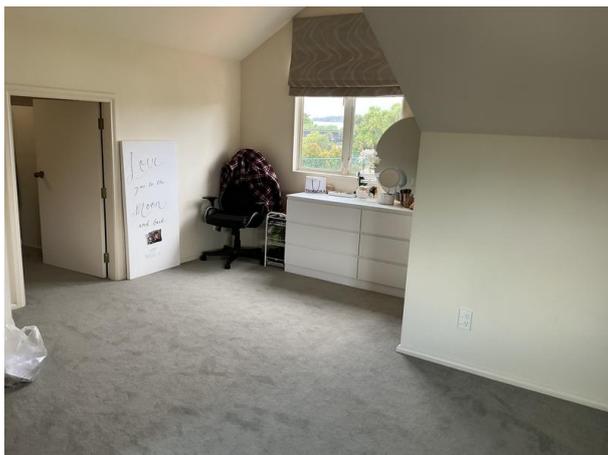
Photo 73
Bedroom 2.

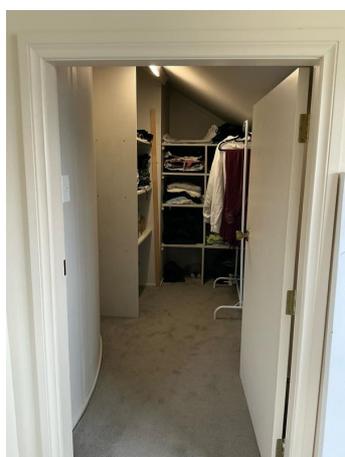
Photo 74
Walk in wardrobe.

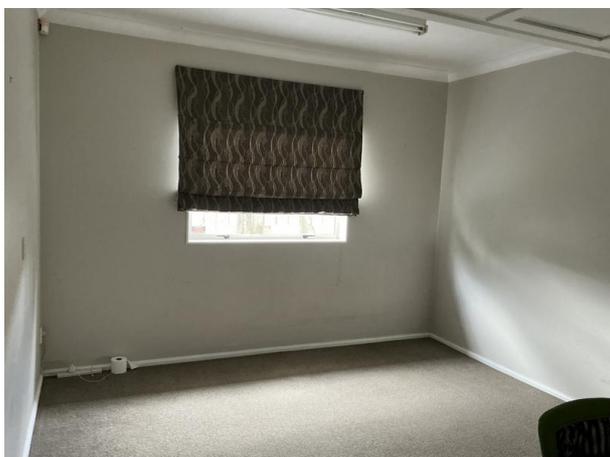
Photo 76
Room converted from a garage.

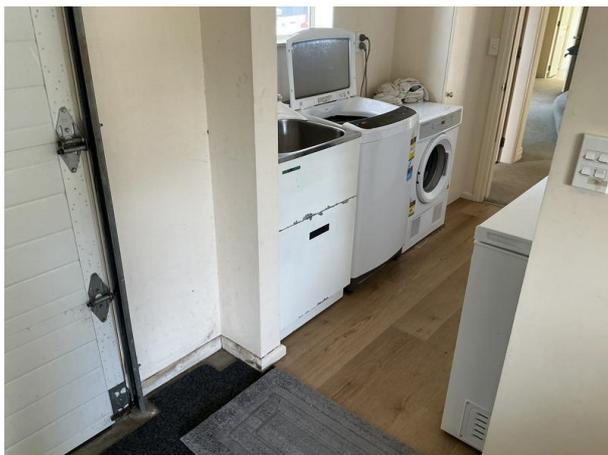
Photo 77
Laundry.

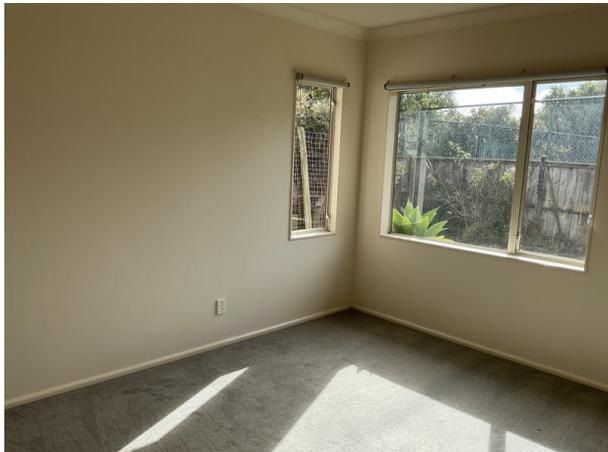
Photo 80
Bedroom 3.

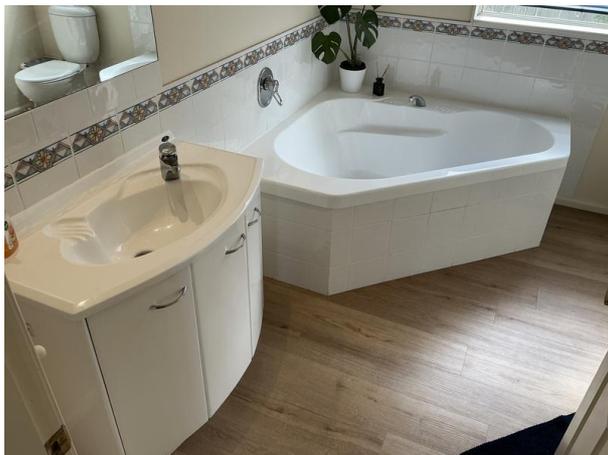
Photo 81
Vanity and bath tub.

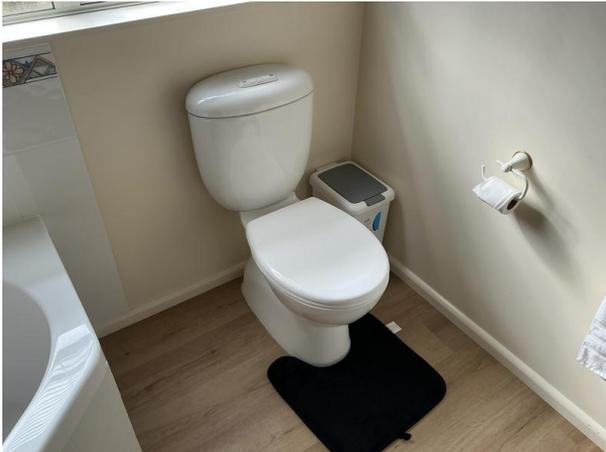
Photo 82
Toilet.

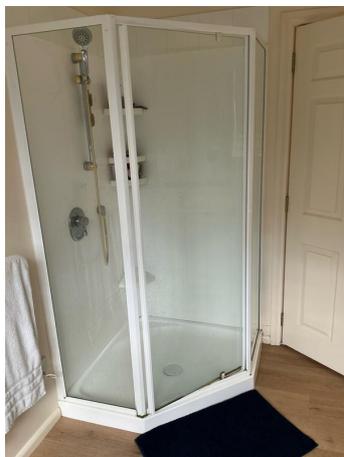
Photo 83
Shower.

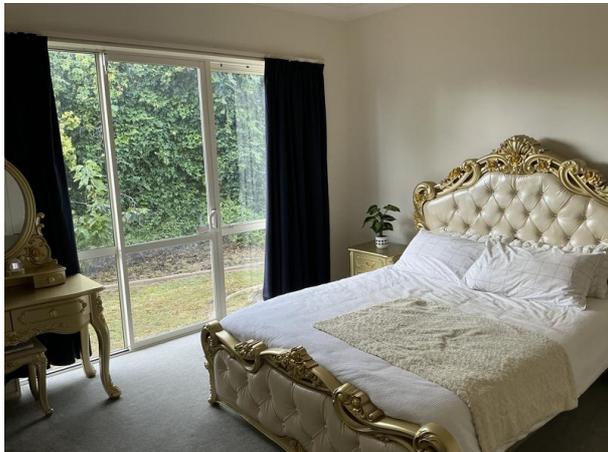
Photo 86
Bedroom 4.

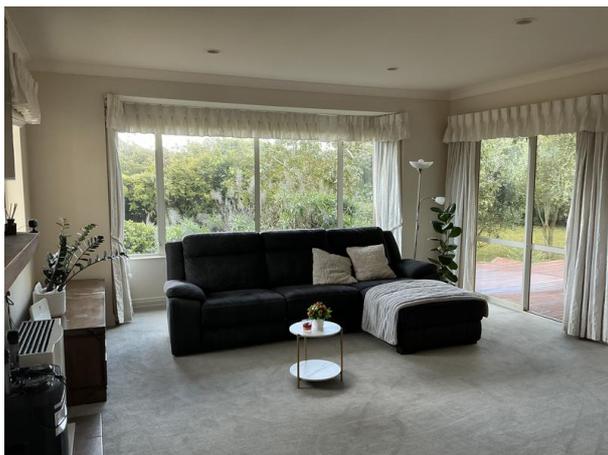
Photo 87
Living room.

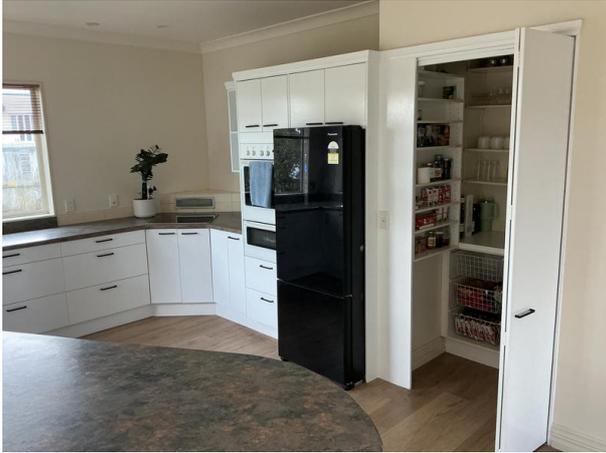
Photo 88
Kitchen.

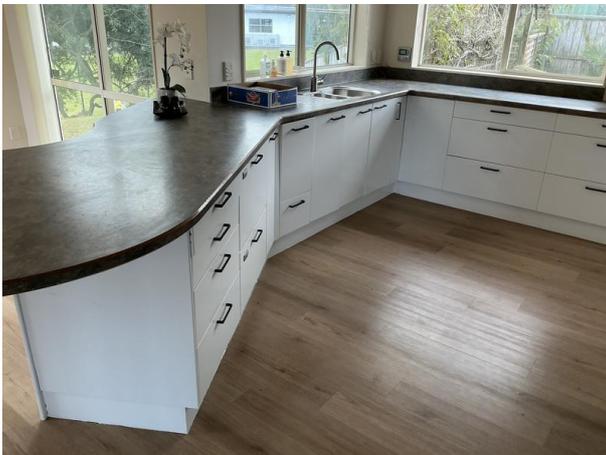
Photo 89
Kitchen.

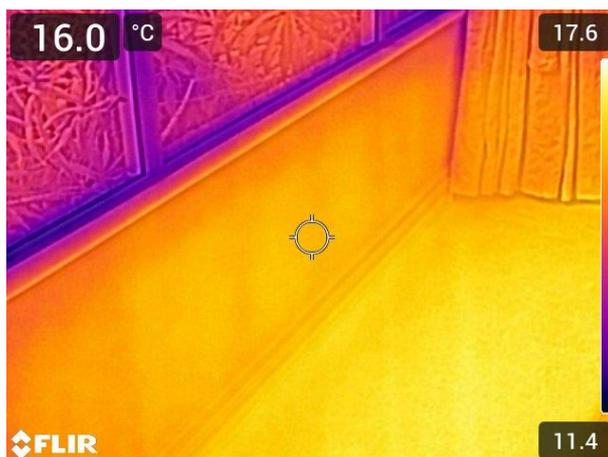
Photo 90
Living room west facing wall has no notable temperature differences.

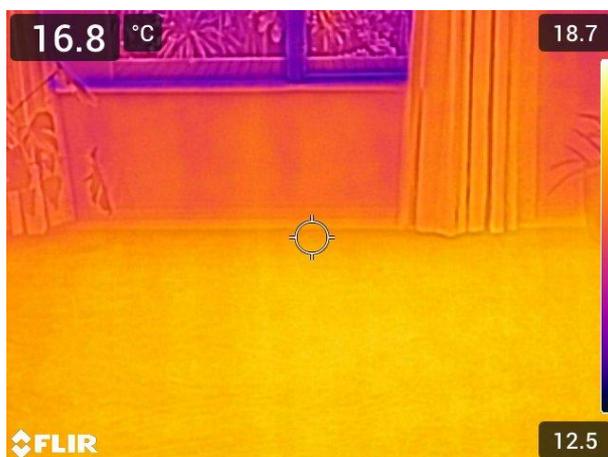
Photo 91
Living room north facing wall has no notable temperature differences.

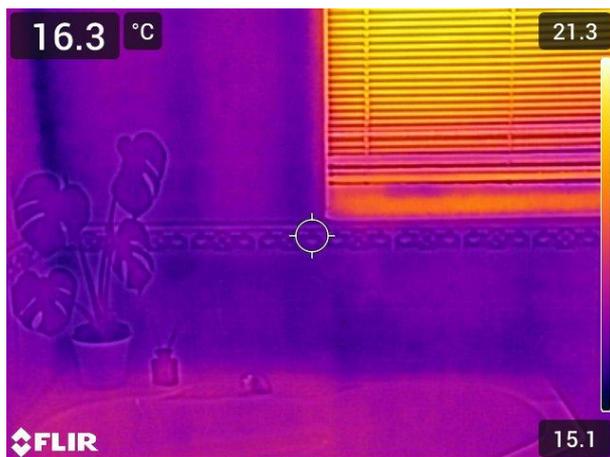
Photo 92
Bathroom has no notable temperature differences.

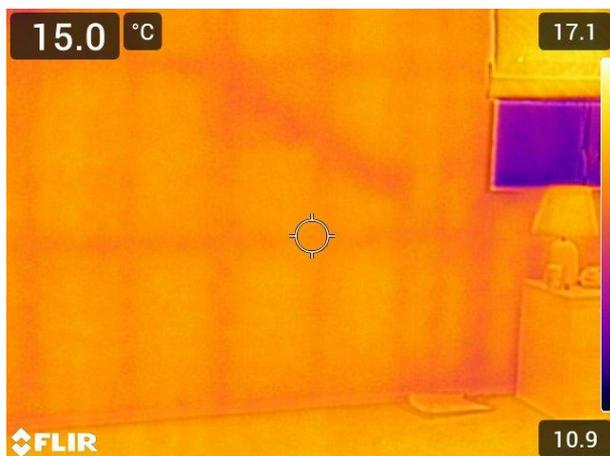
Photo 94
Bedroom 2 south facing wall has no notable temperature differences.

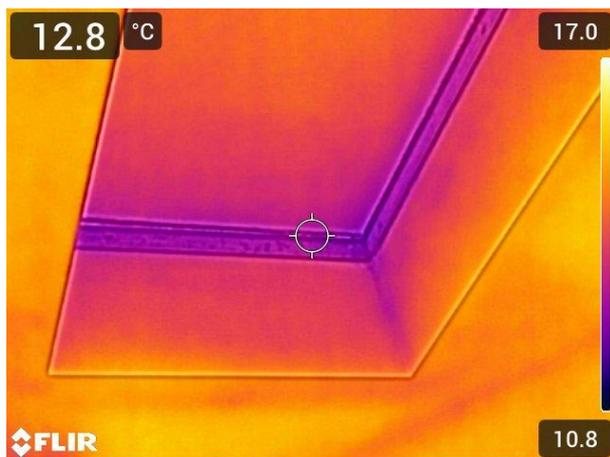
Photo 95
Skylight has no notable temperature differences.

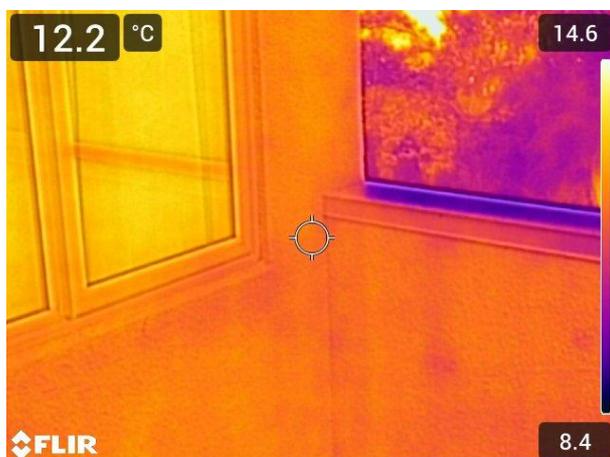
Photo 96
Balcony barrier wall junction with the house has no notable temperature differences.

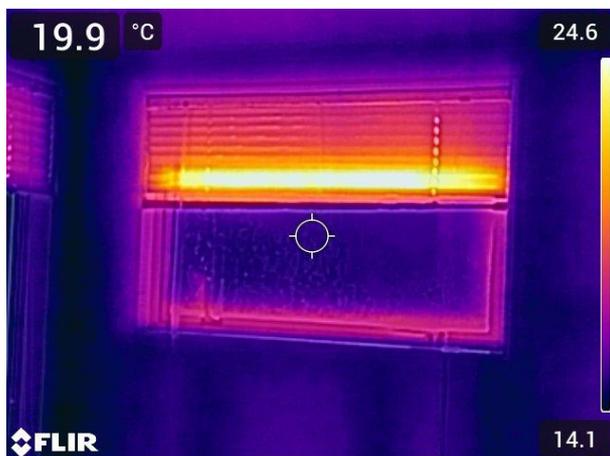
Photo 97
Ensuite east facing wall has no notable temperature differences.

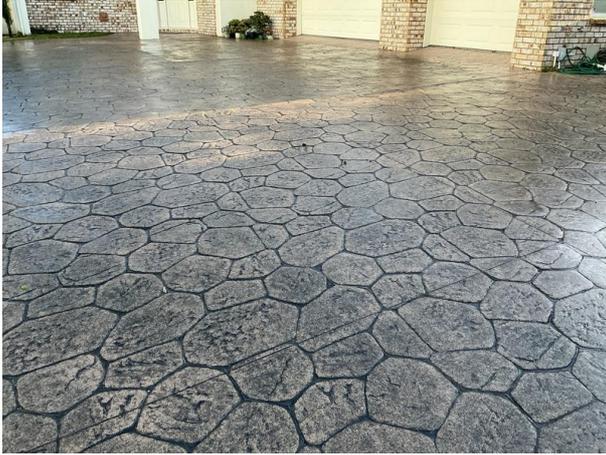
Photo 98
Driveway, functional.

General upkeep and maintenance of driveway by cleaning and keeping free of debris.

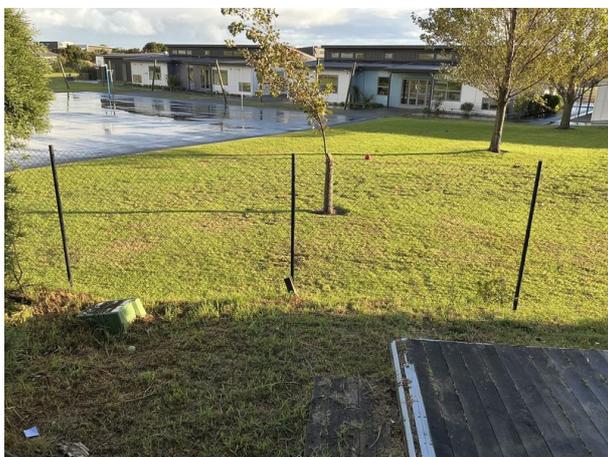
Photo 100

North side wire fence.

General upkeep and maintenance, keep vegetation and soils clear of timbers as these timbers are only exterior treated and will rot if vegetation or soils are up against them.

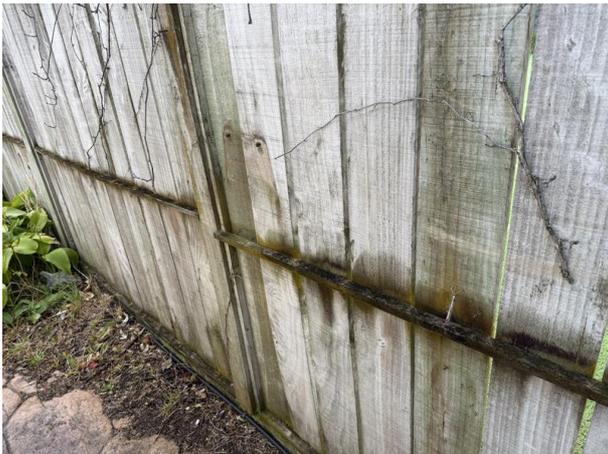
Photo 101
East side detached rail.

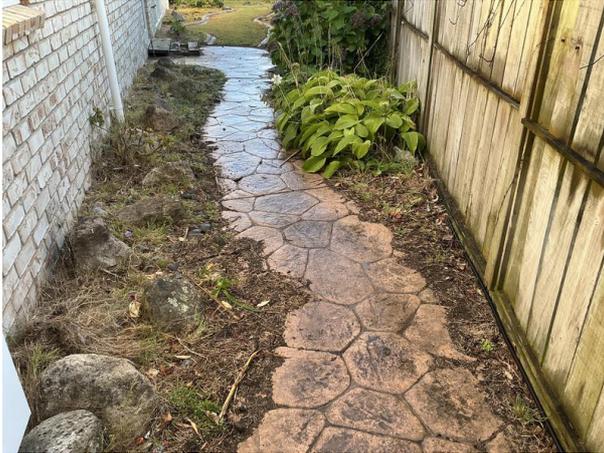
Photo 102
East side, functional.

General upkeep and maintenance.

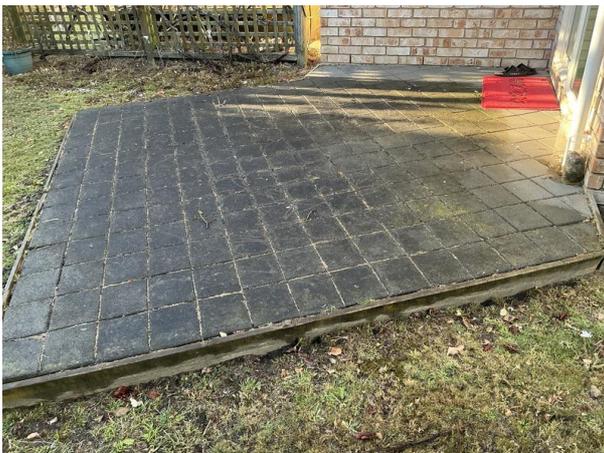
Photo 103
North side, functional.

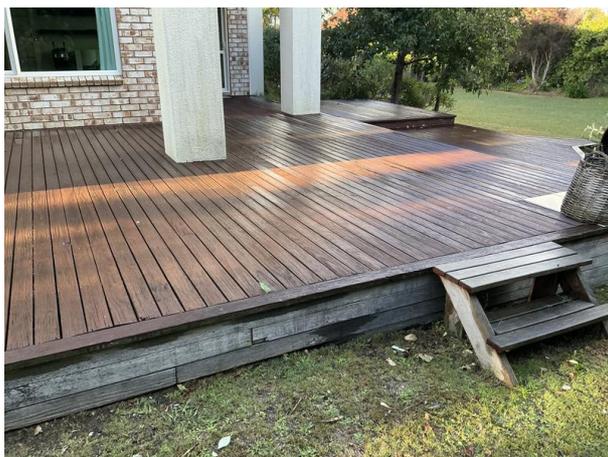
Timber deck over timber substrate with nail fixings.
Connected to dwelling - Yes.
Condition of visible timbers - Some rot visible.

Photo 104
North side deck.

General upkeep and maintenance.

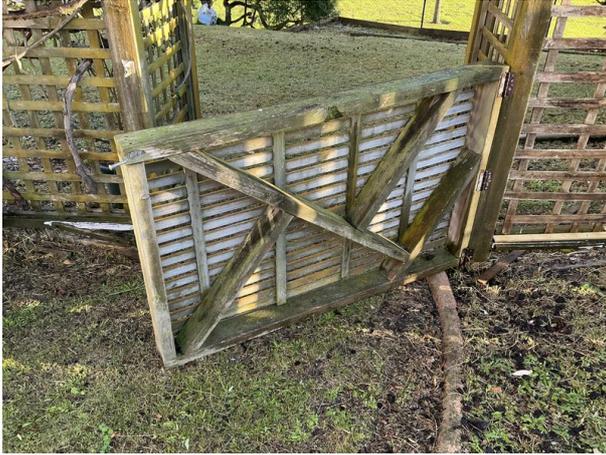
Photo 106
East side, functional.

Recommend regular lubrication of the hinges and latch to maintain full function.

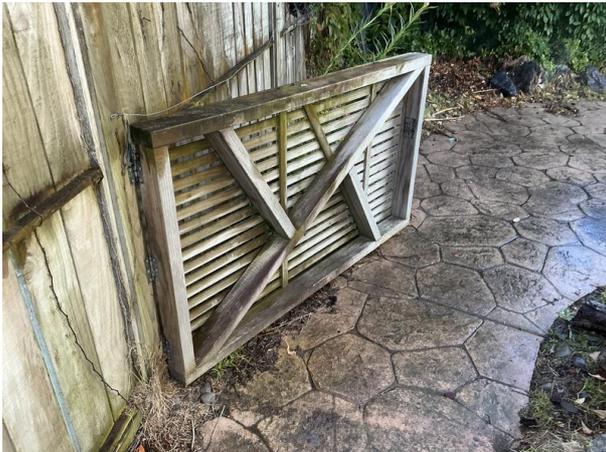
Photo 107
East side, functional.

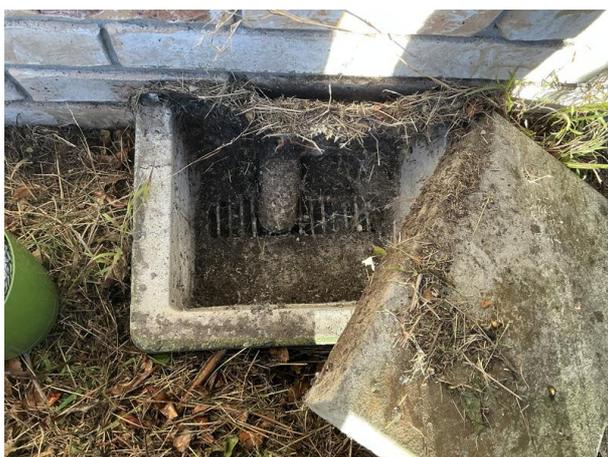
Photo 109

Gully trap located on the east side.

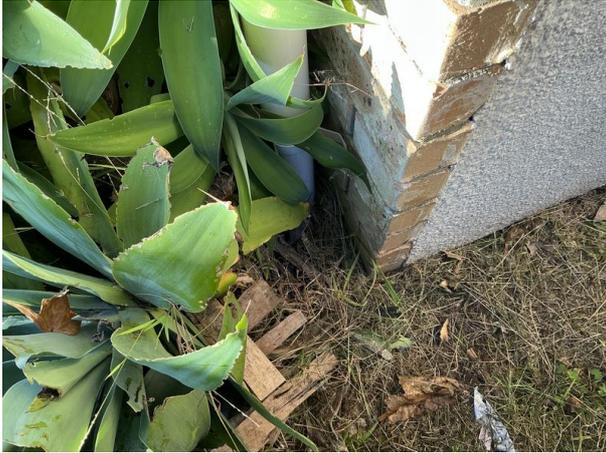
Photo 110
Downpipe located on the east side
connection not visible.

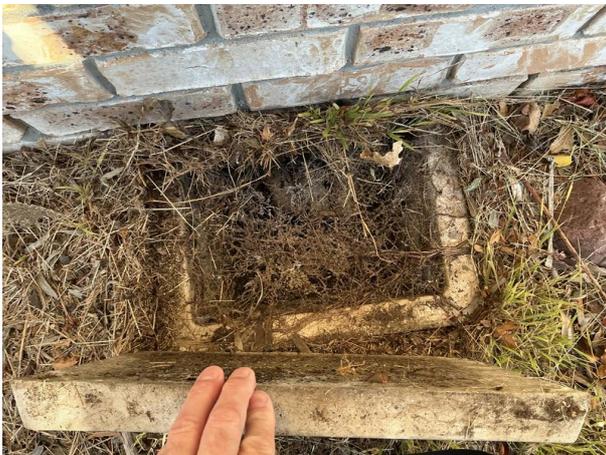
Photo 111
Gully trap located on the east side has
debris inside it.

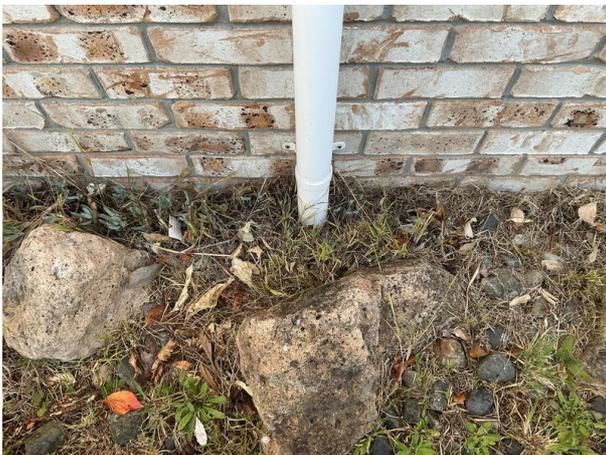
Photo 112
Downpipe located on the east side
connection not visible.

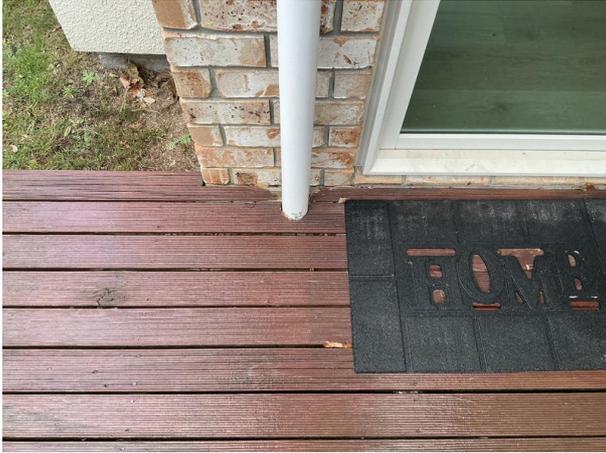
Photo 113
Downpipe located on the north side
connection not visible.

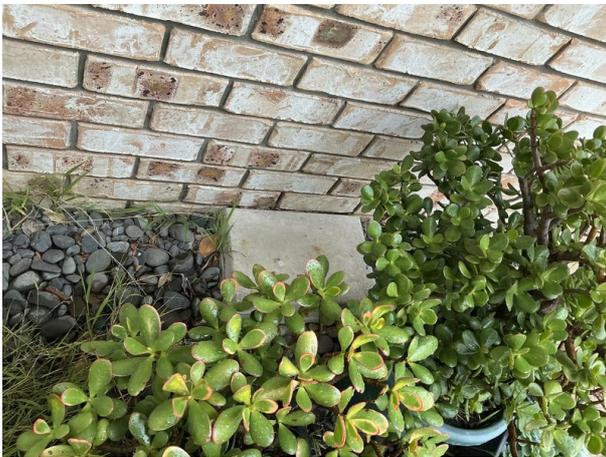
Photo 114
Gully trap located on the west side.

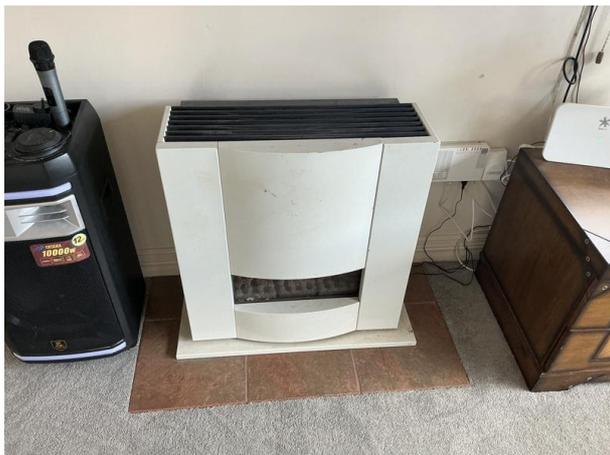
Photo 116
Gas fire located in the living room.

Follow the manufacturer's recommended servicing schedule to ensure the equipment operates efficiently and maintains optimal performance. Adhering to these guidelines helps identify and address potential issues early, reducing the risk of costly repairs and ensuring compliance with warranty requirements.

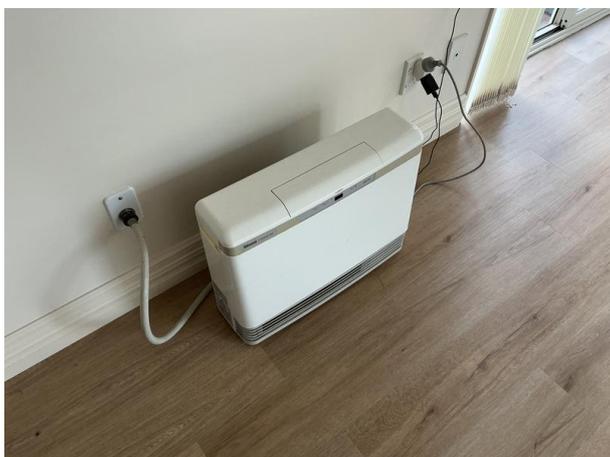
Photo 117
Gas heater located in the kitchen.

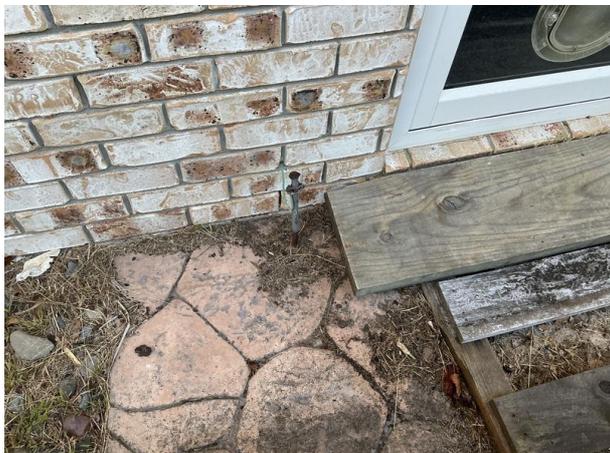
Photo 118
Earth stake located on the east side.

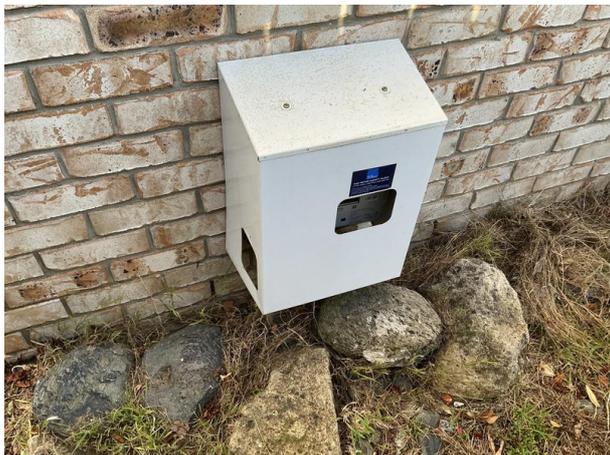
Photo 119
Gas meter located on the east side.

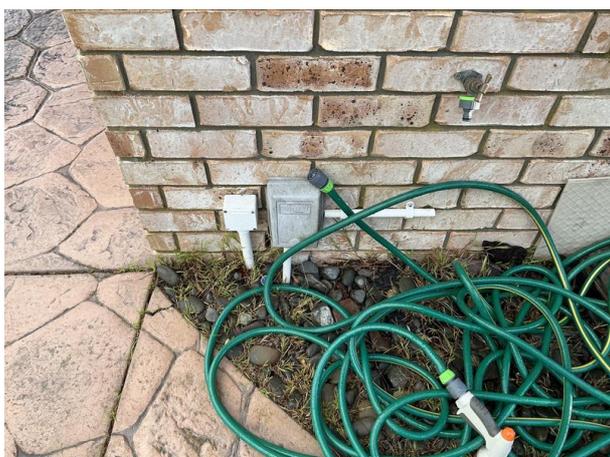
Photo 120
Telco and cable TV located on the southside.

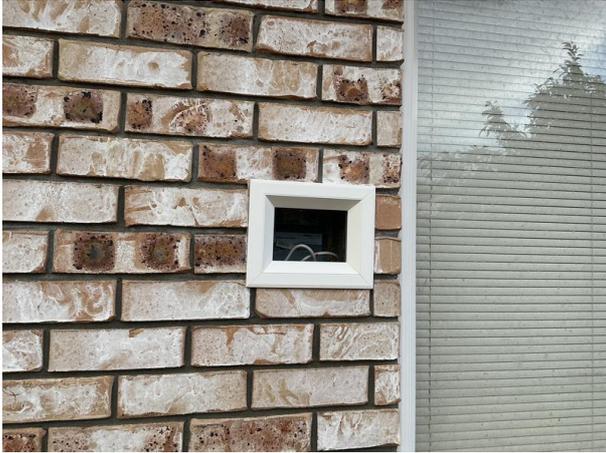
Photo 121
Meter board located on the southside.

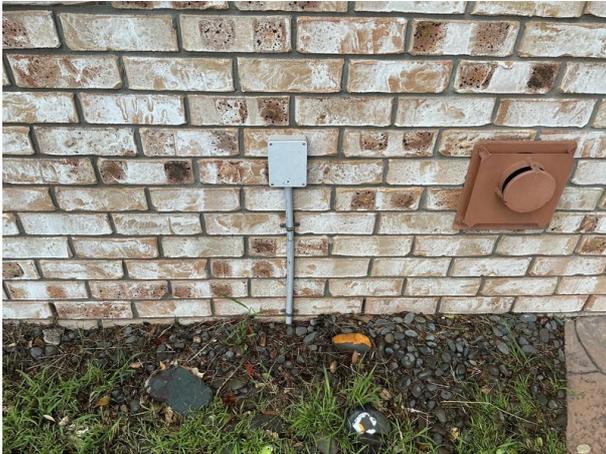
Photo 122
Data located on the west side.

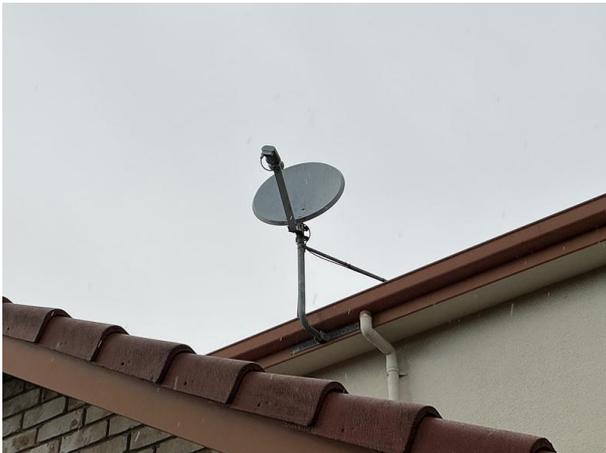
Photo 123
Sky dish located on the north side.

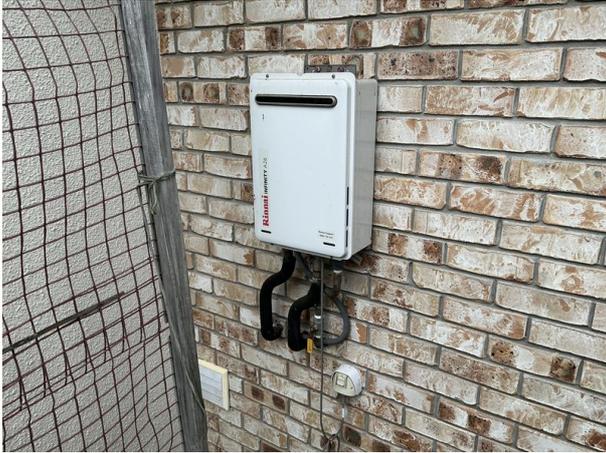
Photo 124
Califont located on the east side.

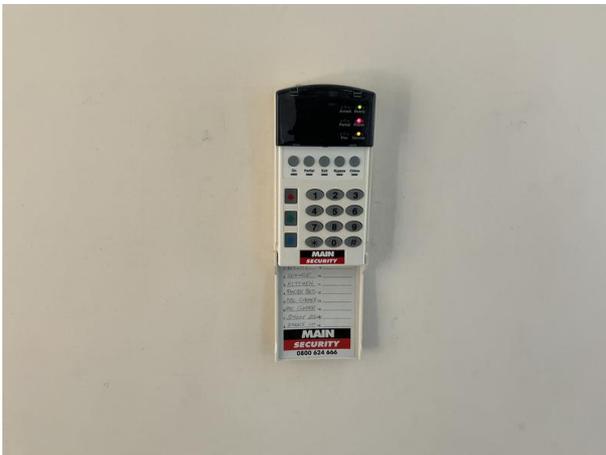
Photo 125
Security system keypad is located by the front door.

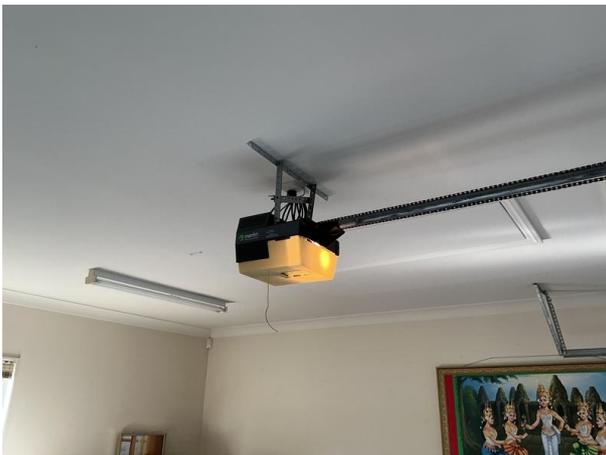
Photo 126
Garage door opener is functional.

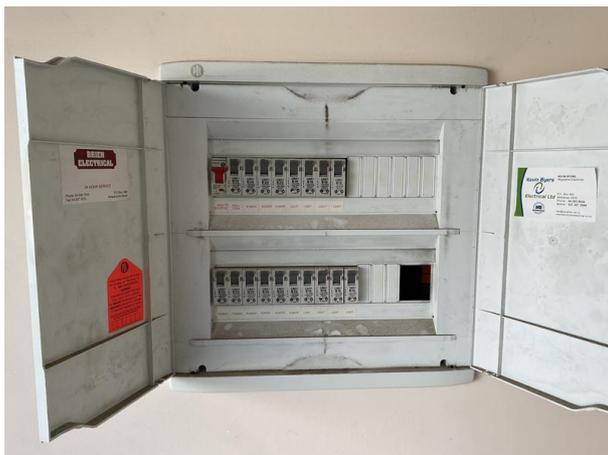
Photo 127
Distribution board is located in the garage.

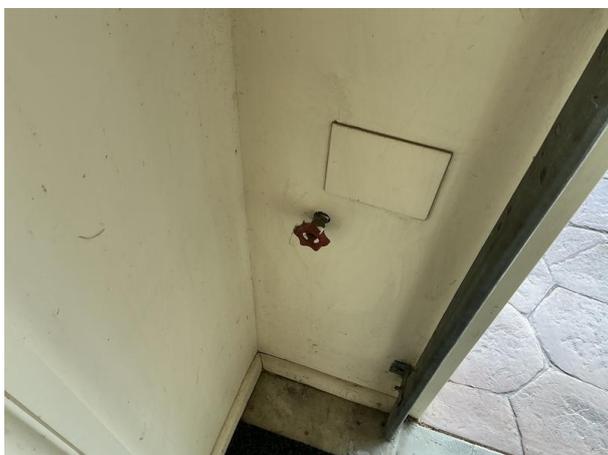
Photo 128
Toby is located in the garage.
