RED LBP WEATHERTIGHT REPORT

WEATHERTIGHT REPORT

Property Address	15 Compass Court Paraparaumu
Client	Sitha Than
Date of Inspection	3rd March 2026
Time	8:00 am
Inspector	Trevor Garrett MSc, LBP, Advanced Trade Cert Carpentry, Nat Diploma Construction Management. Member of NZIOB.
LBP Number	131790
People Present	Inspector
House Occupied	No

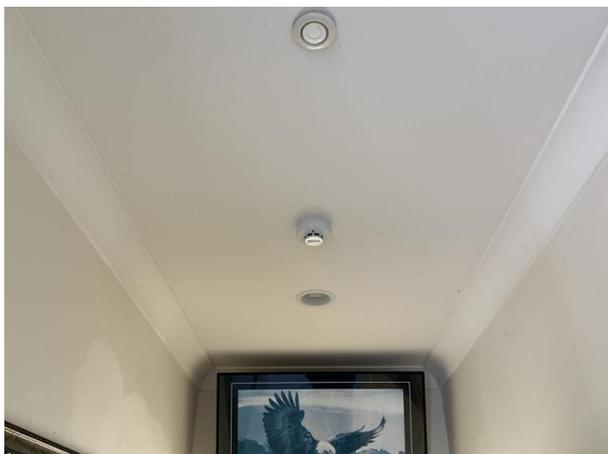
Photo 129
Smoke detector located in the lower hallway.

All services should be tested and maintained by certified professionals to the manufacturer's specifications. Regular checks to ensure smoke detectors are functional.

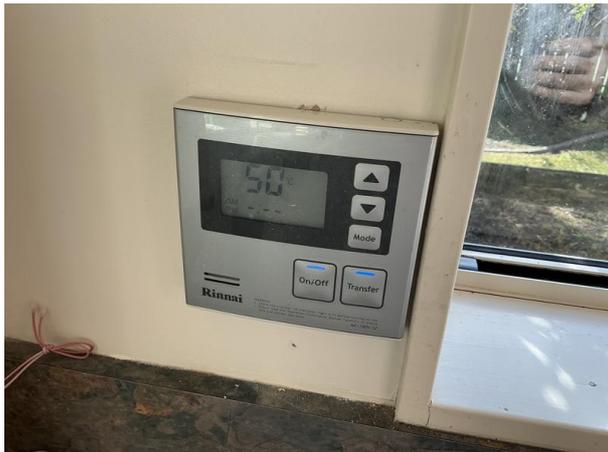
Photo 130
Water temperature controllers are located in the kitchen and bathrooms.

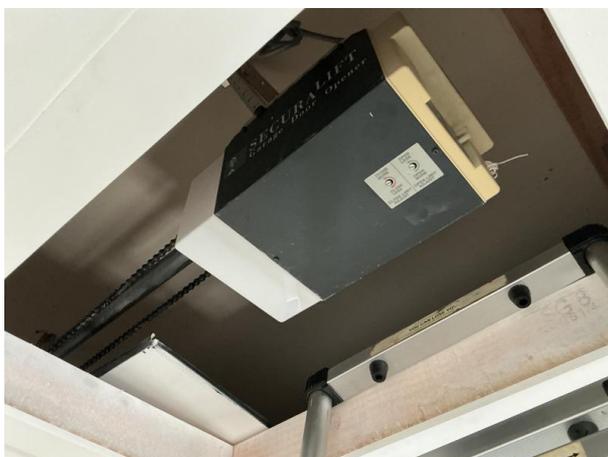
Photo 131
Second garage door opener, not tested.
