## Brian Marsh Property Inspection

17 c Epiha Street  
Paraparaumu  
Kapiti

## Inspection Overview

**Date of Inspection** 31 July 2026

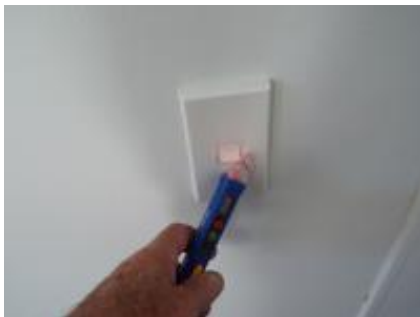
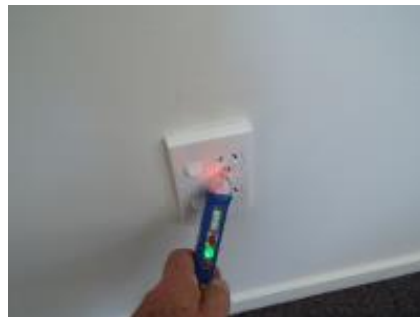
good order

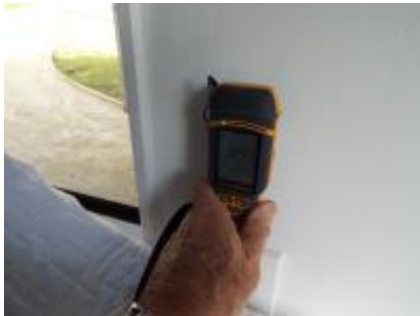
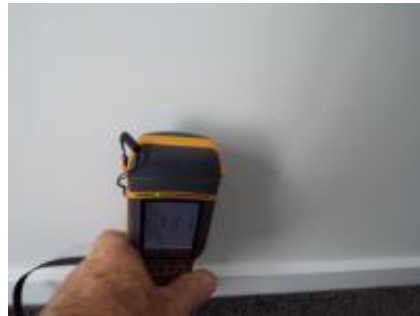
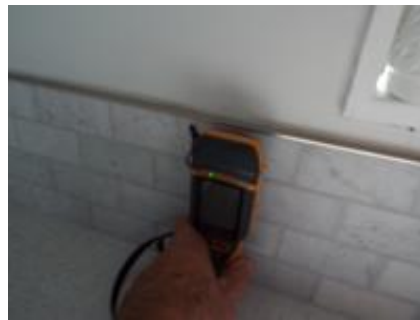
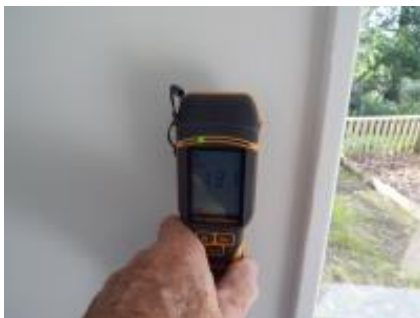
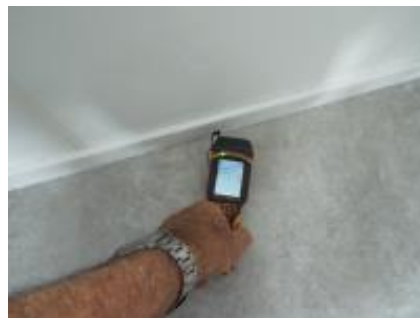
| <b>Levels were found to be</b> | NO ISSUES FOUND AT THE TIME OF INSPECTION<br>Acceptable in all areas checked<br>Protimeter SurveyMaster (model BLD5375 )Search Mode (Non-Invasive): Uses radio frequency to scan up to $(19 \text{ mm})$ $(0.75 \text{ inches})$ deep below the surface. It gives a relative reading from 60–999 and is ideal for rapidly checking walls and floors unaffected by surface moisture. Green light indicates dry, red light indicates wet.. |

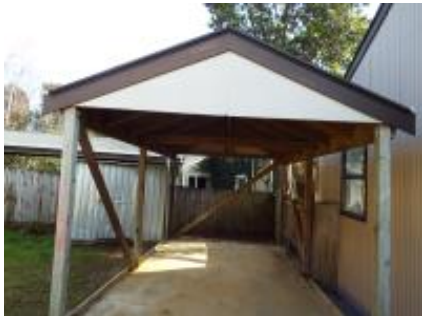
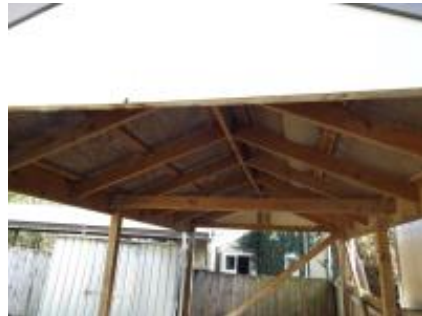
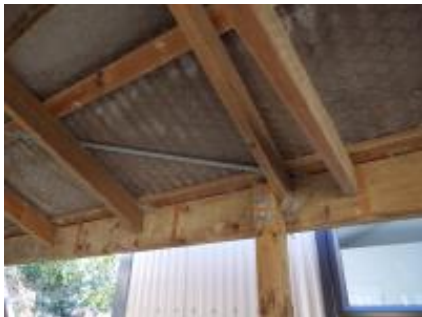
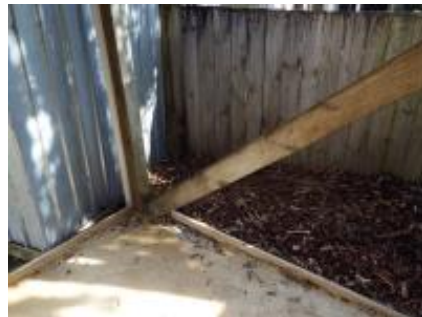
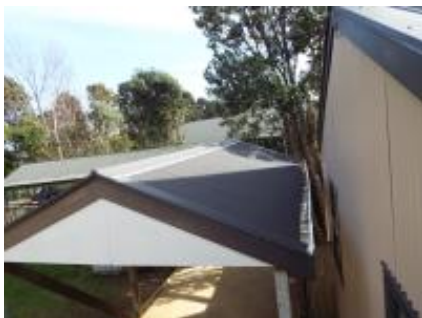
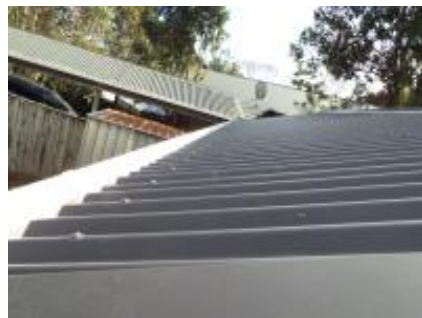
## Carport

| <b>Roof</b> | Iron<br>Generally Good |
| <b>Floor</b> | Gravel<br>Generally Good |
